ENGLISH HERITAGE

DAMP TOWERS CONFERENCE

18TH APRIL 2013

INTRODUCTION AND OVERVIEW OF THE DAMP TOWERS RESEARCH PROJECT

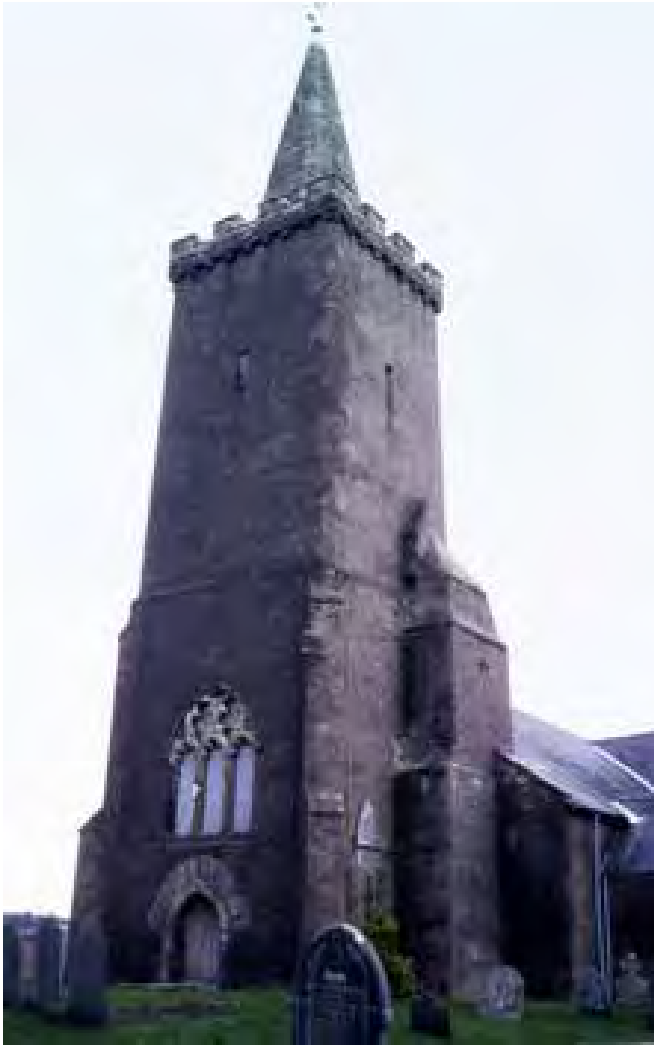
This is St. Mary's, Rattery. This had been given a rough cast render and was still leaking.

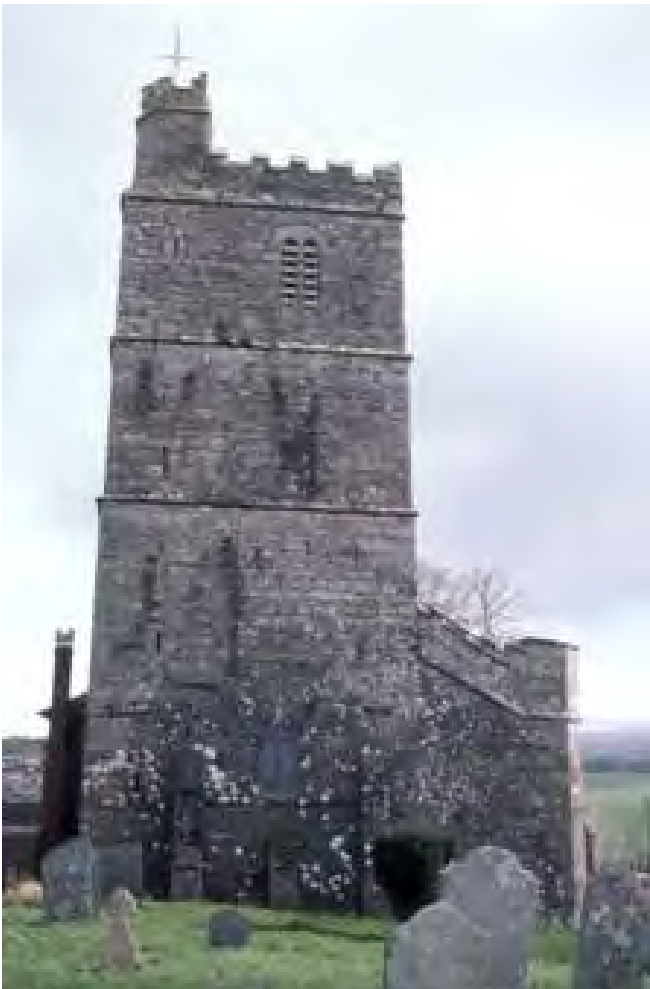
Bratton Clovelly, on the west side of Devon, again similar problem: granite rubble, cement pointing, water escaping on the outside and inside the ringing chamber.

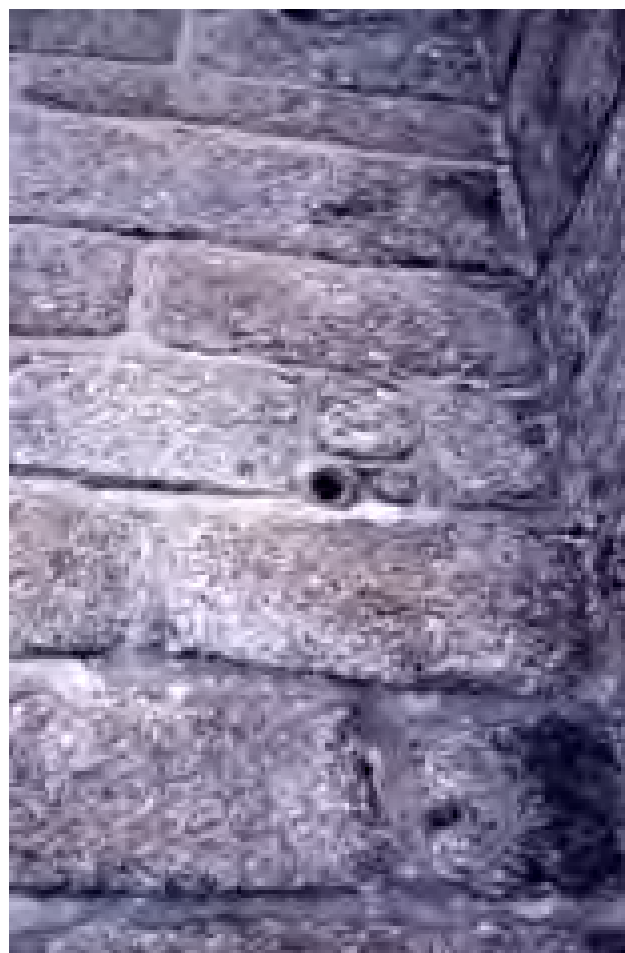
Drainage channels were put in on the outside right up to the middle of the core. As you can see there's water coming out everywhere except of course from the drainage channels. The report concluded that these structures were built with impermeable stones and suffer from very high levels of exposure. This means that all the work in terms of dealing with moisture is done by the joints. Joints invariably crack and the problem is made worse, seemingly by shallow pointing using impermeable materials.

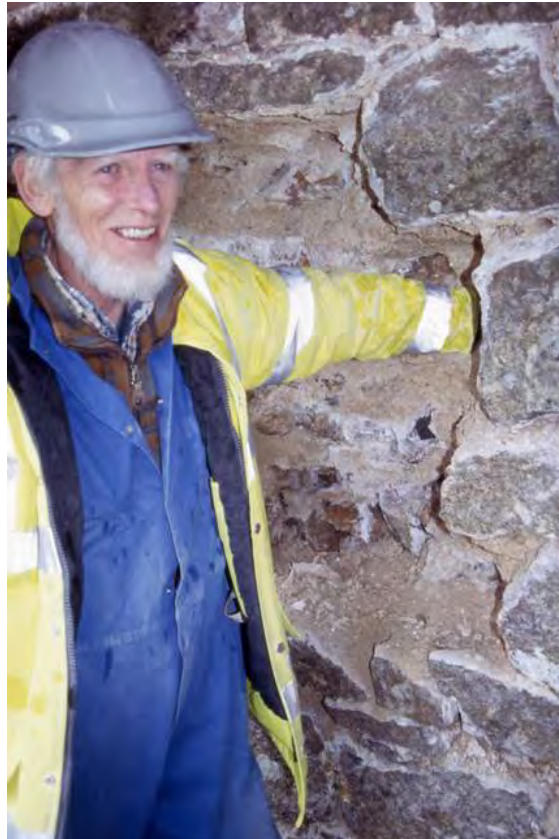
We've got water coming through straight away, escaping on the inside. The original intention was to use an hydraulic material (NHL5) and a very gritty aggregate, and grout with a fairly cementitious mix. At the time it was justified on the basis because the weather was not good (it was far from ideal time to be doing this sort of work), it was a very tough stone (they had to rebuild quite a bit). It was a substantial job carried out in very adverse conditions.

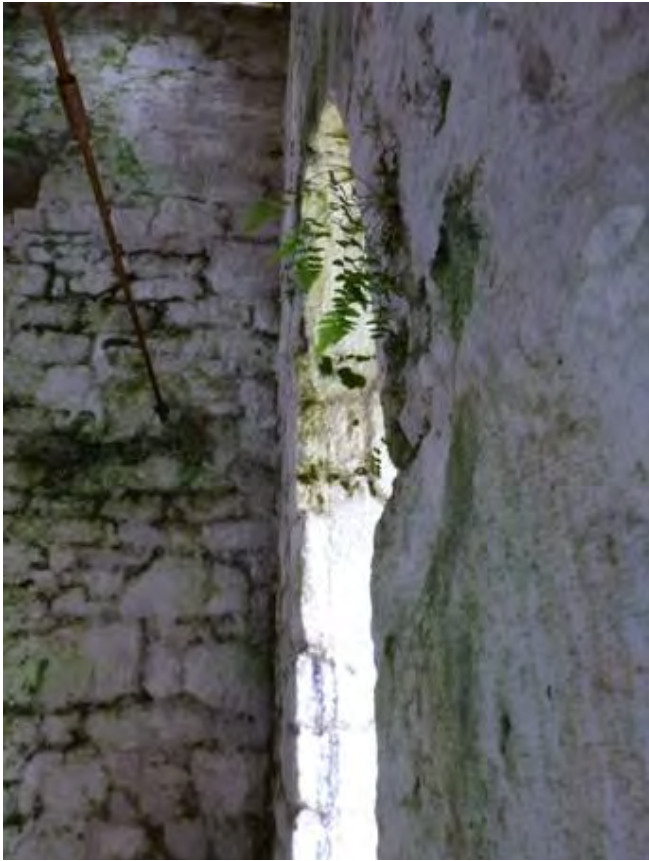
This is what it's like in November of last year – it looks like we've got neat penicillin growing up on this wall. It is a really grim state and most unfortunate. When you look on the outside there is very little evidence of bad workmanship or problems – there's no cracks in any of this pointing. We can see moss beginning to accumulate, which may mean we are getting excess moisture between the joint and stone. On the other hand it's simply that we've got a horizontal ledge that moss will sit on and it's bound to be wet. And the solution? Well, we haven't been asked fortunately, but clearly one would have to carry out some careful investigation of the core to try and discern what has actually been going on.

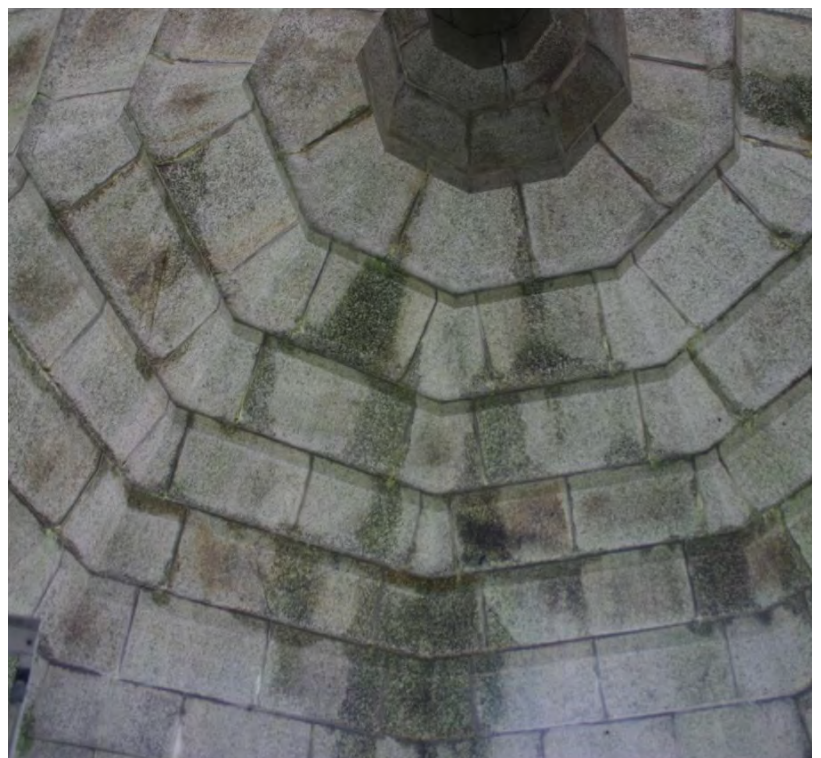
Chris has already mentioned penicillin growing on the walls. You can see the moisture glistening on the surface. This is the inside surface of the tower, in Dartmoor, it's just so unhealthy. We were in there probably 20 minutes and couldn't wait to get out.

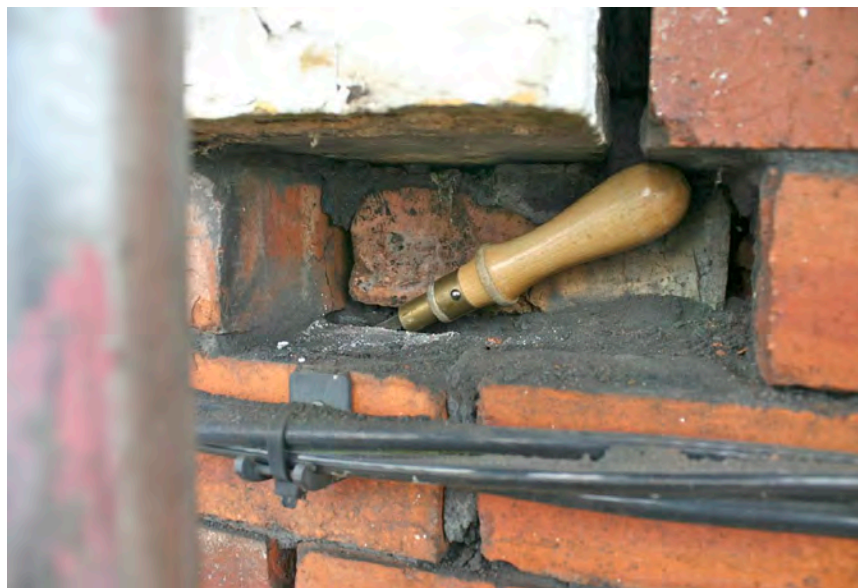
Here you can see that the beds are solid, but the perpendiculars are open.

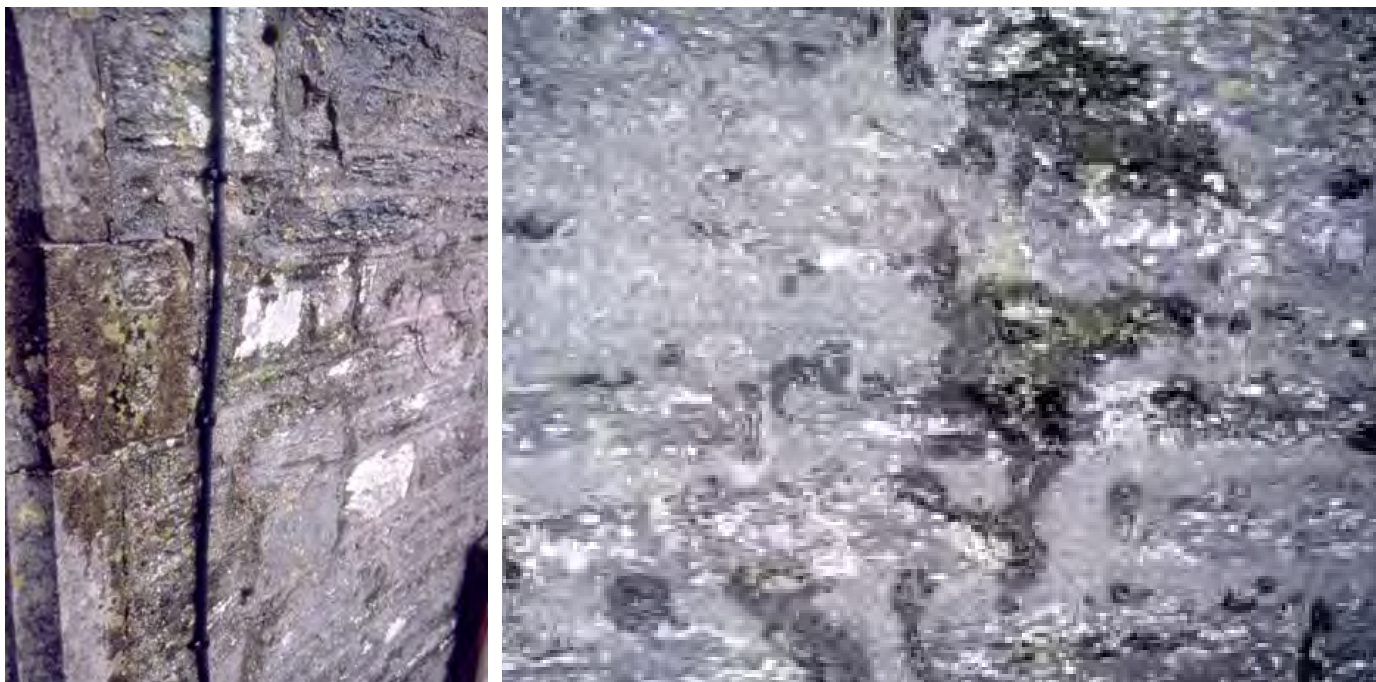
This slide shows a drying elevation with very clear dark marks to indicate where the moisture is escaping through the cracks and patches of cement and obviously you've got the same at this window.

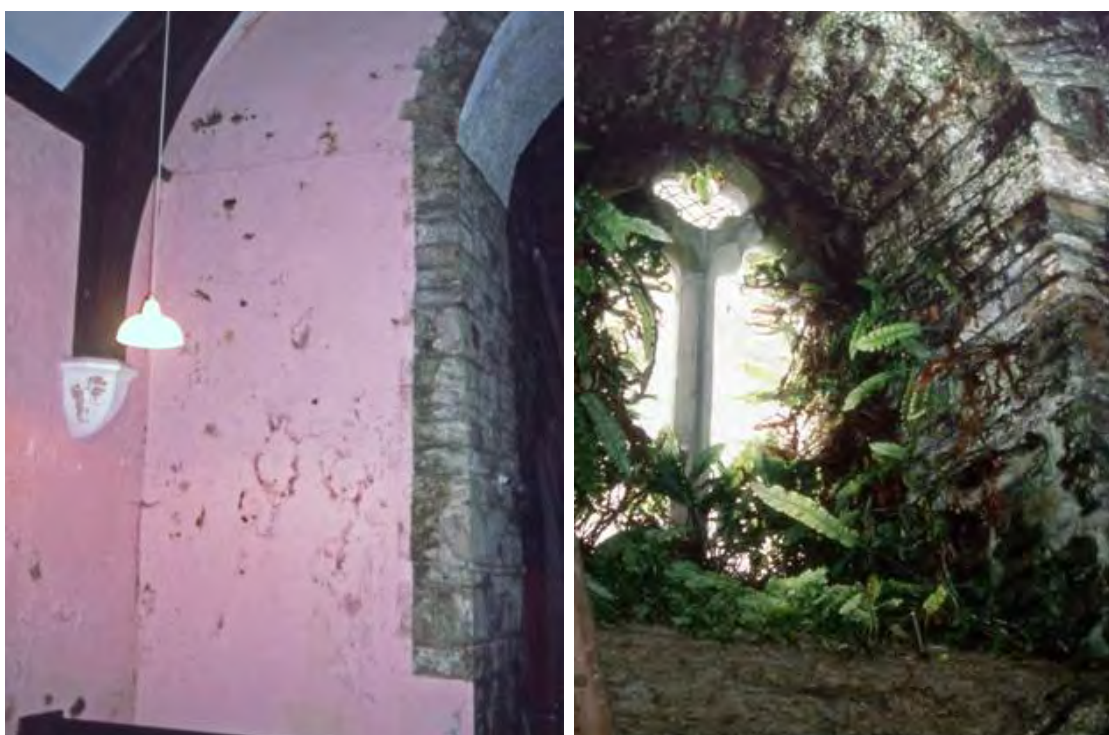
On the left hand side just some of the mould. There was mould everywhere which is not very surprising since that's pretty hard plaster on the inside. That's up in the belfry absolutely covered in lime bloom. So what we did as part of the grant aid, was to monitor the walls with the timber dowel method for a whole year. Essentially what it shows is that the whole tower was absolutely saturated, bar a small part of the eastern wall. Fairly invasive investigations took place on the west wall there. The initial conclusion here was in fact that the core had suffered some sort of washout – it appeared to be voided. There was a lot of earth material within the core and the thought was that major grouting would be required, but after a year of monitoring the tower was then shrouded in monoflexed scaffolding and kept up for 15 months. The cement joints were knocked out both externally and internally and basically this thing was allowed to dry down – 6 foot gap at the base of the scaffold was not covered by the monoflex to allow the wind to flow.

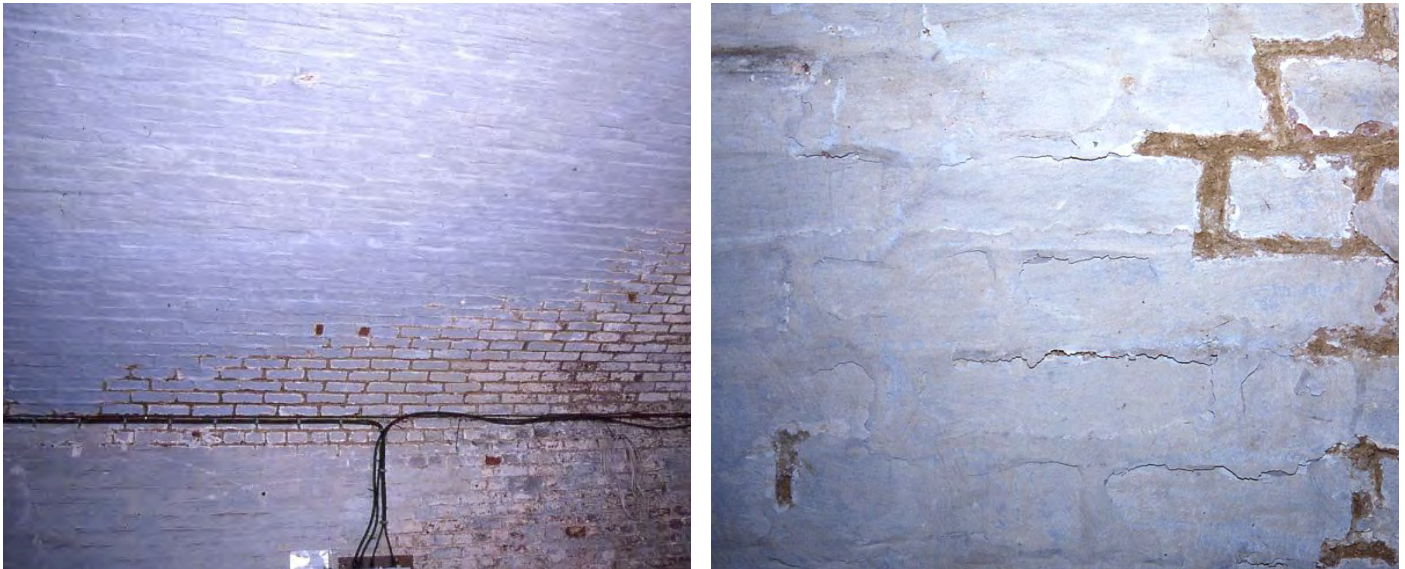
And here we see after many, many years of limewash build-up, the moisture is moving through, carrying salts through, getting that crypto efflorescence to the back of this limewash and its being burst off the face of the joint. That's exactly what we want – the joints are working. A relatively simple task now is to rake out the defective lime based mortars, and replace it with a nice soft mortar. It is a sacrificial material. We must keep that in mind. This business of pointing it up to last the next 40 years, is rarely achievable.
