Historic England

Energy Efficiency and Historic Buildings

Insulating Timber-Framed Walls

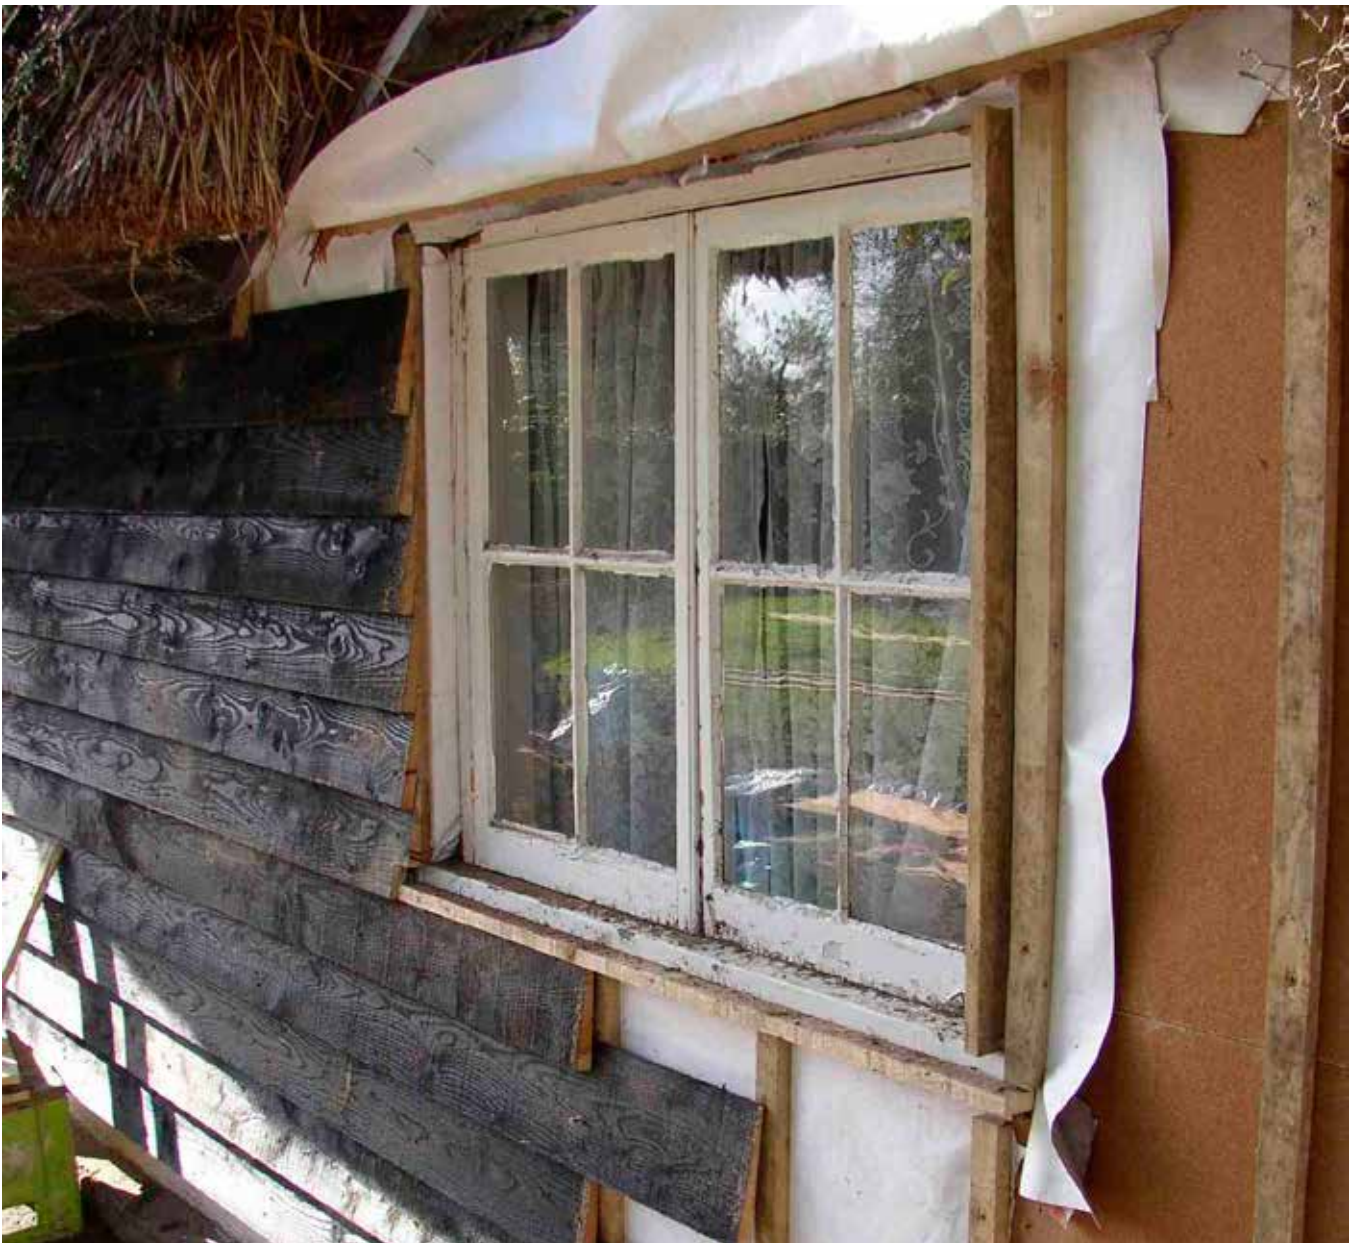
Front cover:

A vapour permeable membrane and tongue and grooved wood-fibre board has been added onto the frame below weatherboarding.

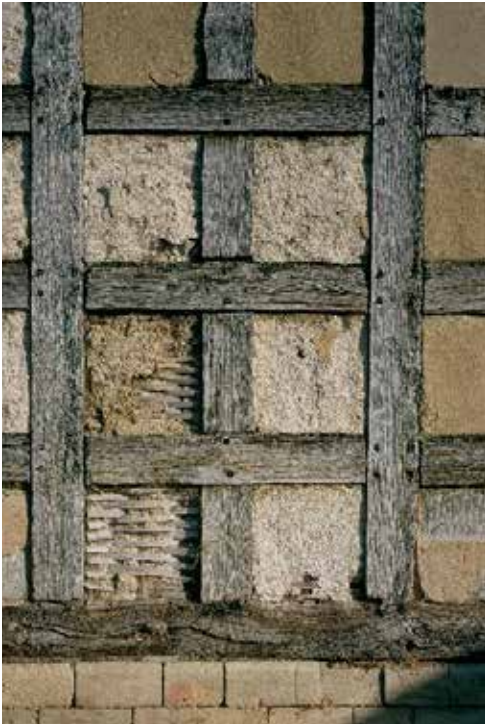
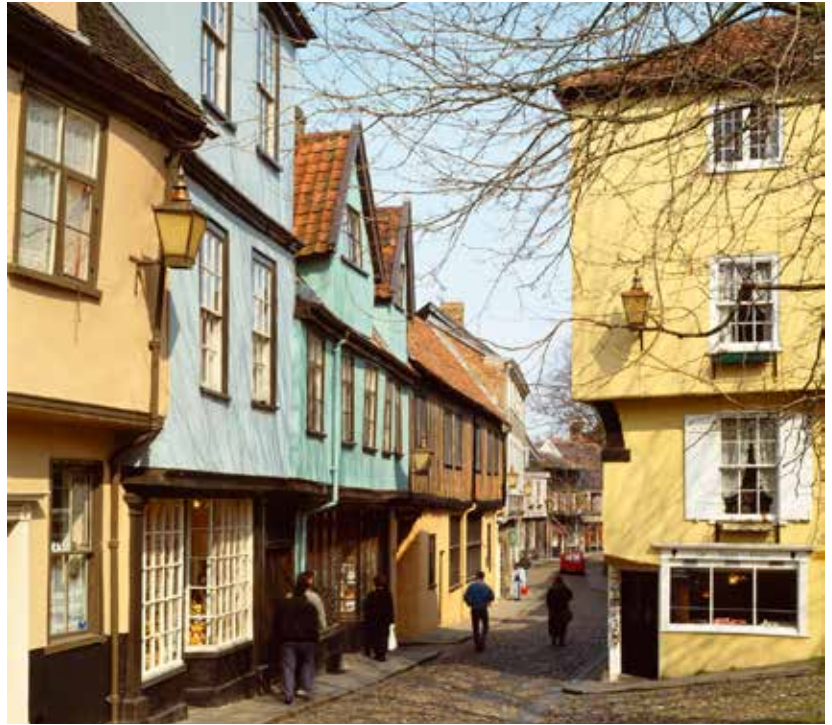
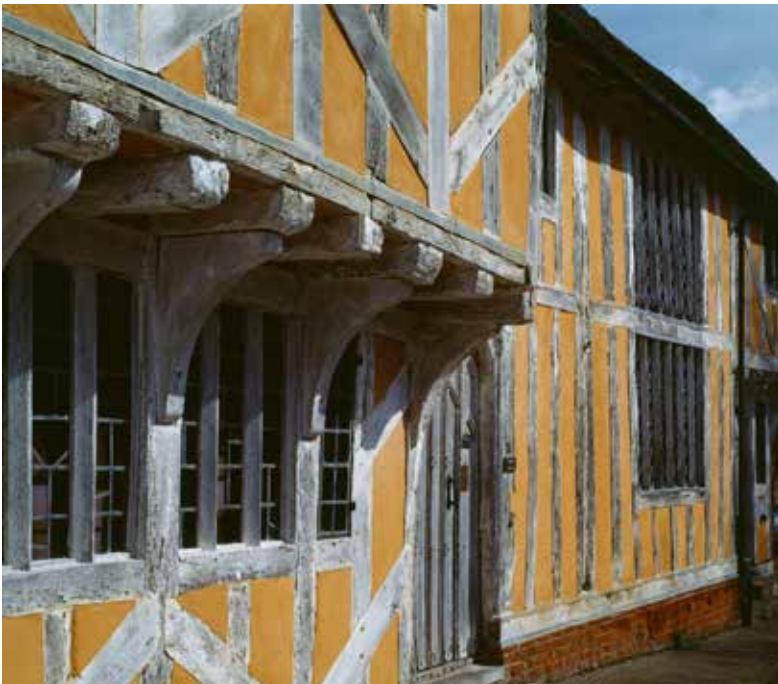
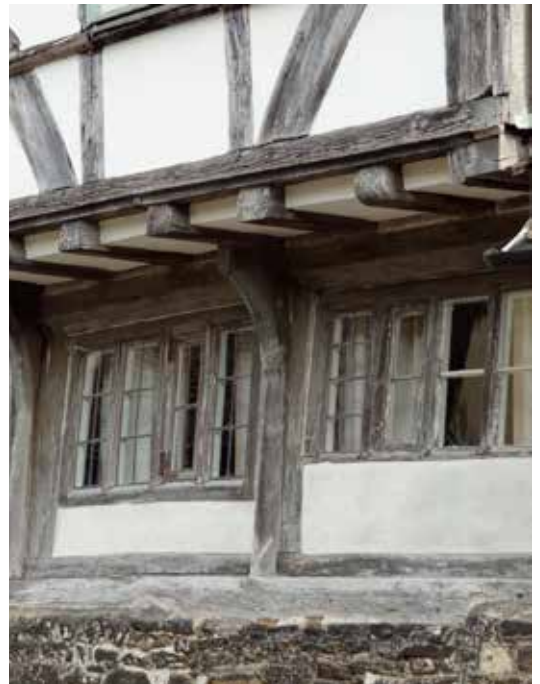
Figures 1-4

There are many variations in the construction of timber framed buildings resulting in a wide variety of thermal performance.

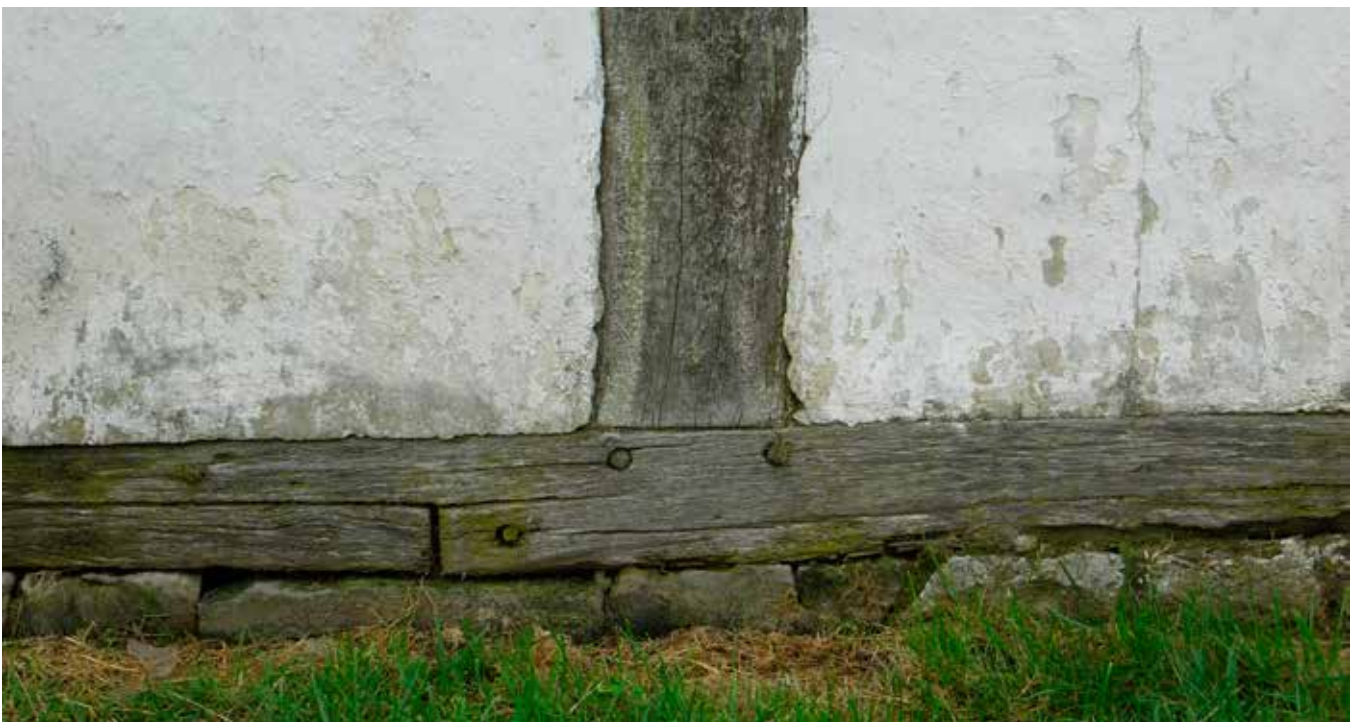
Figure 5

The most vulnerable part of the timber frame to damp is the lowest horizontal timber the sill beam or sole plate as this is the timber nearest the damp ground.

Timber-framed buildings were normally constructed with the lowest horizontal timber (the sill beam or sill plate) resting on a masonry plinth wall. One of the functions of this wall was to isolate the timber frame from the damp ground. This was possible without using a damp-proof course by allowing the maximum of evaporation from the surface of the permeable plinth material.

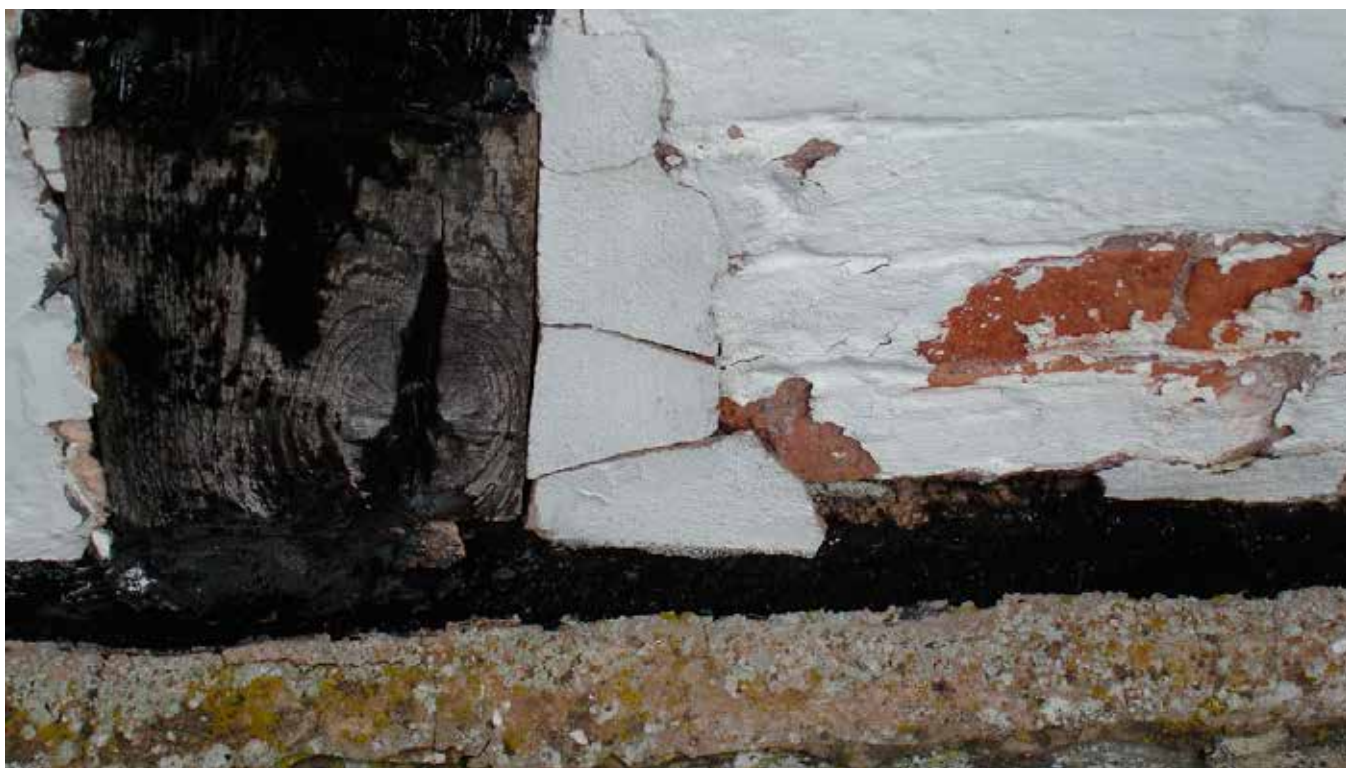
Figure 6

A hard cement mortar has been used to fill the gap at the edge of a brick panel. As the mortar

is inflexible it has cracked and will trap moisture against the frame possibly leading to decay.

The most damaging decay to a timber-framed building is usually found where inappropriate materials have been used to repair the building. The introduction of impermeable materials, such as cement-based renders and modern paints, will significantly increase the risk of water being trapped within the fabric resulting in prolonged dampness causing decay. Decay in the timbers of a historic timber-framed building is not only an aesthetic problem, it can also result in the loss of structural integrity

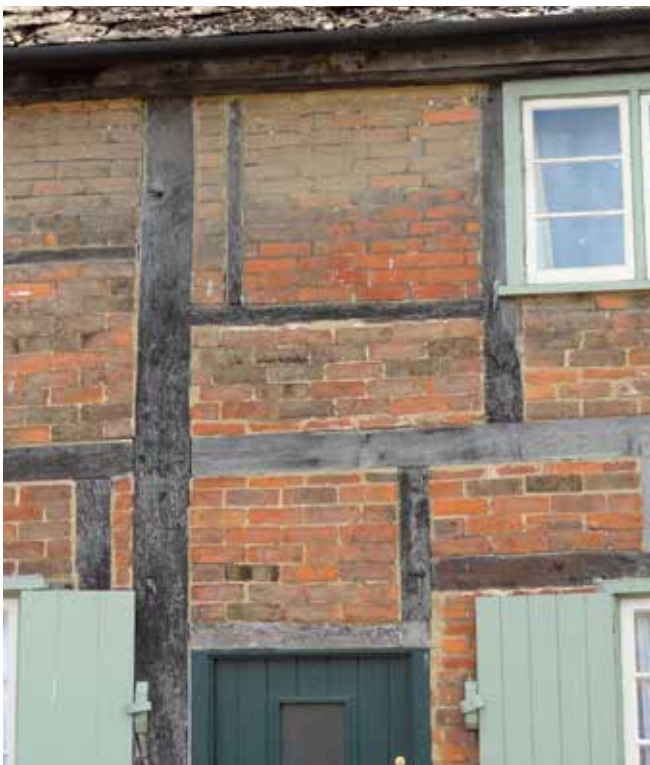
Figure 7 (left)
A timber framed cottage with brick infill panels.

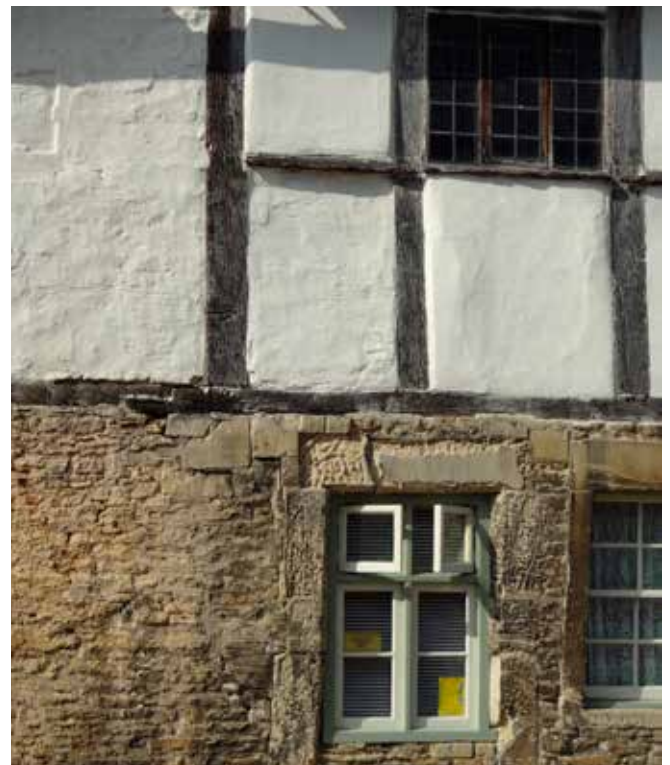
Figure 8 (right)
A timber frame above a stone ground floor.

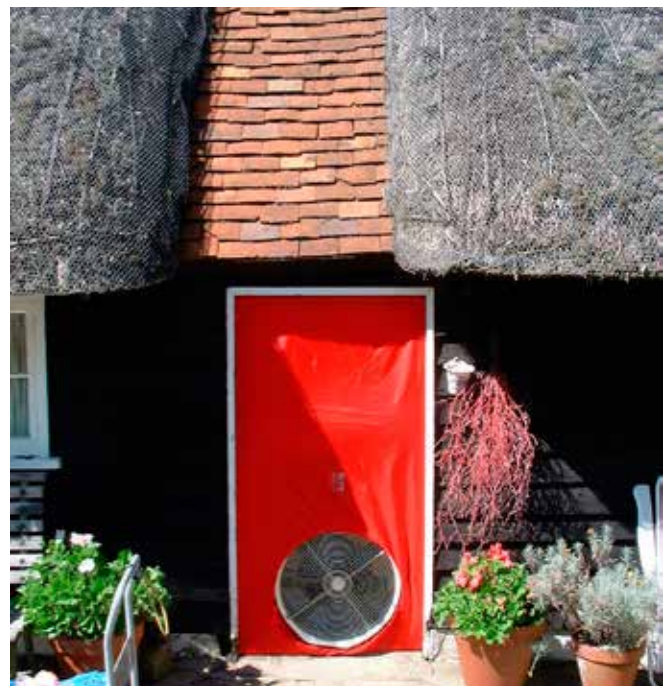
Figure 9
Pressure testing a timber framed building can give a good indication of where there is excessive air infiltration. Such areas can then be targeted in any planned thermal upgrading.
© Oxley Conservation

One of the characteristics of timber-framed buildings is that there can be a high number of cracks and gaps in the construction, particularly between the timber frame and infill panels. Some of these sources of draughts will be obvious to a visual inspection (chinks of light) or to an occupant on a cold windy day feeling the draughts. However, a more thorough and far more effective way to identify all the cracks and gaps will be to carry out an air pressure test.

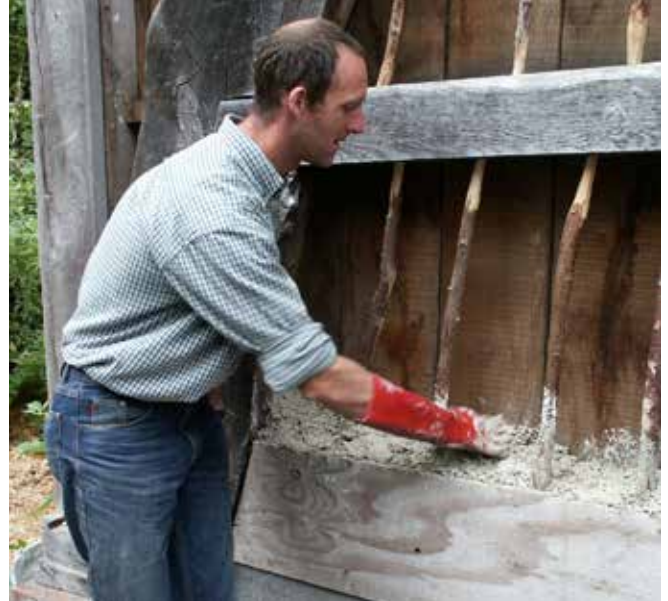
Figure 10
Hemp-lime being installed as an infill panel.

Hemp-lime composite materials have been successful in France and more recently in the UK and Ireland in providing compatible insulation which can infill timber-frames. The material has also been successful in meeting very demanding thermal performance targets in new buildings. The material is based on chopped hemp 'shiv' (the remains of the woody stem of the plant) mixed with specially developed lime based binders. It can be mixed conveniently on site to give a lightweight 'concrete' or 'hemcrete' containing a great deal of air. It is then finished externally and internally with lime renders, cladding or clay plasters.

The resulting material is a rigid cast insulation which can accommodate a certain amount of movement in the timber frame and which is highly compatible with the moisture behaviour of the timber itself. It also has inherent thermal mass and can therefore help to dampen out the internal temperature fluctuations which can be such a problem in lightweight construction (typically 10mm or so), or it can be cast to a greater thickness if the opportunity arises.

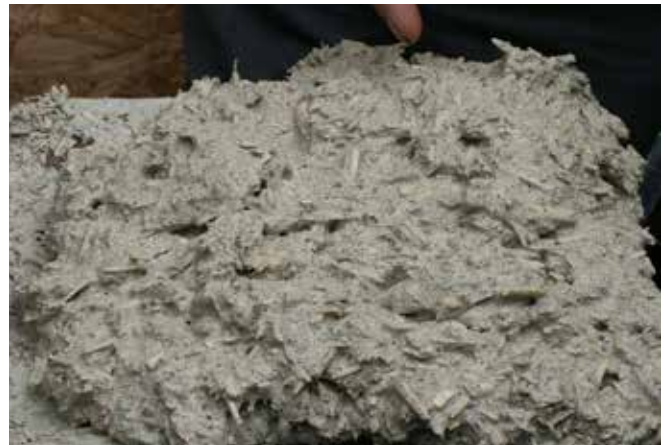
Figure 11
Hemp-lime is a mix of chopped hemp mixed with a lime based binder.

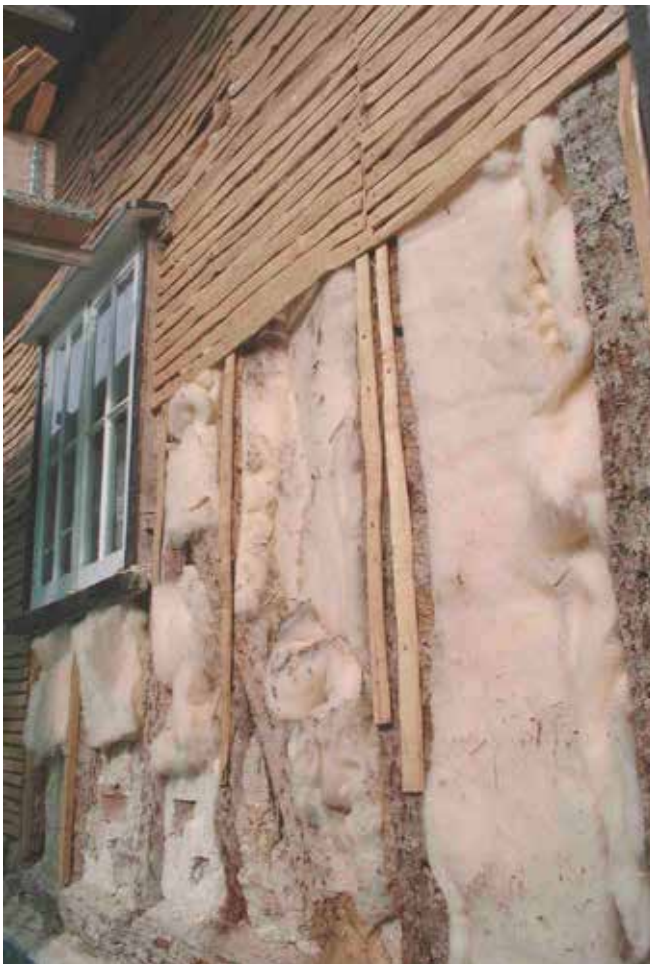
Figure 12 (left)

Timber laths being added over a frame to take an external lime render. Sheep's wool insulation has been added between the frame.

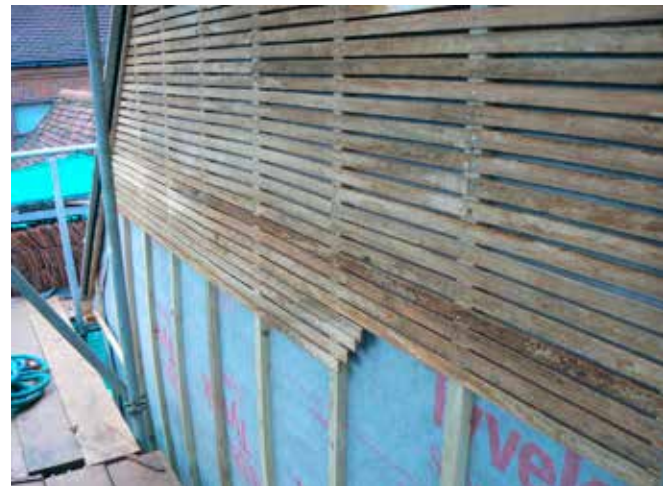
Timber laths being fixed externally over a vapour permeable membrane.

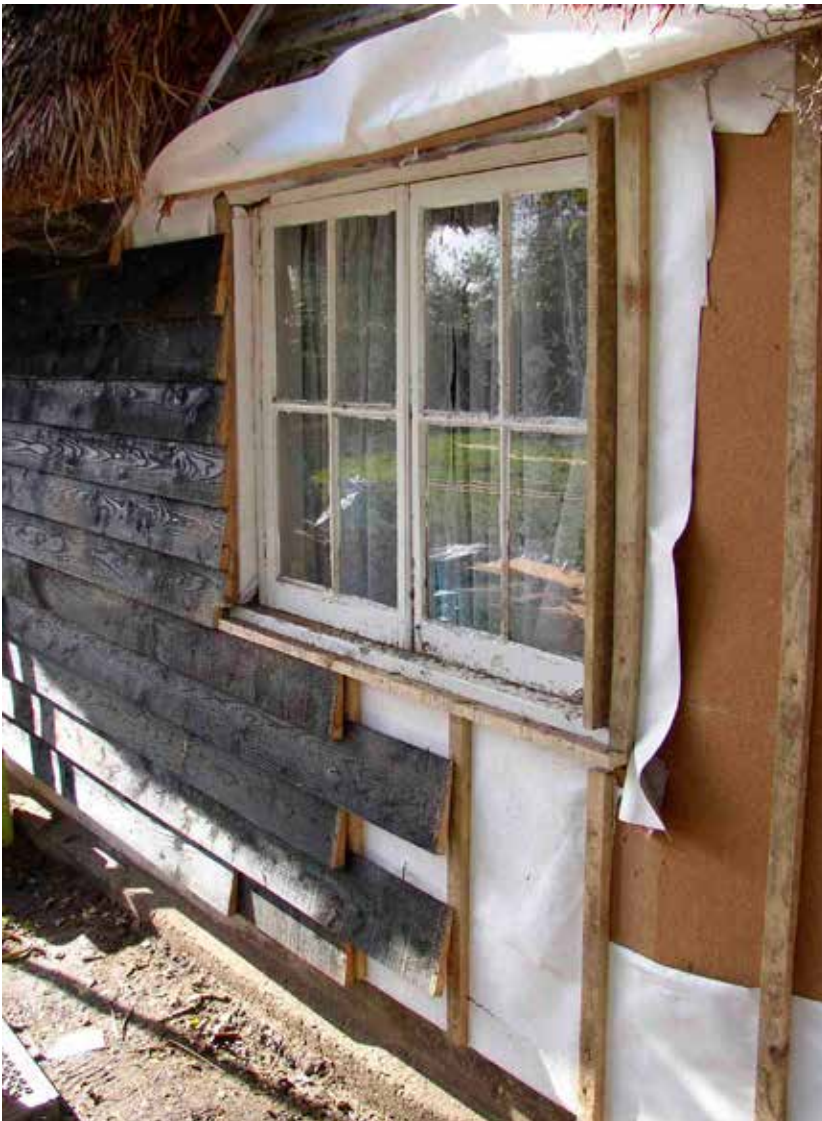
Figure 16

A vapour permeable membrane and tongue and grooved wood-fibre board has been added onto the frame below weatherboarding.

The removal of tile-hanging or weatherboarding for repair will also provide an opportunity to install insulation within the thickness of the timber-frame. Cladding can be relatively easily removed, and in the case of tile or slate hanging, can normally be re-used. The removal of weatherboarding is more difficult without causing some damage, particularly if any rot has occurred. Reinstatement of the cladding over a vapour permeable ‘breather membrane’, added as a secondary

barrier behind the cladding, can significantly improve the performance and effectiveness of the insulation by reducing air infiltration. The breather membrane should be installed with some ‘slack’ behind the cladding particularly when used with weatherboarding so that it is not held tight to its back face. This will allow any water that penetrates the cladding to run freely away down the face of the membrane without being redirected against the timber cladding.
