Unknown Wreck Off Eastbourne (The Klein Hollandia)

Conservation Statement and Management Plan

Historic England Project Number 8572

Nautical Archaeology Society

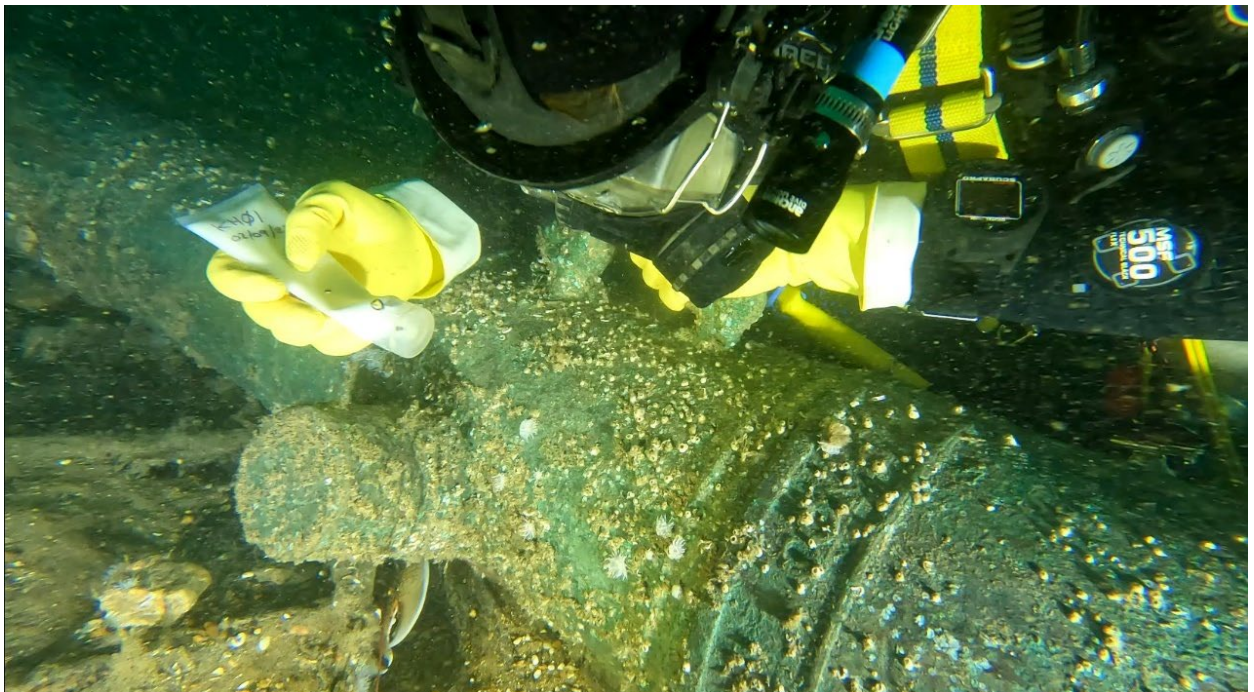
- 4.3.1 In 2023 the *Klein Hollandia* was part of the Historic England and RCE funded Protective Marking for Protected Wreck Sites project (HE Project Number 7591). This work undertaken by MSDS Marine involved divers and archaeologists from MSDS Marine, the NAS and the RCE (Fig.6).
- 4.3.2 The protective marker was applied to several objects on the wreck including all the bronze cannon. This was the first time in the UK, that this new technology had been used to forensically mark artefacts including cannon on one of England's most historic and archaeologically important protected wreck sites.
- 4.3.3 As well as the *Klein Hollandia*, the protective marking material was also applied to other protected wrecks in 2023.

Figure 6: A diver applying a protective marking solution to a bronze cannon on the Klein Hollandia. © MSDS Marine / Martin Davies.

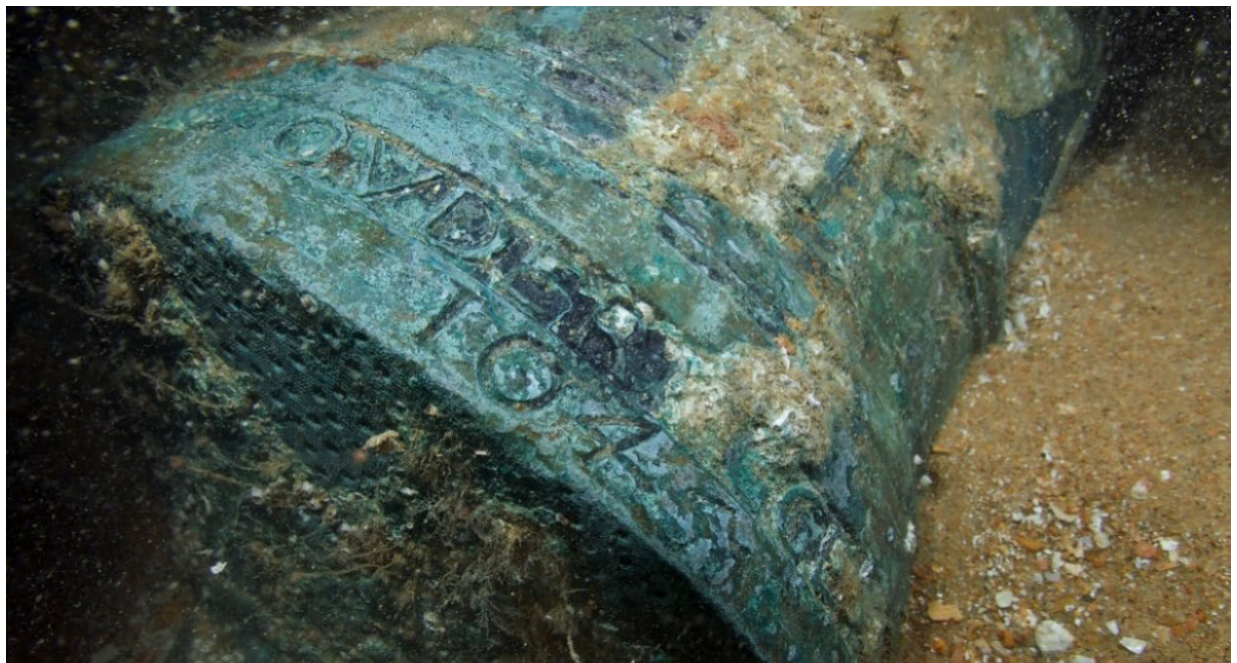
- 4.4.5 Markings have been recorded on three of the bronze cannon. Makers names on cannon No.1 and No.8 show that they were both made by Cornelis Ouderogge (1599-1672) (Fig.7). The Ouderogge's were a family of bronze founders that cast cannon, clock, bells and sculptures in Amsterdam and Rotterdam. Cornellis made cannon for the Rotterdam Council as well as the Admiralty of Rotterdam (also known as the Admiralty of the Maze) based in Rotterdam.

Figure 7: Cannon No.1 made by Cornelis Ouderogge © James Clarke.

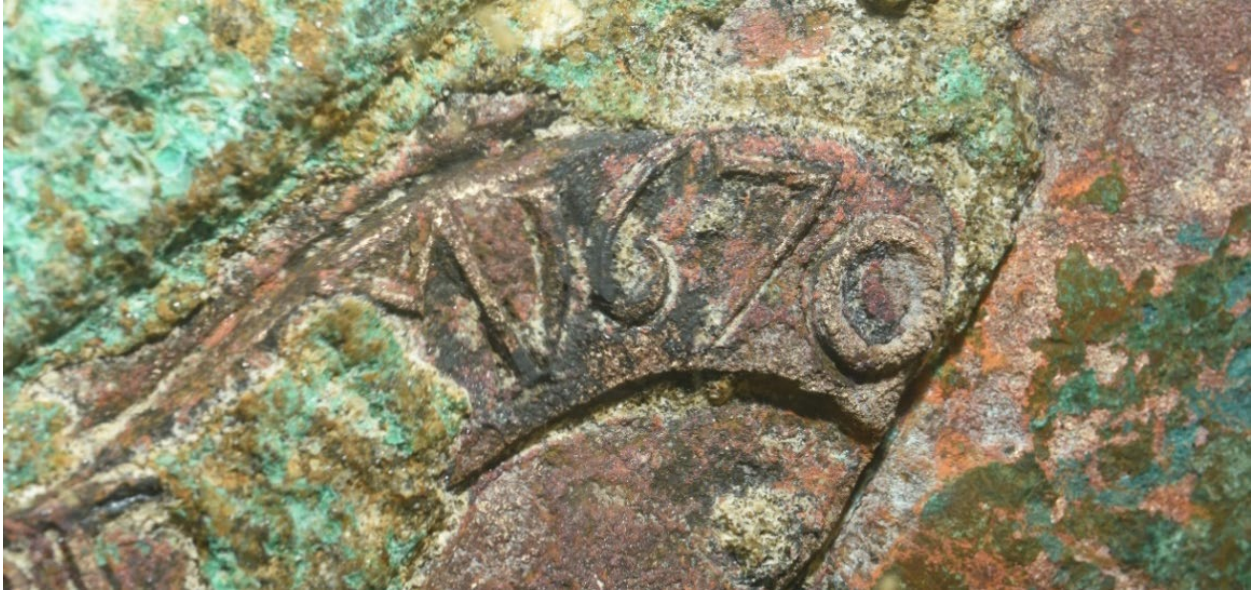
- 4.4.6 Cannon No.1 has a date stamp of 1670 (Fig.8).
- 4.4.7 Markings on cannon No.6 suggest it was also made for the Admiralty of Rotterdam. The marks include two crossed anchors and the initials P P P - for *Pro Patria Pugno*, which translates as "*I Fight for the Fatherland*" - the heraldic motto of the Admiralty of Rotterdam.
- 4.4.8 The remaining bronze cannon have not yet yielded any identifying marks.
- 4.4.9 Iron cannon make up the majority of the armament of the ship. So far 24 iron cannon have been recorded on the wreck, scattered all over the site. As would be expected all

Figure 8: The 1670 date visible on cannon No.1 © NAS / Martin Davies.

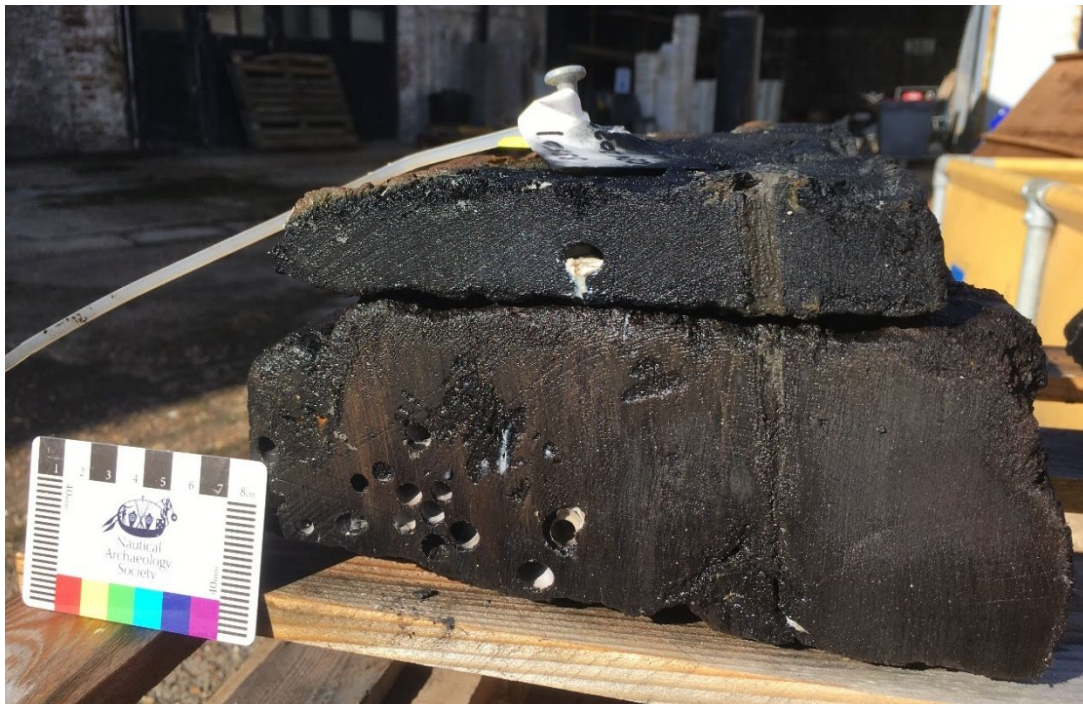
- 4.4.13 In 2022 a small number of wood samples were recovered from the site for dendrochronological analysis. To date only two conifer hull internal ceiling planks (T1 and T5) and a single oak ceiling plank (T8) have been sampled (Fig.10). The analysis of the only structural oak timber (undertaken by DendroArch and funded by Historic England) indicates that at least some of the timbers employed in the ship's construction was sourced from modern Germany, an area where the Dutch sourced their wood in the 17th

century. The report highlights the dating potential of the oak structural timbers which await future sampling stating that “*only sampling and analysis of timbers which retain partial or complete sapwood will improve dating precision*” (Nayling & Tyers 2023).

Figure 10: Timber samples T1 (upper) and T8 (lower). Scale 8cm © NAS

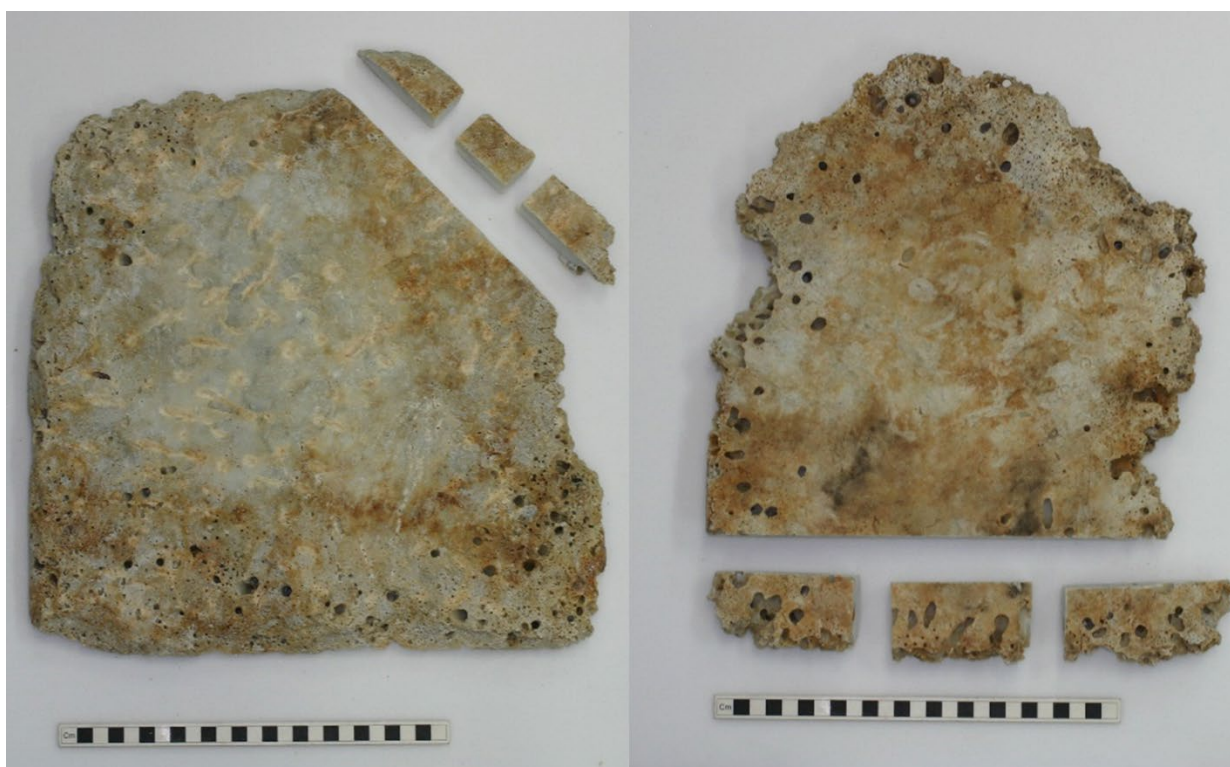
- 4.4.16 In 2020 the RCE funded a survey by the NAS, that included the recovery of two cut stone tiles for analysis by Historic England material scientists (Fig.11). Petrographic examination including mineral composition and isotope analysis identified the stone as being marble from the Apuan Alps quarries close to Carrara, Italy, home to some of the finest marble in the world (Gherardi 2021).

Figure 11: Marble tiles UID 8 (left) UID9 (right) recovered in 2020 for analysis (Scale 20cm) © Historic England.

- 4.4.17 The sampled cross-sections were analysed by scanning electron microscopy (SEM), using a FEI-Inspect F combined with an energy dispersive spectrometer (EDS) INCA X-Act. The mineralogical composition of the finely ground samples was defined by X-ray

powder diffraction (XRD), by using a X-Ray Diffractometer D8 Advance (Bruker), operating at 40 mA and 40 kV (Gherardi 2021).

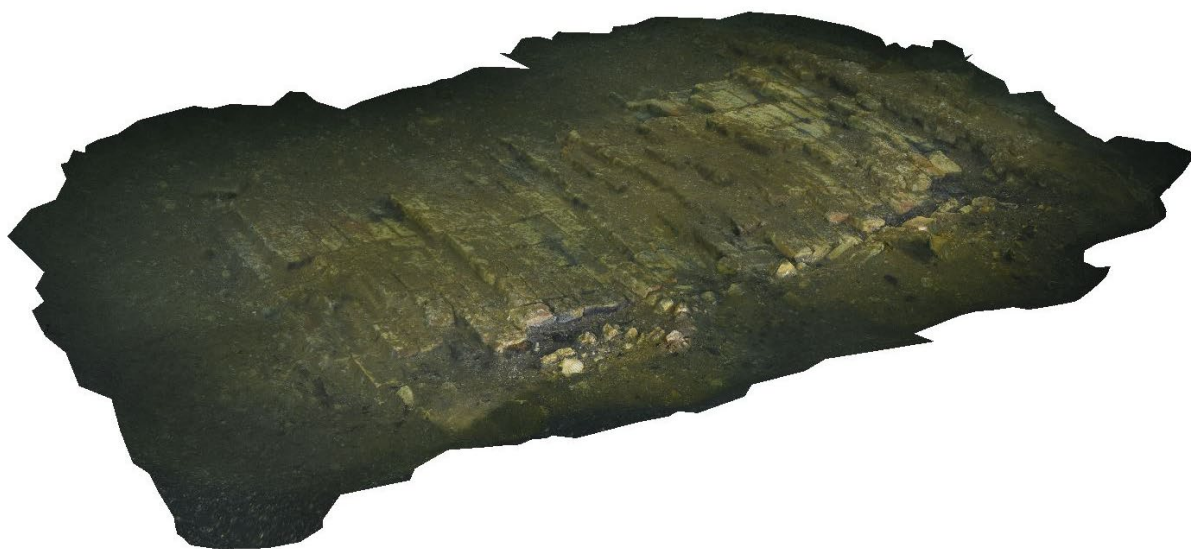
Figure 12: Photogrammetry survey of galley hearth © NAS / Martin Davies.

- 4.4.21 The bricks appear to form a floor, presumed to be the hearth in the galley area of the ship. Whilst other single bricks are scattered over the site, the bricks in the hearth area are bonded together with cement. Subsequent investigation has shown the floor of bricks to be at least twelve courses thick, but without excavation it is not possible to determine conclusively just how the hearth was constructed. In the 17th century ships galleys were normally located on the forward area of the ship, forward of the main mast.

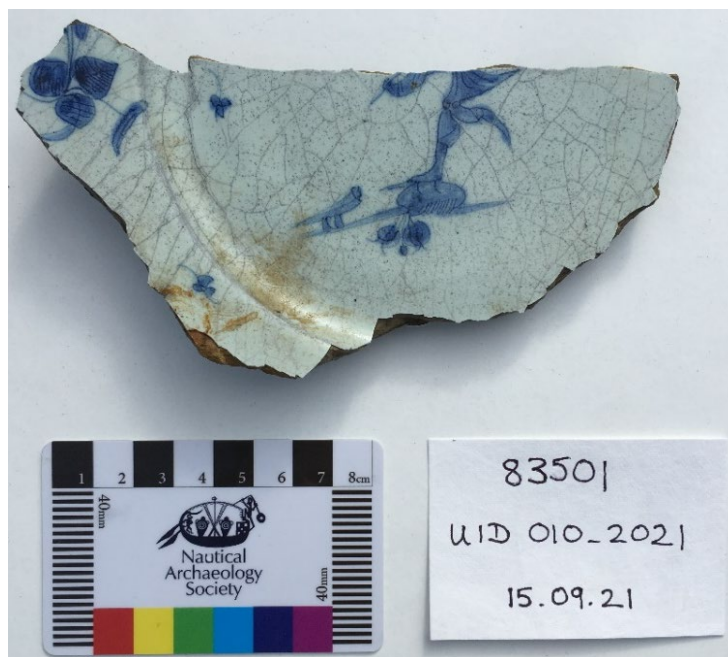
4.4.22 **Ceramics:** Since 2019 the wreck has revealed numerous pieces of ceramic, including Northern European domestic wares. In 2019 a complete Bellarmine jug that still had the cork in place was discovered and recovered for conservation. A smaller jug was found and recovered in 2023. Numerous fragments of Italian majolica pottery have been recovered to aid the identification of the ship. All the majolica pieces observed and recovered are decorated with a white tin-glaze and painted with a blue nature themed design (including plants and animals) and are suggestive of a 17th century date, originating from the area around Savona, to the west of Genoa in Italy (Fig.13).

Figure 13: Plate fragment (UID 010) with glaze and decoration recovered in 2021 (Scale 8cm) © NAS.

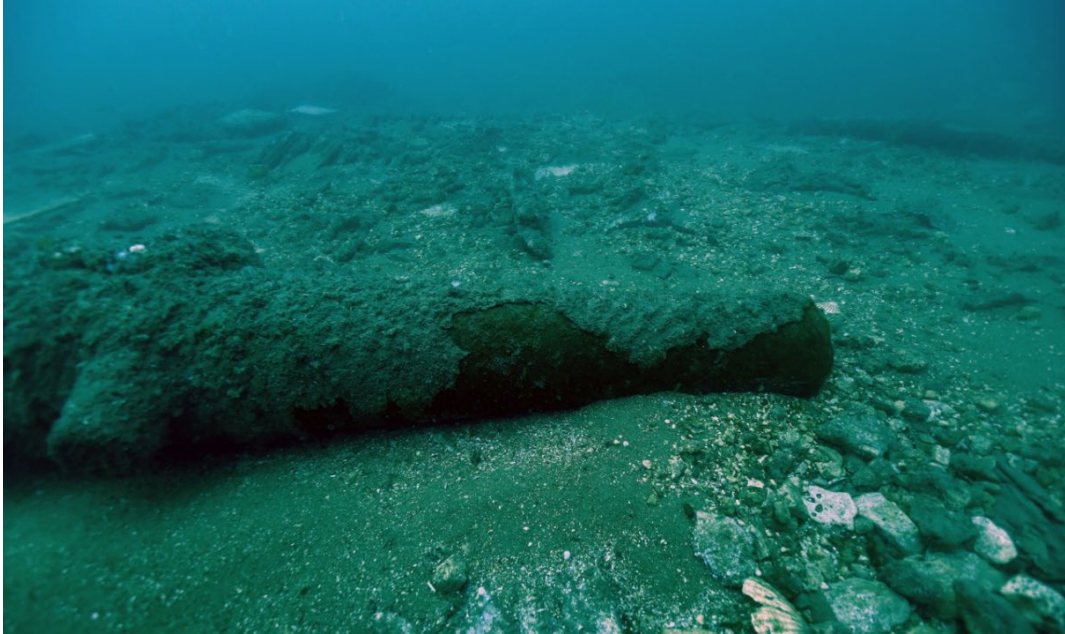
In April 2021 licenced divers noticed that the site had been impacted by some unknown type of action, resulting in stone blocks, and cannon being moved around the site and concretions removed from iron cannon (Fig. 15 & Fig 16). Subsequent investigation,

**Figure 15: Concretion removed from iron cannon No.9 by trawling impact
© NAS / Martin Davies**

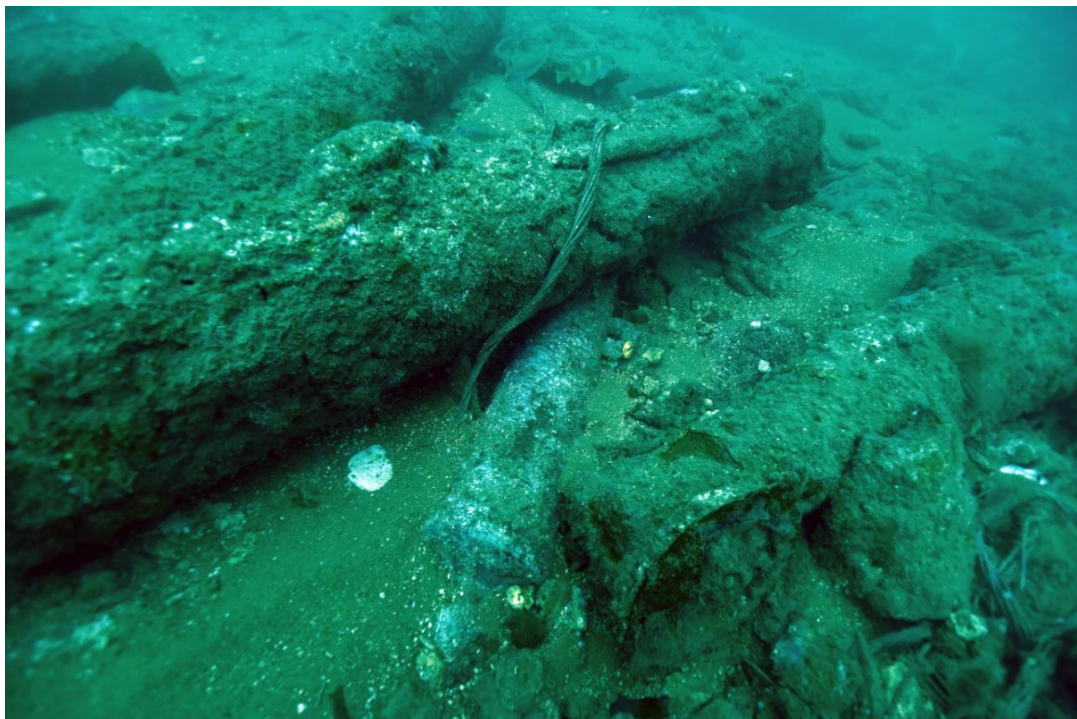
**Figure 16: Bronze cannon No.8 partly covered by an iron cannon that was moved to this position as a result of a trawling event. Note the steel cable lying over the iron cannon
© NAS / Martin Davies**

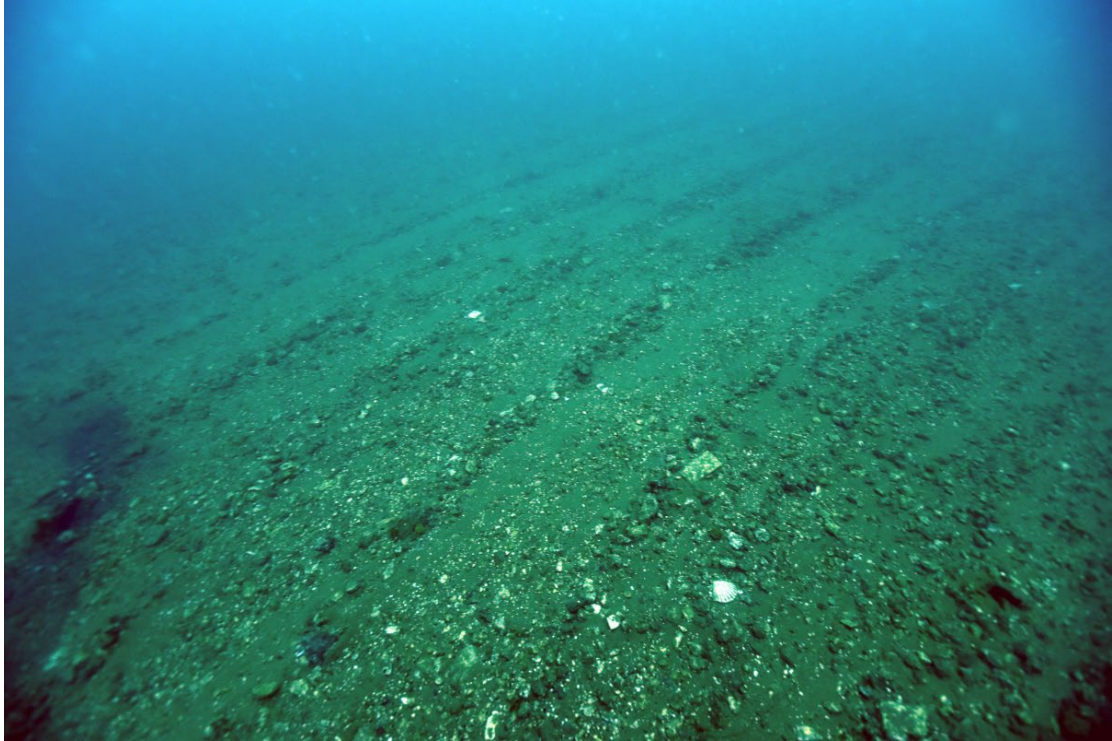
documentation and analysis identified trawl scars around and over the wreck assemblage (NAS 2021) (Fig.17). The matter was dealt with as an allegation of Heritage Crime and was reported to Sussex Police as crime report no: 47210119128. No prosecution has yet resulted.

Figure 17: Parallel lines on the seabed around the site caused by trawling equipment
© NAS / Martin Davies
