# Stockton & Darlington Railway Locomotive-Coaling Stage, Shildon, Co. Durham: historic building investigation and assessment of significance

**STOCKTON & DARLINGTON RAILWAY  
LOCOMOTIVE-COALING STAGE,  
SHILDON, Co. DURHAM**

**historic building investigation and assessment of  
significance**

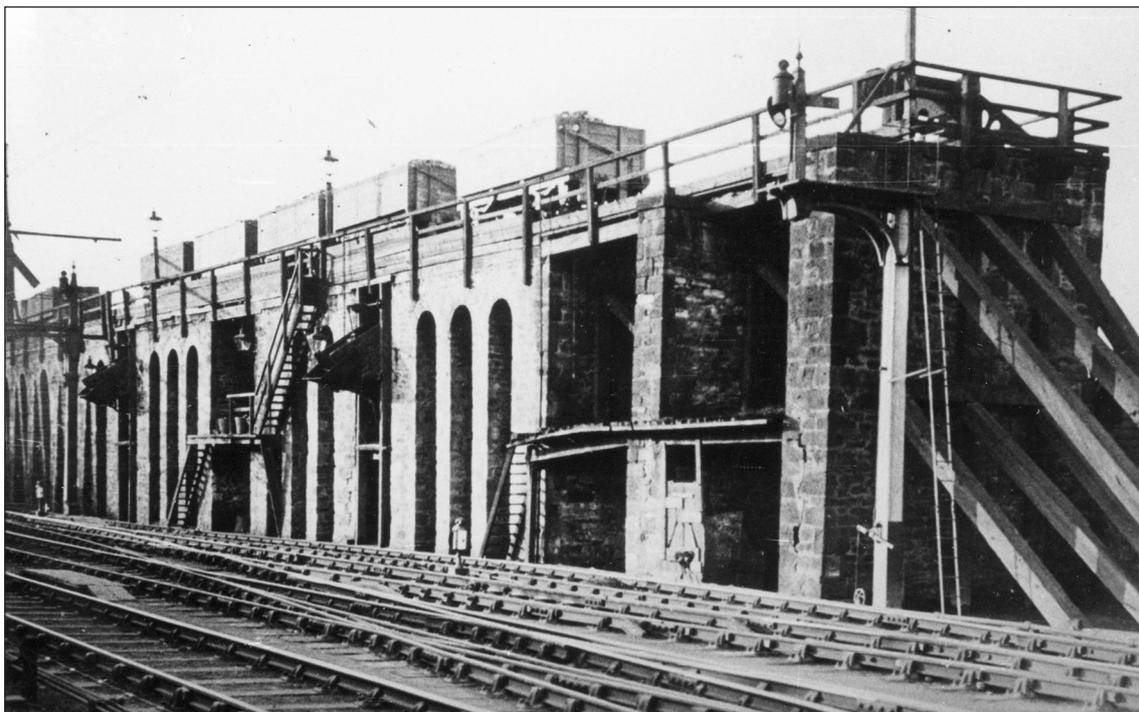
Figure 5. 1925 photograph showing the pre-1896 timber-decked extension. Note timber bracing is visible within the two bays of the extension but only towards the rear of those bays. Note also the door beneath the platform in the end bay suggesting the sub-platform area was at one time used for storage. [Unknown photographer © Ken Hoole Collection/ Head of Steam – Darlington Railway Museum].

In one of the historic photographs (see Figure 5), the area beneath the platform in bay VI has what looks like the remains of a dilapidated timber door at its western end, suggesting the sub-platform area had once been boarded off as a storage facility. If so, the absence of boarding beneath the rest of the platform indicates that this function had ceased long before the photograph was taken in 1925.

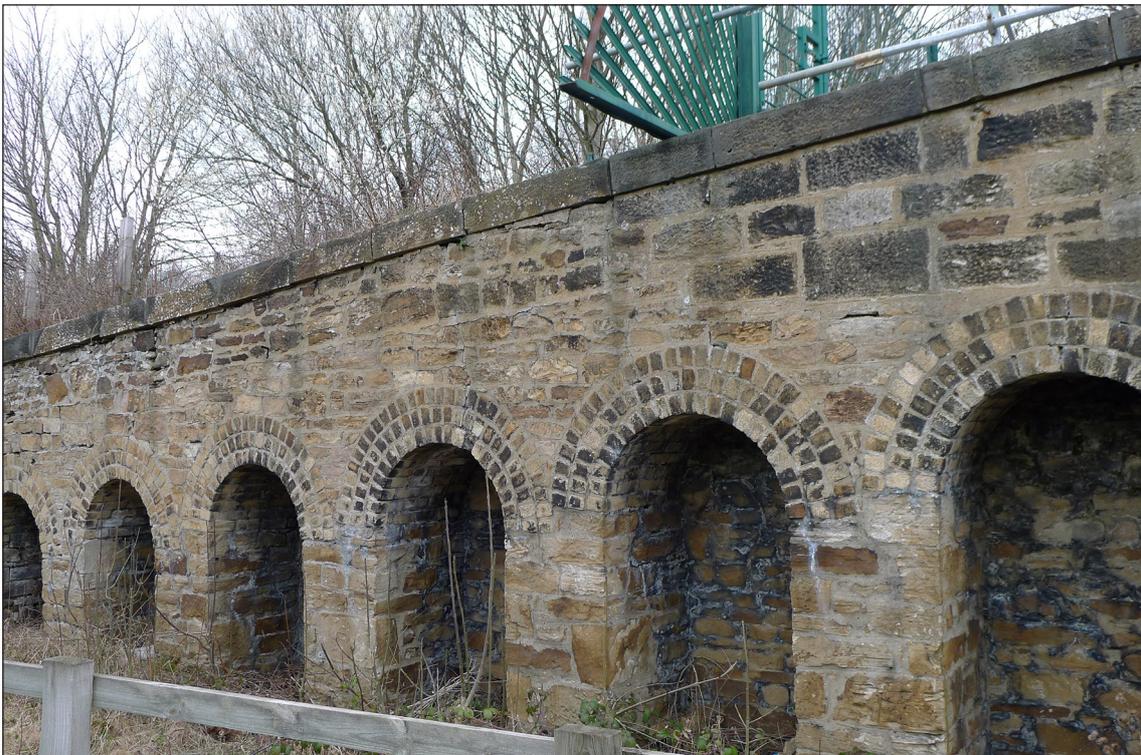
Nevertheless, construction joins and/or areas of rebuilt fabric are apparent in the masonry. First, in the west, a diagonal construction join is discernible a short distance below the level of the coping stones that cap the front wall of the staging. This is present over approximately the western third of section A, commencing close to the base of the ramp and continuing as far as the western springing of the arch in recess 10 (Figure 9) where it disappears, destroyed by later rebuilding (*see below*). The fact that the masonry above the join is laid on a slight angle in keeping with the overall gradient of the ramp in contrast to the masonry below which is laid more on the horizontal indicates that it represents a later raising of the height of the staging with consequential slight lengthening of the ramp. The vertical height of the raise is about 0.48m.

*Figure 9. The vertical raise in height to the Drops, destroyed by later rebuilding (the larger blocks at right of frame) east of the start of recess 10. [Marcus Jecock 6 March 2020 © Historic England].*

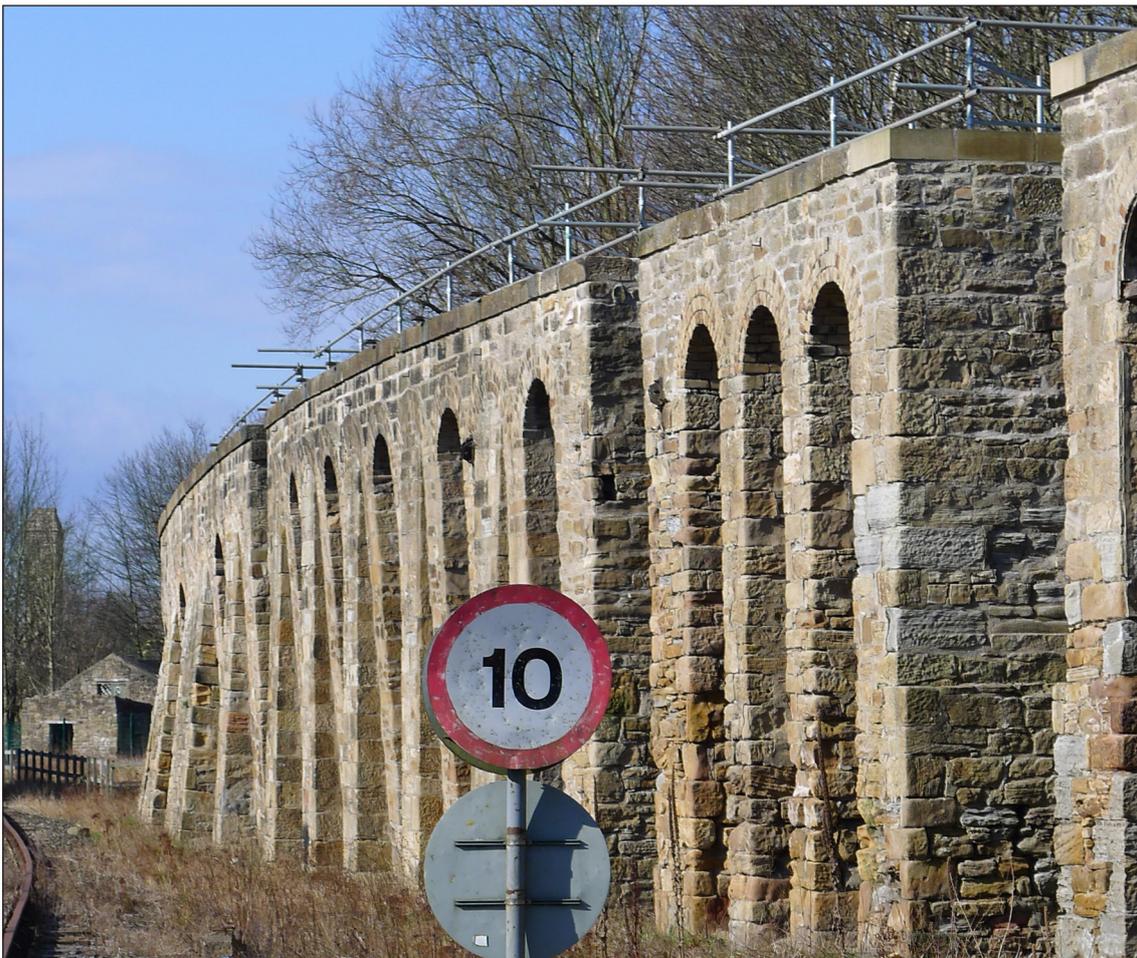
Secondly, it is clear that the buttresses which infill certain recesses in between recess 18 in section A and recess 39 in section B, are all secondary, and that the masonry above them (from the coping down to a level just below the crowns of the arches, beginning at recess 10 and continuing as far east as the crown of recess 40) was at some point (but subsequent to the raising just described) rebuilt in a different, darker stone (Figure 9). This rebuilding is evidenced visually by the presence of large, rectangular blockwork laid in slightly irregular horizontal courses, in noticeable contrast to the quality of the masonry elsewhere in the front wall of the staging which, apart from quoining is generally smaller, more rubbly, lighter in colour and more heavily weathered. Indeed, the bricks used to form the arch rings above some of these recesses, particularly recesses 30-40, also appear darker than elsewhere (certainly darker than those lying further west towards the base of section A), suggesting that unless the colour difference is due to smoke-staining these arch heads were rebuilt at the same time in a different brick. The two elements (buttressing and rebuilding) are almost certainly contemporary with each other: both must have been part of the same programme of work, the purpose of which was to address a substantial ( $5^{\circ}$ ) outward lean that had developed in the front wall of the staging due to soft ground and/or inadequate foundations particularly on the curved ramped section (Figure 10) where lateral

*Figure 10. The Drops looking west from bay IV, showing the lean out of the curved ramp section and the buttressing added to remediate the lean. [Marcus Jecock 6 March 2020 © Historic England].*

forces on the structure were greatest. The buttressing was needed to stop the lean developing further, the rebuilding to return the masonry above the level of the buttresses to the vertical (as is demonstrated by vertical sections through the Drops generated from the 3D modelling, illustrated at Figure 37, especially sections 6 and 8). The buttresses are built up from foundations that chamfer in at ground level (Figure 11).

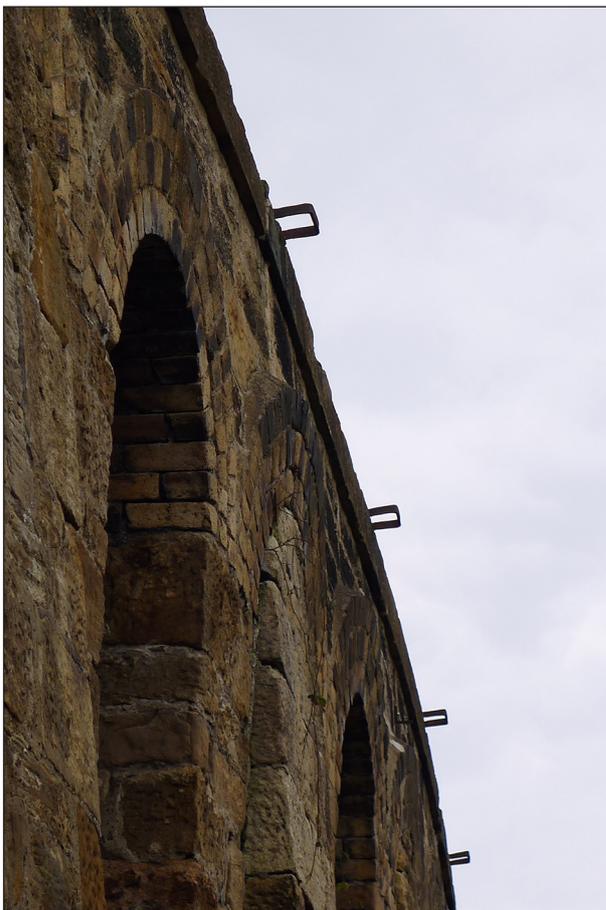
As already stated, the front wall of the staging is capped by flat coping stones. Some of these have square, iron straps (or else bear the remains of now incomplete examples) leaded in to them (Figure 12) at intervals of 2.4-3.0m between centres. These mark the positions of timber uprights that formed part of a post-and-rail safety fence attached to the edge of the more elevated parts of the Drops (as can be seen on the various

*Figure 12. A run of the iron straps that supported the upright posts of the safety fence. [Marcus Jecock 6 March 2020 © Historic England].*

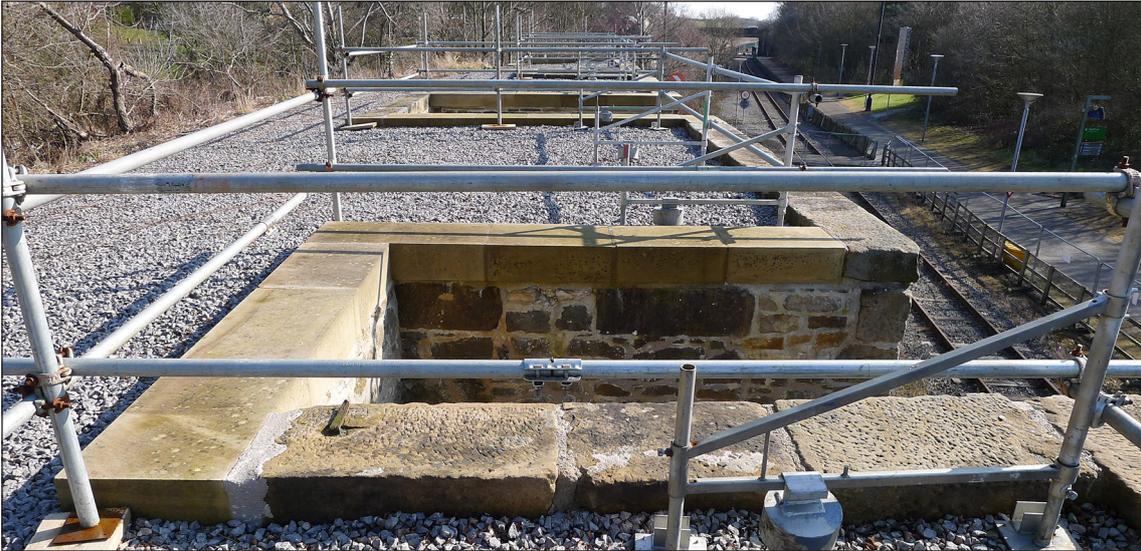
historic photographs Figures 5, 7 and 8). The photographs show that the fence also featured a low kickboard. However, some of the coping stones were seemingly badly damaged or else had become loose and had fallen when recent restoration work was undertaken in 2018 (a diagram showing the extent and specification for the works is held by DCC). Visual inspection suggests that some displaced coping stones were retrieved and put back in place, while others that were missing or too damaged were replaced by new. However, the field evidence also suggests that some of the replaced stones have been put back in positions that they could never have occupied originally. For instance, an original stone that retains part of an iron strap (part of the safety-fence attachment mechanism) and therefore which must have formerly lain along the front wall of the staging, has been re-instated to the north-west corner of bay II (Figure 13), while stones with traces of leading also now cap the rear wall of bay IV. Following on from this, the positioning of other

*Figure 13. Coping stone (with part of an iron strap) wrongly re-sited to the north-west corner of bay II. Note the large padstones surviving in the top of the far wall. [Marcus Jecock 6 March 2020 © Historic England].*

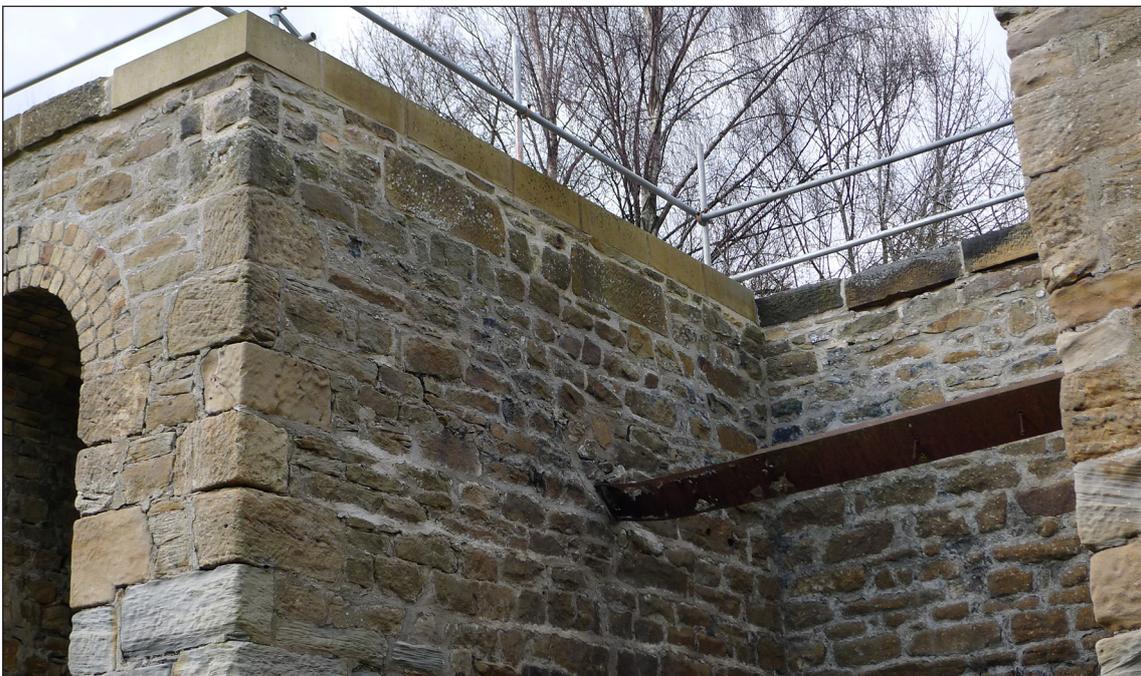
original coping stones may be questioned. For example, it is very unlikely that the coping originally continued all the way round the bays (as it now does), since here it would have interfered with the placement of the rail track that ran along the top of the staging. Indeed, two large padstones are still visible towards the top of most sides of bays I - IV – with centres some 1.5m apart (approximating to the standard UK track gauge of 4 feet 8.5 inches or 1428mm) - sometimes with a thin fillet of stones now laid above them to level up to the height of the coping (e.g. Figure 14). Fillet and coping along the sides of the bays must represent modern 'over-restoration', since the purpose

*Figure 14. Padstones in the west wall of bay III. The narrow stone fillet and the coping stones above the two large in-situ padstones represent modern 'over-restoration'. [Marcus Jecock 6 March 2020 © Historic England].*

of the padstones is to take the weight of large timber waybeams or steel girder rails that would have been placed to carry the track across each bay while allowing open space between the rails for coal to fall through from the bottom-discharge wagons in to the hopper mechanism suspended beneath. This is confirmed by photographs in the Historic England Archive dating from 1992 that show the coping then terminated prior to the centre of the first padstone in bay I (Figure 15). Girder rail (that is, flat-bottomed rail with an enlarged basal flange strengthened at intervals by triangular stiffening plates

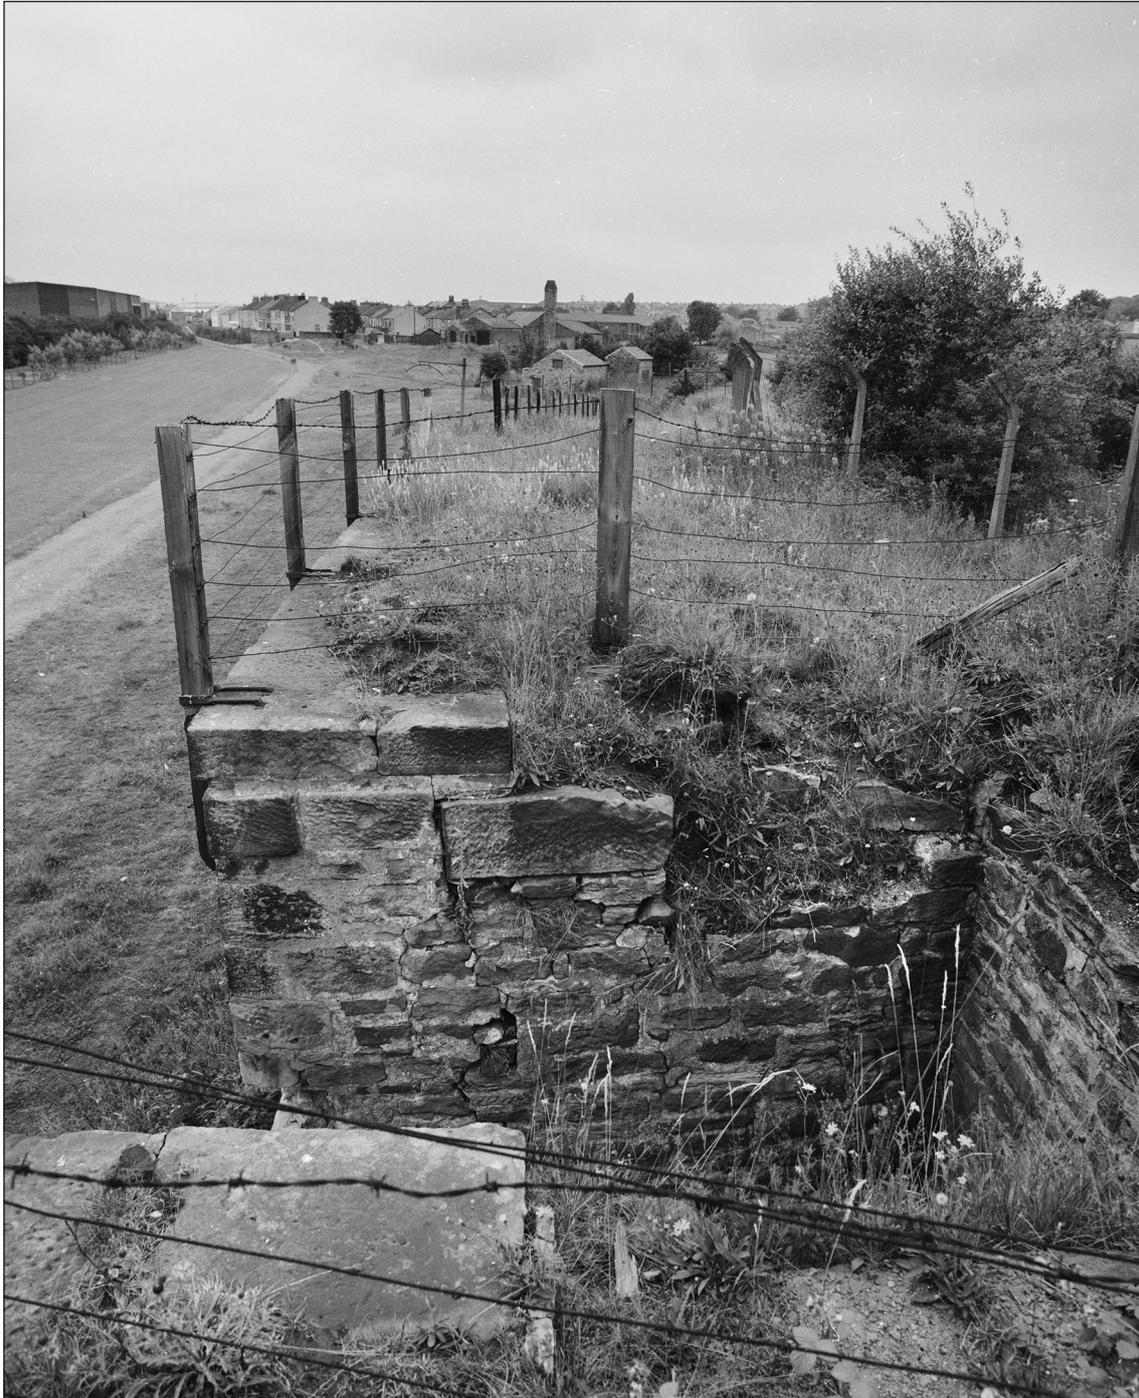
*Figure 15. Photograph looking west over the top of bay I in 1992 showing the state of disrepair but also the original extent of coping stones. [Roger Thomas 7 July 1992 © Crown copyright Historic England Archive AA92/4236].*

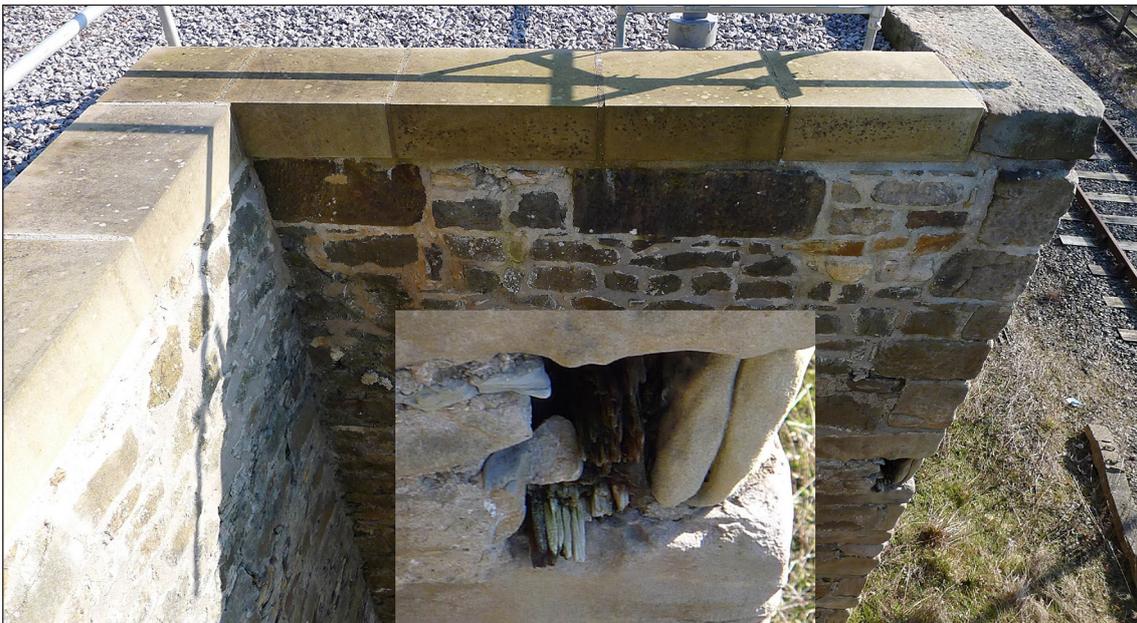
The actual mechanism of the three gravity-fed coal drops is difficult to reconstruct in detail. No drawing or written description is known, and the only evidence is the historic photographs plus hints in the surviving stonework. It must be stressed that the photographs record the mechanisms in their final phase of use which may not be exactly as they were initially designed and built. The photographs suggest coal was dropped from bottom-discharge wagons in to a timber hopper suspended directly beneath the track and housed within the bays. Rather than being attached directly to the staging, each hopper seems to have been carried on a largely free-standing timber framework of uprights and beams within its bay, although a number of empty sockets visible in the extant fabric (one in bay II with the end of a timber still *in situ*; Figure 16) suggest this framework was keyed - at least at a high level - in to the sides of its bay. Bay IV has a second pair of sockets at a lower

Figure 16. Socket in the east wall of bay II for tying the hopper support-framework to the bay wall. Inset: detail of surviving *in-situ* timber. [Marcus Jecock 6 March 2020 © Historic England].

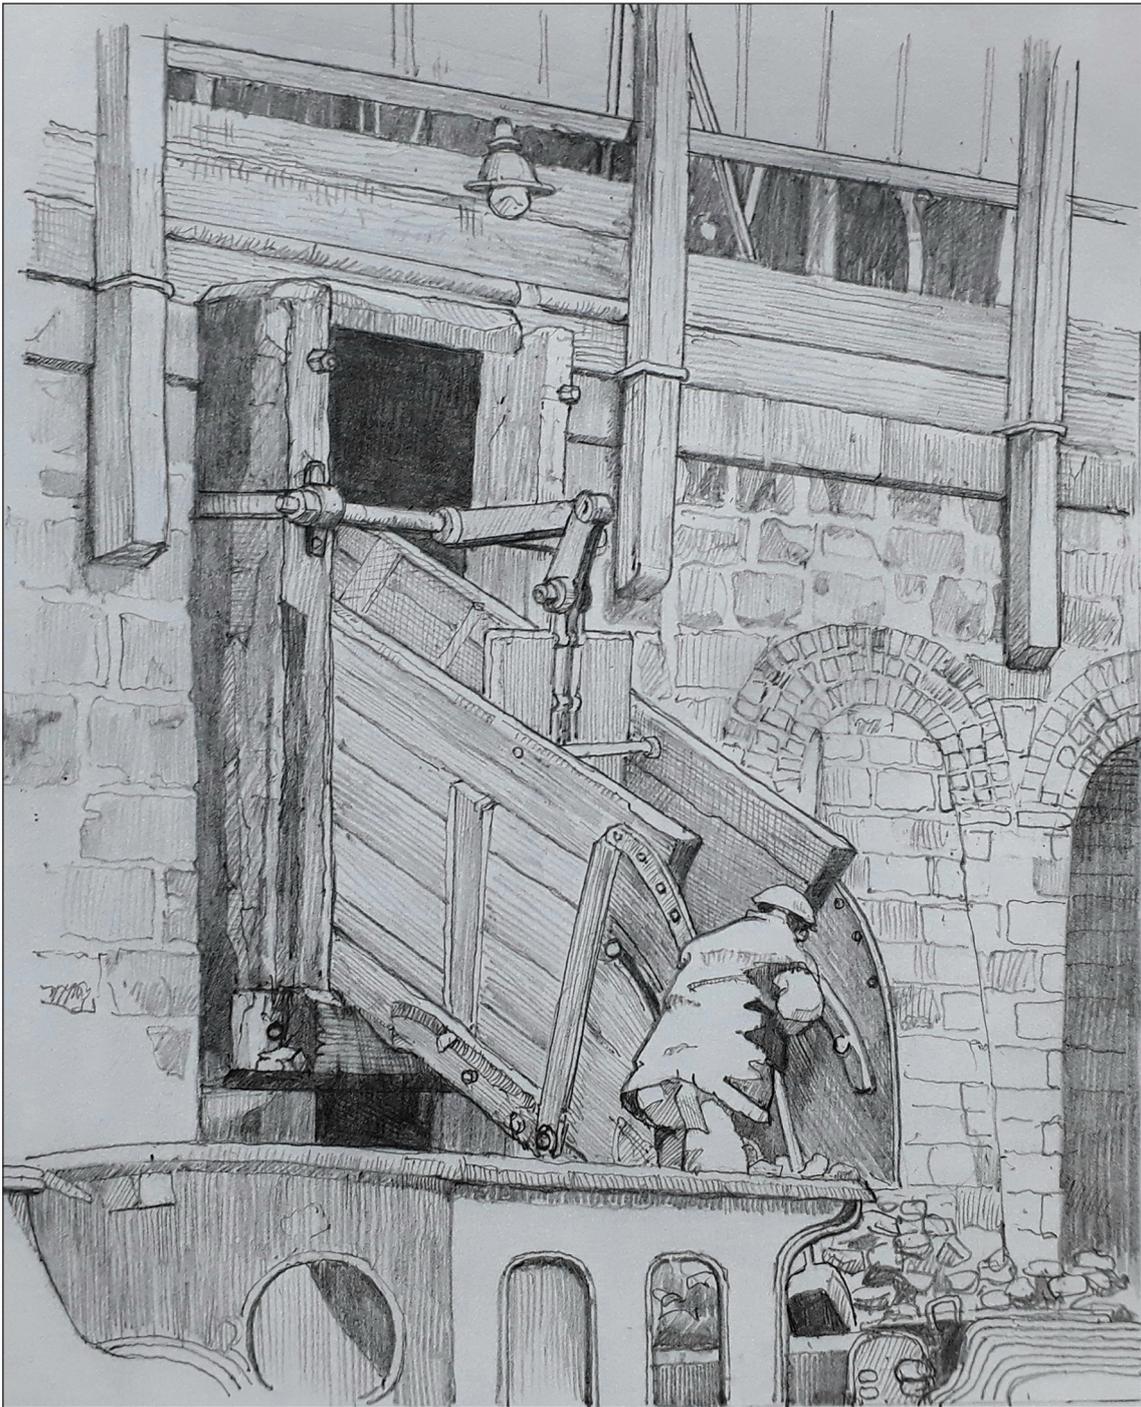
*Figure 18. Reconstruction drawing of a locomotive taking on coal using the hopper/chute mechanism, based on historic photographs especially Figure 7. [Allan Adams © Historic England].*

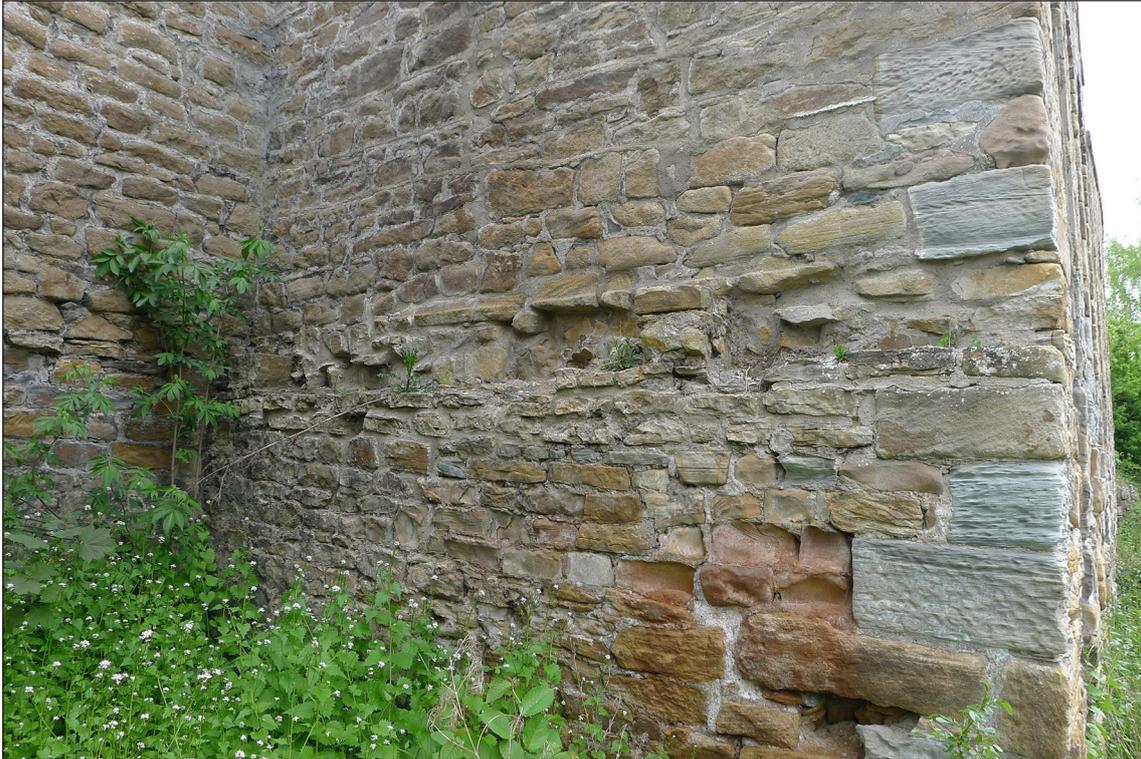
Figure 19. Stone plinths on the platform ledge in the east wall of bay III. [Marcus Jecock 5 May 2022 © Historic England].

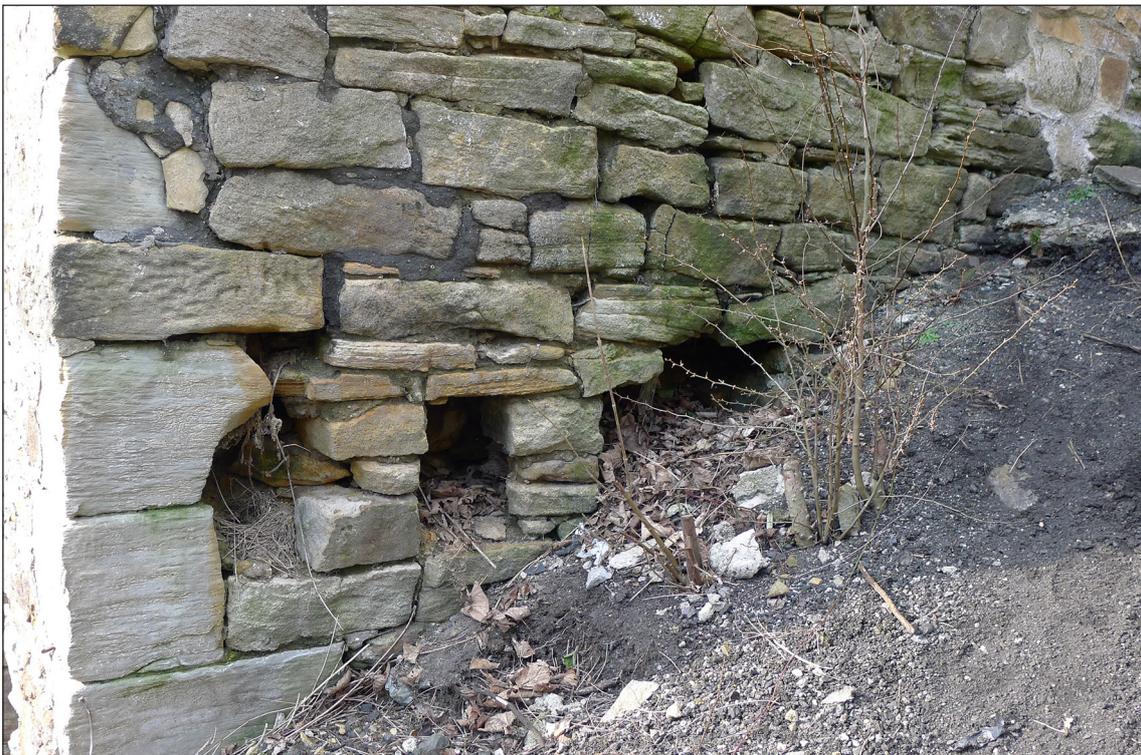
Figure 20. Joist sockets in the west wall of the demolished bay V. [Marcus Jecock 6 March 2020 © Historic England].

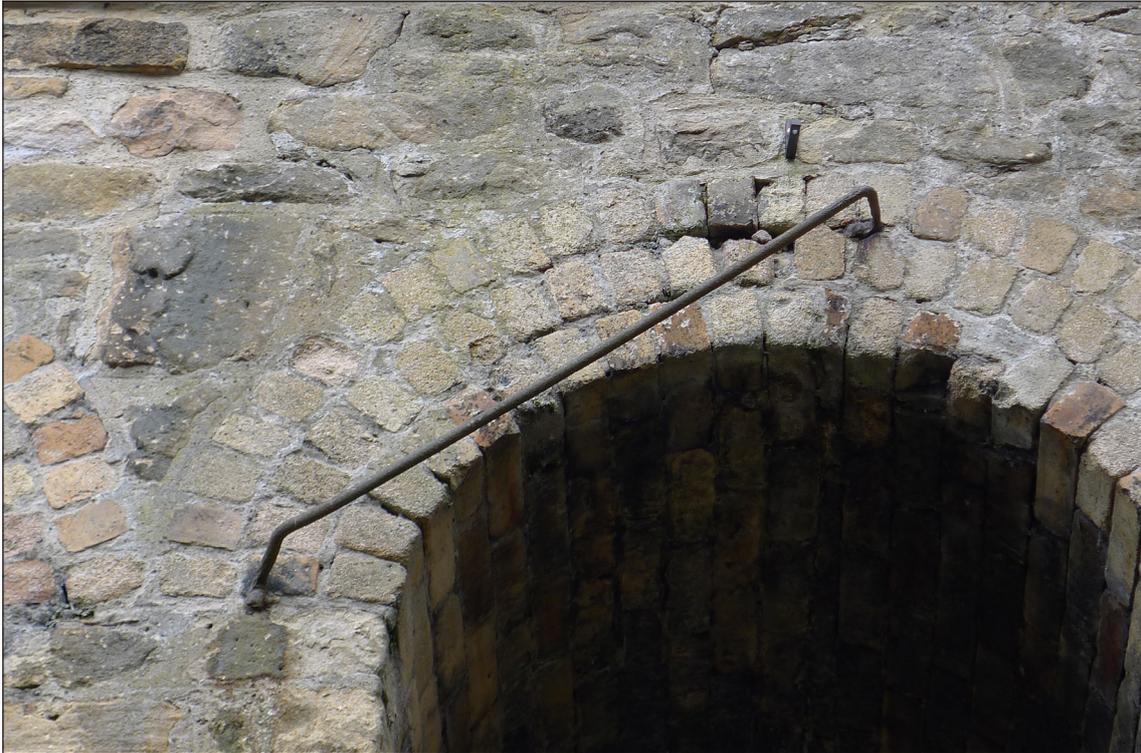
It was obviously important for locomotive crews to be able to access the top of the stage from trackside, if only to replenish the hopper after use or move an empty coal wagon away from the drop and replace it with a loaded one (unless this was done by a dedicated attendant or cokeman always on hand at the staging). The historic photographic evidence (e.g. Figure 7) shows that access was facilitated by the two-stage flight of wooden stairs that first gave access to the western end of the platform in bay III before at the eastern end of the platform a second flight led on up to the top of the staging. No evidence for either flight survives apart from a short diagonal length of metal handrail attached to the brick arch rings of recess 45 (Figure 21).

*Figure 21. Detail of metal hand rail attached to the arch rings in recess 45. [Marcus Jecock 6 March 2020 © Historic England].*

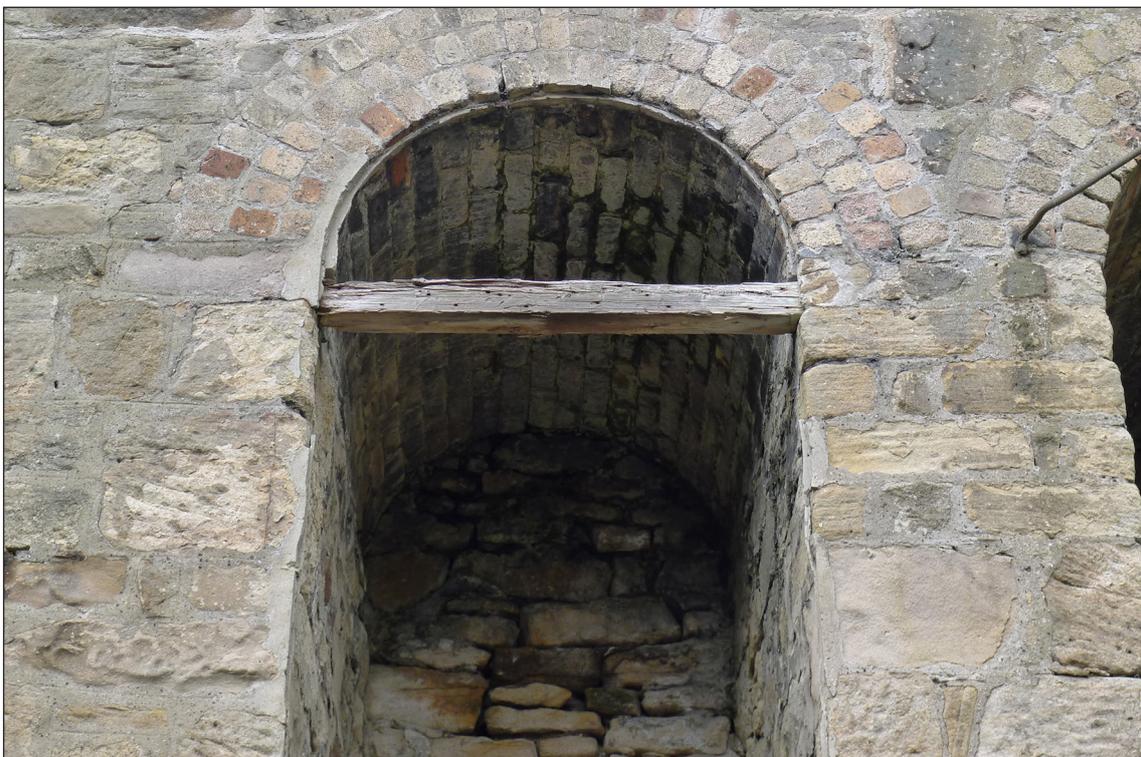
*Figure 22. Timber batten and cement fillet in recess 44. [Marcus Jecock 6 March 2020 © Historic England].*

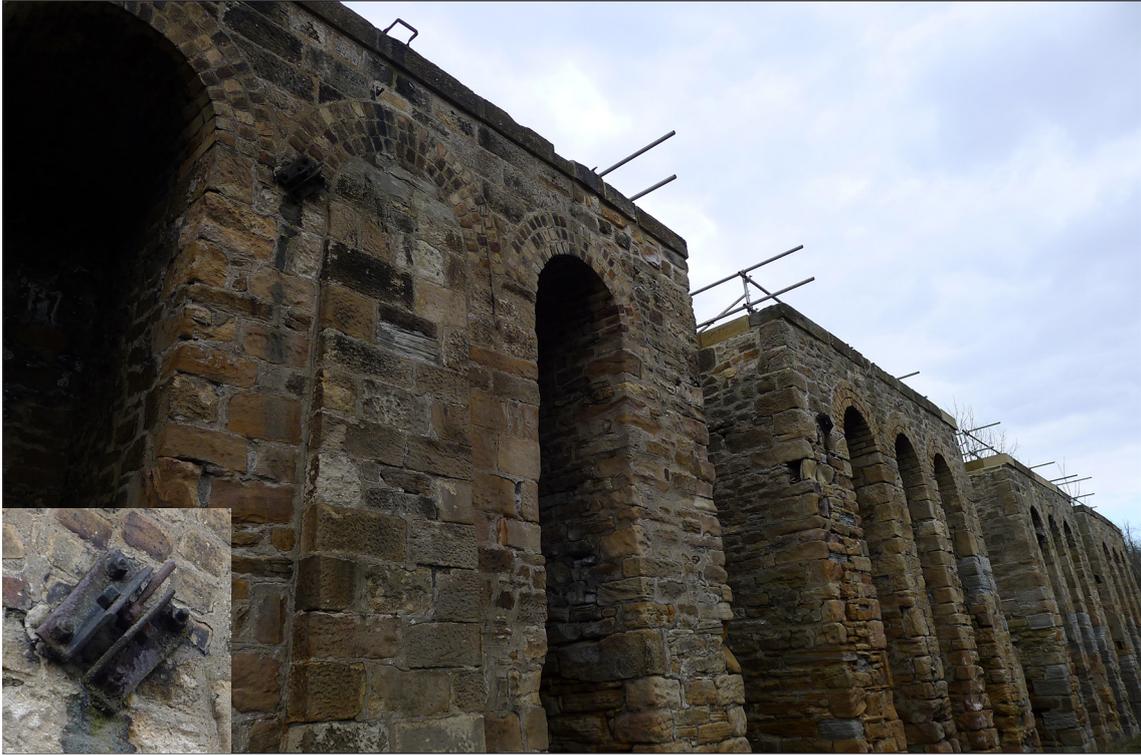
*Figure 23. Iron brackets either side of bay II, probably anchor points for cable-stays bracing an overhead power gantry. Inset: detail of western bracket showing end of in-situ cable. [Marcus Jecock 6 March 2020 © Historic England].*

small, identical, metal clamps or brackets set at the same high level either side of bay II, one retaining the start of a cable or round bar (Figure 23 and inset); two eye bolts at low level but again at identical heights, one between recesses 38 and 39 (Figure 24) and the other recesses 41 and 42; and sundry metal nails, or holes where nails have been, in the rear walls of some of the recesses and in the walls of the bays (e.g. Figure 25). Furthermore, there appear to be the remains of timber or metal spikes set or driven in to the rear walls of recesses 14, 16 and 26, just below arch-crown height (e.g. Figure 26). Historic photographs suggest the two metal brackets may be anchor points for cables bracing a nearby overhead power gantry (see Figures 7 and 8): the line between Shildon and Thornaby - which branched from the S&DR main line at Simpasture Junction to run direct to docks on the Tees - was electrified in 1915 and remained electric-hauled until the mid-1930s (Smith 2019, 140-46). Without similar direct evidence, it is presently impossible to suggest functions for any of the other fittings.

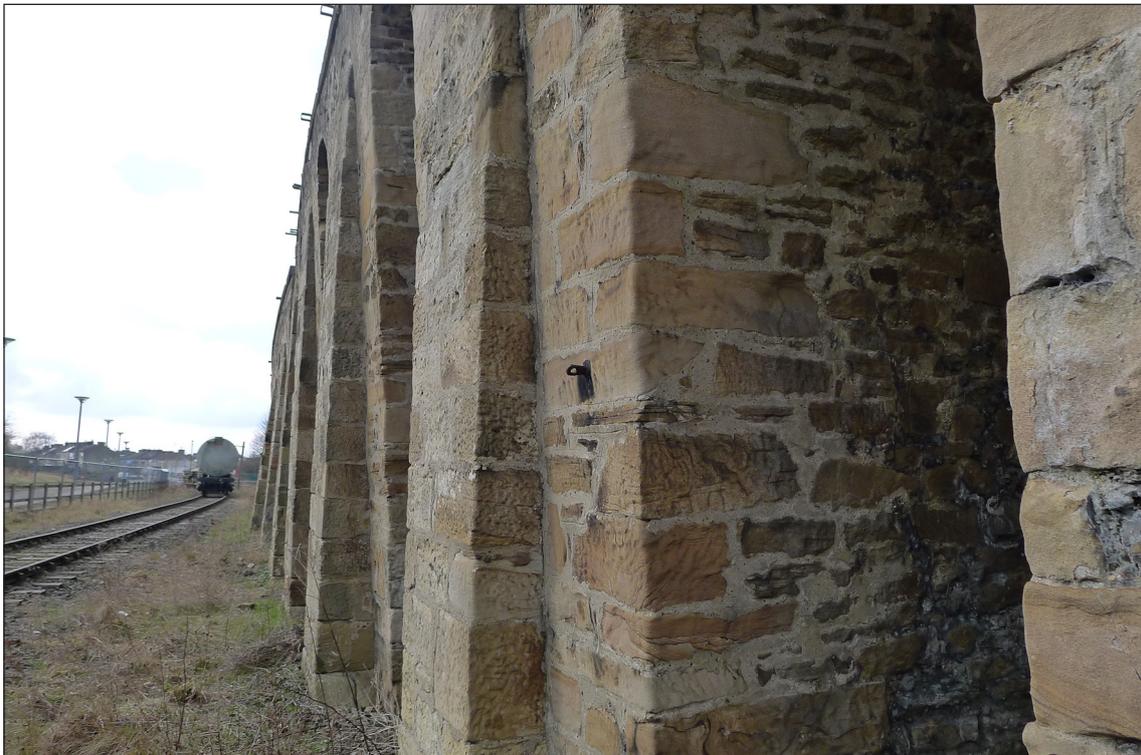
*Figure 24. Eye bolt between recesses 38 and 39. [Marcus Jecock 6 March 2020 © Historic England].*

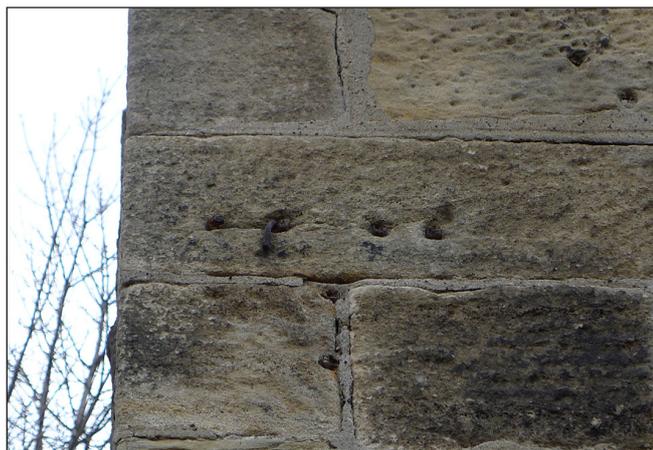
Figure 25. Detail of nail holes in fabric. [Marcus Jecock 6 March 2020 © Historic England].

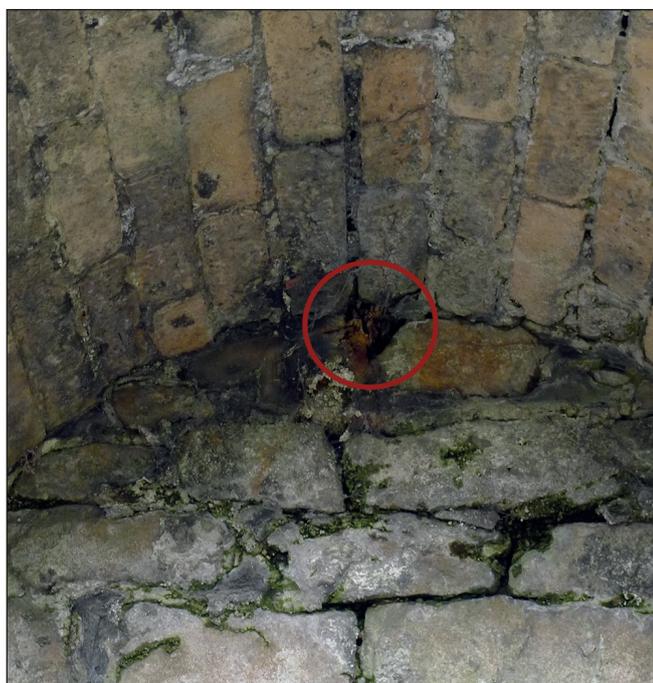
Figure 26. Detail of metal or wooden spike (ringed) in rear wall of recess. [Marcus Jecock 6 March 2020 © Historic England].

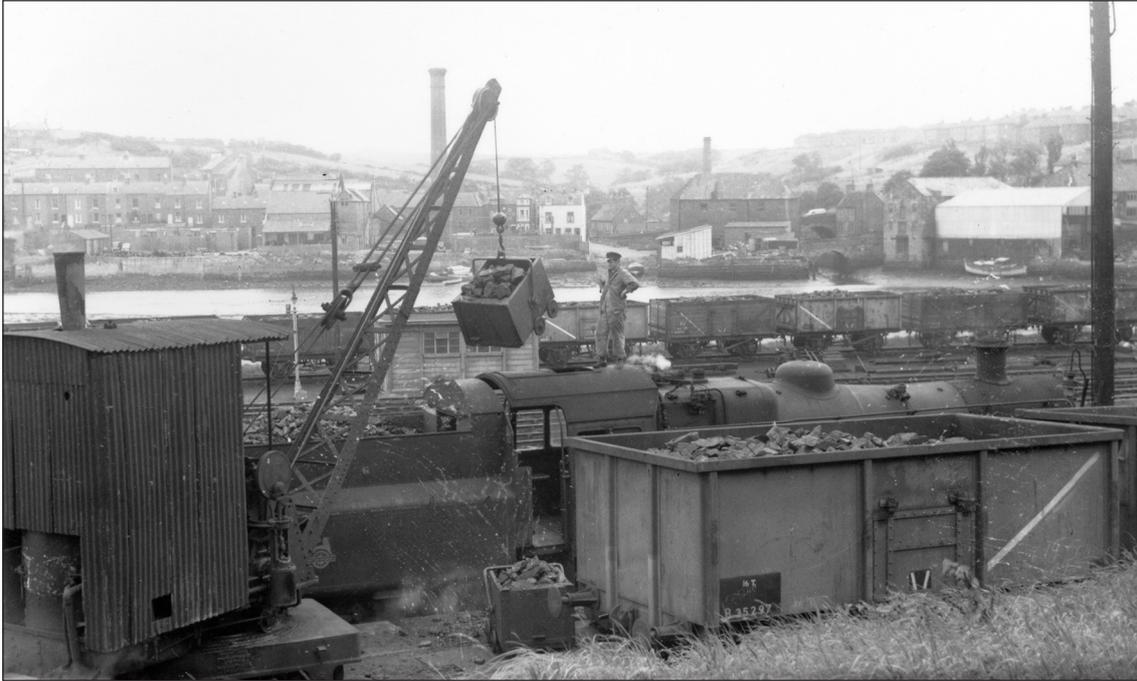
*Figure 31. Steam crane coaling a locomotive tender at Whitby shed, in August 1957. [NERA Collection, reproduced with permission].*

The former practice (of using cranes to lift tubs of coal) continued right up to the demise of steam on Britain's rail network. Sometimes the cranes were mobile, as is recorded photographically at Kittybrewster shed, near Aberdeen, in the 1920s or early 1930s (Guy in NRM E5B/243, pp12) and again at Whitby shed in the 1960s, but at Consett shed the crane was stationary and mounted on a brick base (Foster 2007); West Auckland shed also had a stationary steam crane in the 1930s but by 1964 this had been replaced by an electric gantry crane (John Askwith, pers. comm.). At other northern English sheds including Pickering, Saltburn, Barnard Castle and Masham, small hand-operated cranes similar to those found inside goods sheds were used; at Kirby Stephen, Carlin How and Wear Valley Junction sheds these cranes had double jibs, presumably to allow a full tub to be attached to one jib whilst the tub on the second jib was being emptied in to the tender, thereby speeding the coaling process. The tubs in such cases had a 'handle' across their top attached to lugs on each side of the body to facilitate lifting by the crane (Figure 31); once above the tender, a lever and rod mechanism was operated by the locomotive fireman

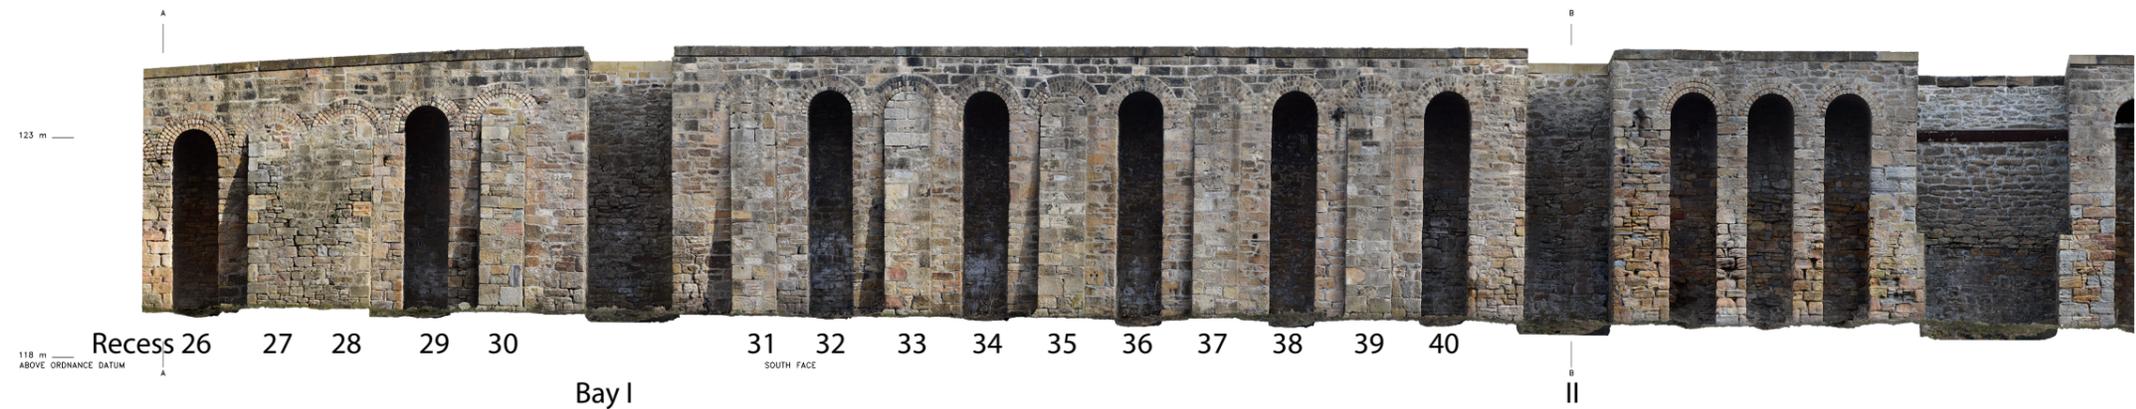
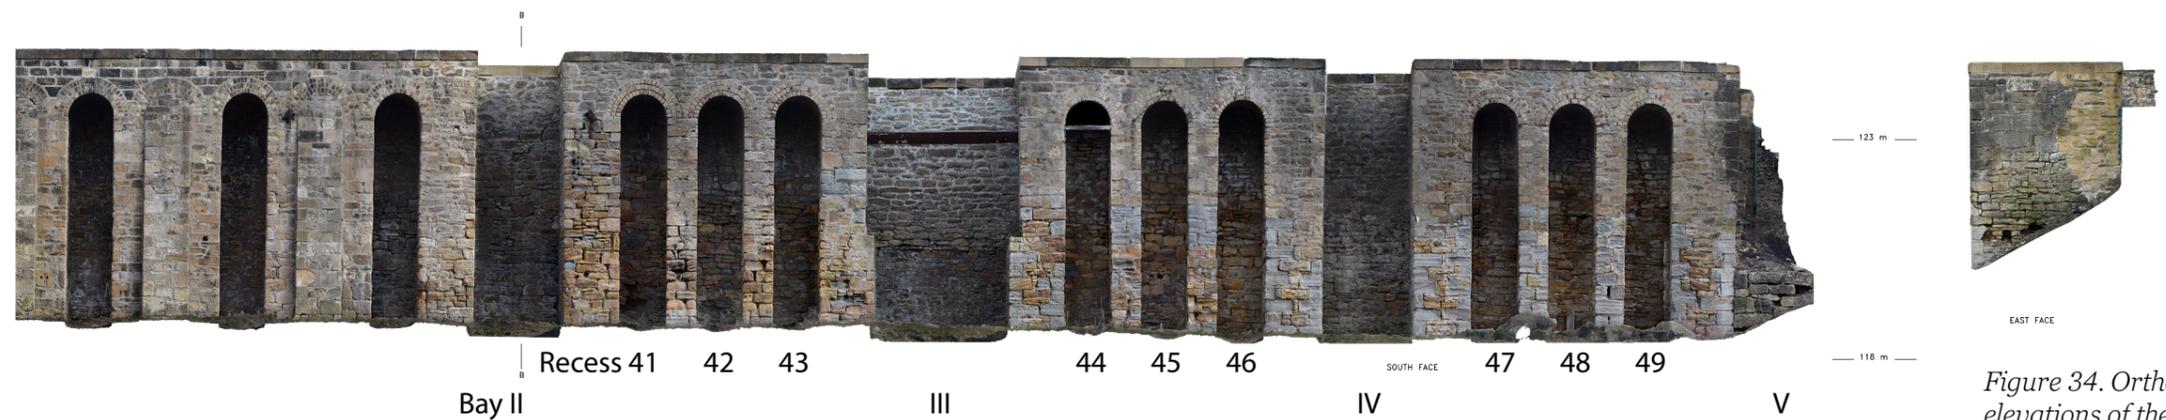
Figure 34. Orthophotographic elevations of the south face of the Coal Drops (recess 25 to end) and of the west face of bay V. From original survey drawings. [© Historic England].
