ENGLISH HERITAGE

DAMP TOWERS CONFERENCE

18TH APRIL 2013

INTRODUCTION AND OVERVIEW OF THE DAMP TOWERS RESEARCH PROJECT

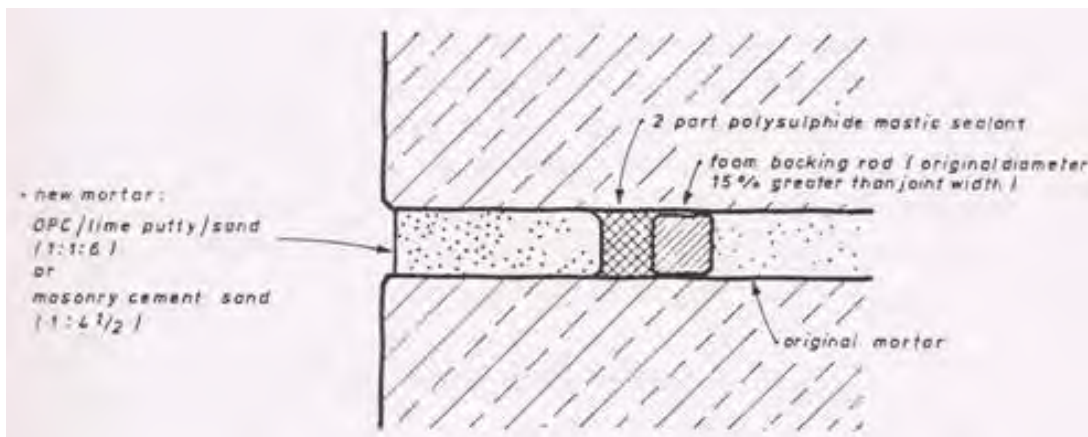
So their solution was to try, on one of the exposed sides, this detail here.

Essentially they cut out the cement joints, put in a foam backing rod at the back of the joint, introduced a two part polysulphide mastic sealant using a mastic gun, put an adhesive along the sides of the joint and re-pointed in a 1:1:6 mix, which was recommended at that time. I'm told for a while it was very successful.

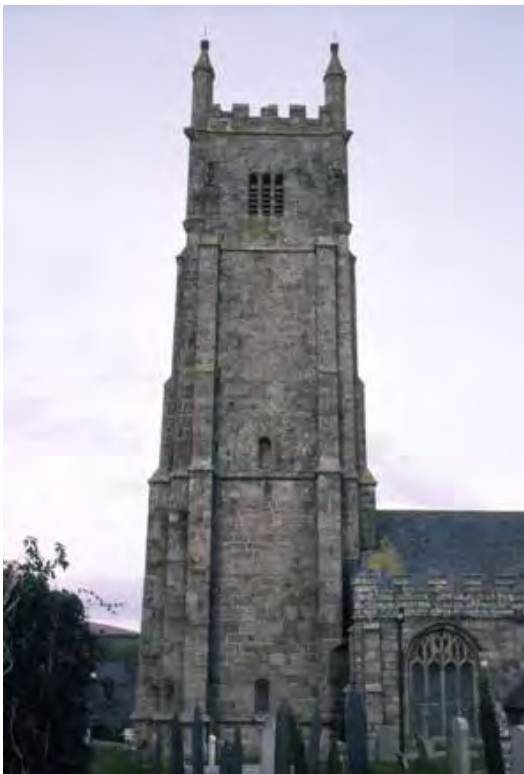
This is St. Peters, Ugborough, South Devon.

This is a very tall exposed tower, two metre (at the base) thick granite rubble walls. It had been re-pointed in cement a couple of years earlier. The cement pointing was pretty shallow; some bits had started dropping out. There was a lot of water coming out through the external façade and significant lime bloom inside indicating that the water washing through the core had washed the lime through and then hardened on the internal surface.

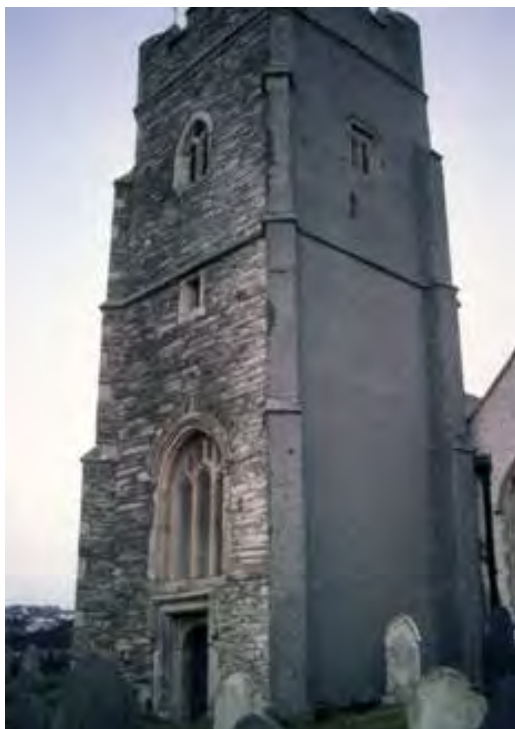
This is St. Werburgh's, Wembury, right on the south Devon coast, hence the cement render on the south elevation. It had been re-pointed in a purpose made mix in a "thoro' dry-joint" about three or four years earlier. This exhibited similar problems, with water getting in.

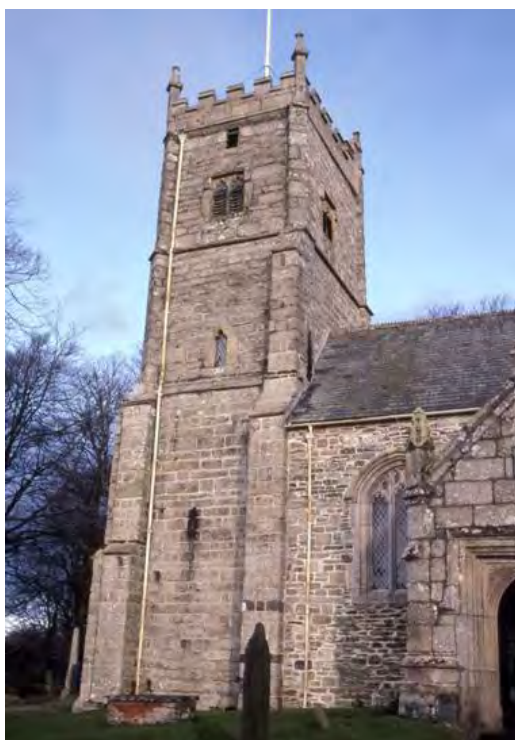
Lastly, St. Andrews, Whitchurch, near Tavistock, on the western side of Dartmoor, high up on a hill, very exposed, with similar problems to the others. Cement pointing which had started to crack, allowing water to get in on the inside.

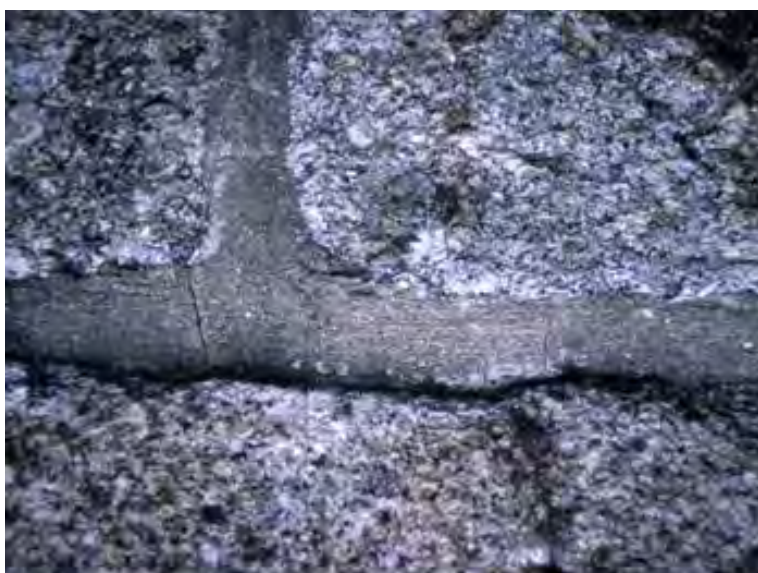
Drainage channels were put in on the outside right up to the middle of the core. As you can see there's water coming out everywhere except of course from the drainage channels. The report concluded that these structures were built with impermeable stones and suffer from very high levels of exposure. This means that all the work in terms of dealing with moisture is done by the joints. Joints invariably crack and the problem is made worse, seemingly by shallow pointing using impermeable materials.

Drainage tubes have not proved very successful.

Potential solutions recommended in the report include:

- point properly i.e. cut out and re-point at least twice the depth (being twice the width), using deep tamping
- grout
- render
- carry out internal improvements i.e. the removal of cement based mortars and replace it with lime
- improve the ventilation.

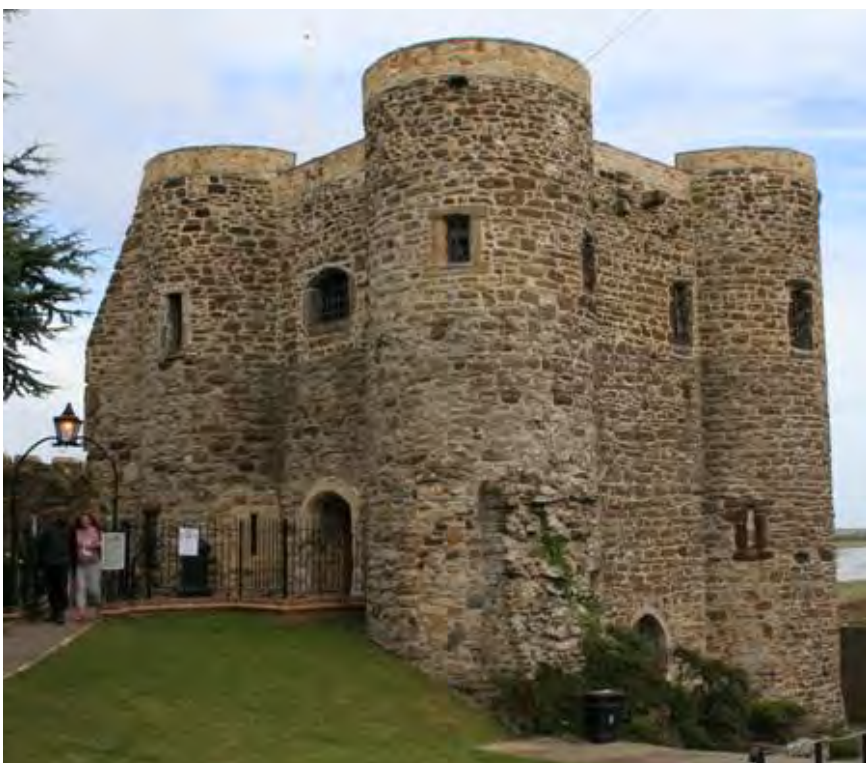
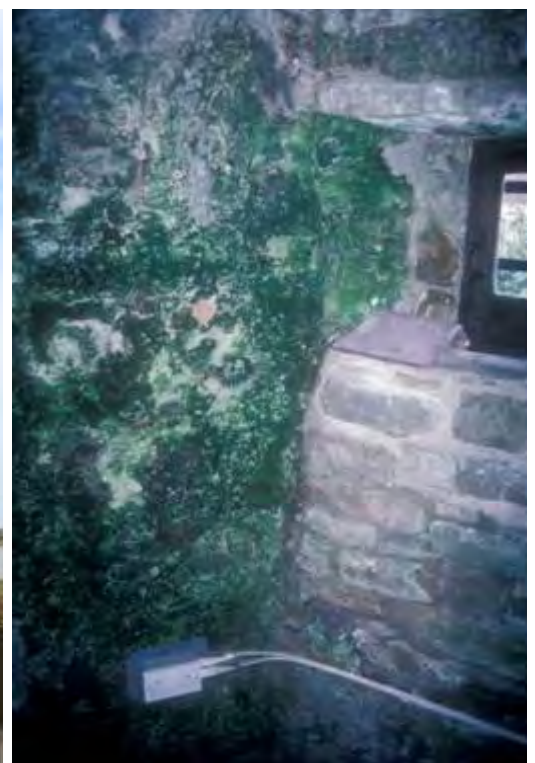
This is a tower in east Sussex. It's medieval in origin. It originally sat on the coast line and is now used as a museum. It had been extensively re-pointed and various other repairs carried out and 18 months later it had extensive mould and various other deposits inside. There are beams which are now ridden with death watch beetle. Essentially the problem was that a lot of moisture was getting in. Why? It's not easy to see from just looking at the façade. The weatherings have been improved, but there are no cracks or holes in the pointing. The contractor had probably used the correct mix but nevertheless, it had not worked. And this is actually one of the hardest things: determining where and how the water is getting in. Many of these towers don't look from the outside to be in too bad a condition.

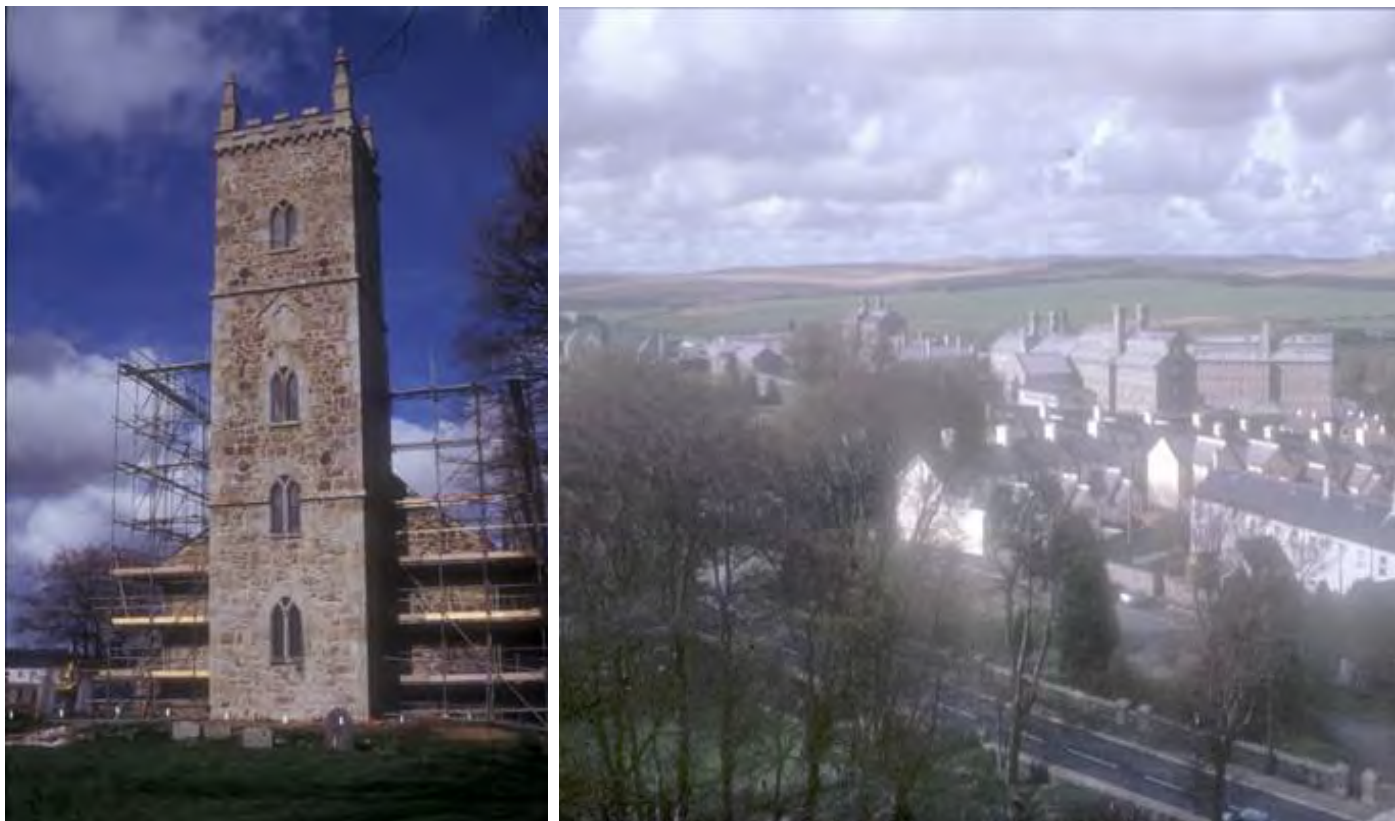
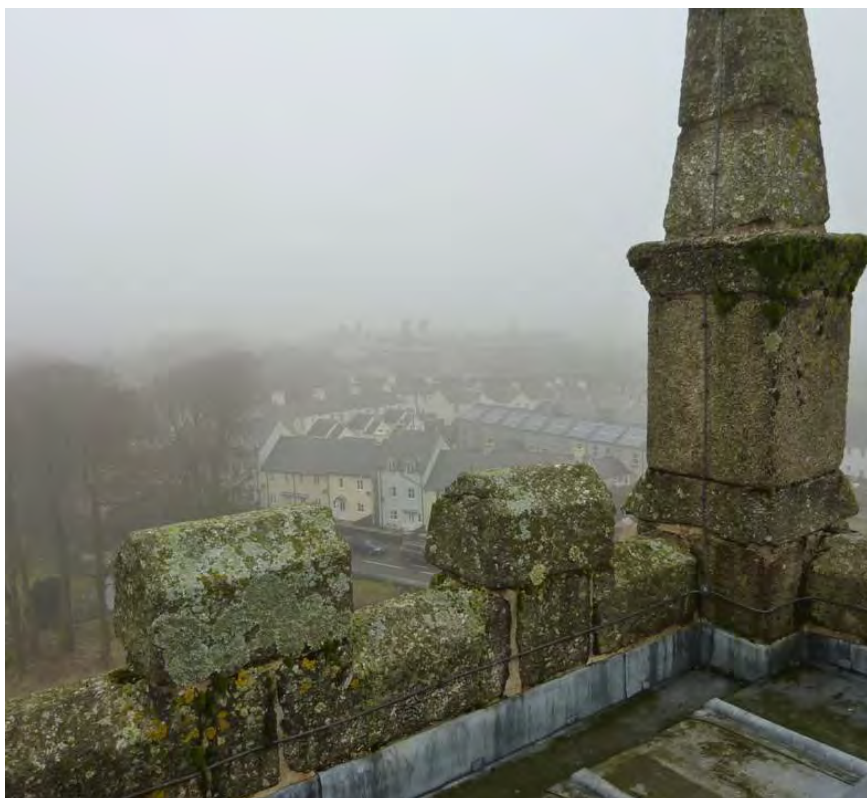
This is St. Michaels Princetown – I suppose in some ways our most spectacular example. For those of you who know Princetown, that's Dartmoor prison.

Once you've visited Princetown, you'll understand exactly why they sited a prison there. Its 420 metres above sea level, it suffers a 120 inches of rain per year and most of that comes in sideways. The tower was built in the early 19th century by French prisoners of war, so not the most motivated of work forces. Cornish masons, apparently, did the dressings – it obviously wasn't built terribly well because substantial ties were incorporated in the 19th century. It was taken over by the Churches Conservation Trust in 1991 and a survey by the architect described it as “dank, dismal and very green”.

That's Princetown on a warm summer's day – it was very challenging for the poor contractor who had to work there – it's bad enough for us just going for a site visit. Now the problems. These pictures are taken from old photographs and slides, because that's the vintage we were in. Essentially we've got a lot of cement pointing which was cracked. There are ferns growing inside. There's no plaster inside. The work was to re-point, carry out selective grouting, to put on a new lead roof and essentially tie the tower together. That work started in 2000. We came to visit after it was completed so we didn't see the works in progress. We were asked because it was still damp, in fact damper than when it started.

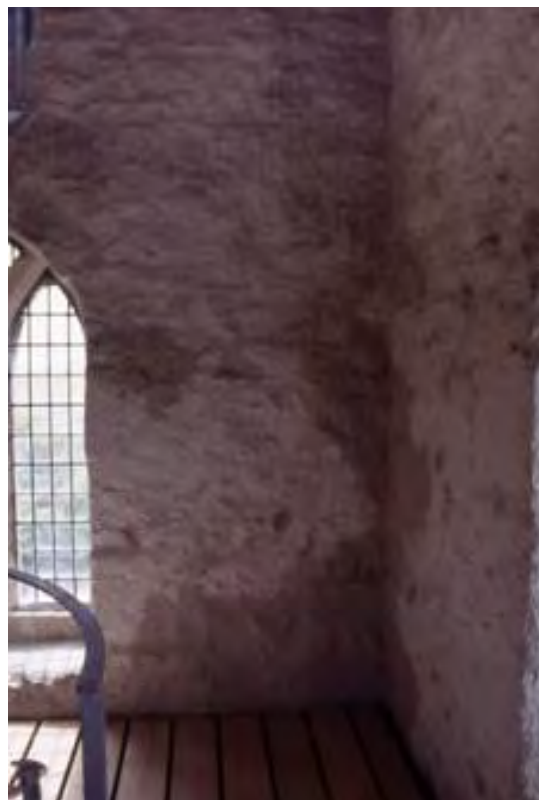
We've got water coming through straight away, escaping on the inside. The original intention was to use an hydraulic material (NHL5) and a very gritty aggregate, and grout with a fairly cementitious mix. At the time it was justified on the basis because the weather was not good (it was far from ideal time to be doing this sort of work), it was a very tough stone (they had to rebuild quite a bit). It was a substantial job carried out in very adverse conditions.

There was a question about the quality of the granite; a suggestion that there was more than one type (there were certainly five different colours) and that some of this was actually porous. Our consultant geologist, David Jefferson, did a permeability test and he took samples to confirm that there were three types. He confirmed they probably came from the prison's own quarry. All of them passed the permeability test, in other words, no water got through. He compared it with the most robust Bath stone used for the pinnacles and coping. Water went through that, so there was basically nothing wrong with the stone, so presumably it was something to do with the mortar or workmanship.

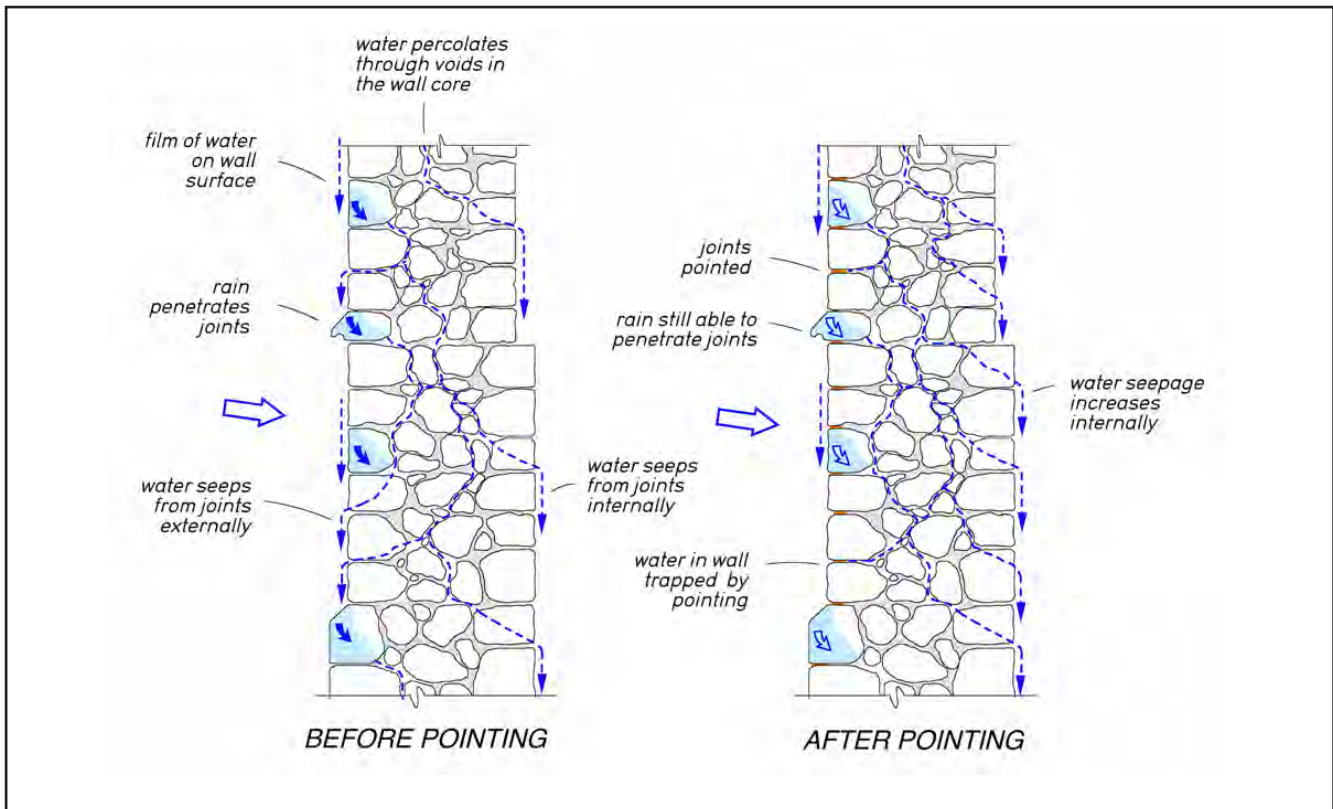
We move down to the north coast of Cornwall. This is St. Senara, Zennor – a very attractive tower on the north Cornish coast, subject to driving rain from three sides. This had been re-pointed with fat lime pointing with a pozzolan.

We thought the work was carried out well, but the church was still very wet inside. We had a look at the joints. One or two of the fairly shallow ones had clearly dropped out, but generally speaking the work was done quite well. The problem seemed to emanate from the stones themselves. They weren't cut 6 sides square, which meant they touched a few millimetres from the surface, resulting in only small amounts of mortar being accommodated.

When you get driving rain down there of days in duration, it can go through a few millimetres in not much time. What we think is happening here is that water is coming in, it goes into the core, some of it goes inside, some of it escapes through the cracks and missing joints on the outside. As soon as you block those with good pointing those escape routes are lost and you get all the water now being transferred internally. Now we've seen this on so many occasions where workmanship seems to have made it worse than it was before. We are reasonably confident, that that is actually what is happening.

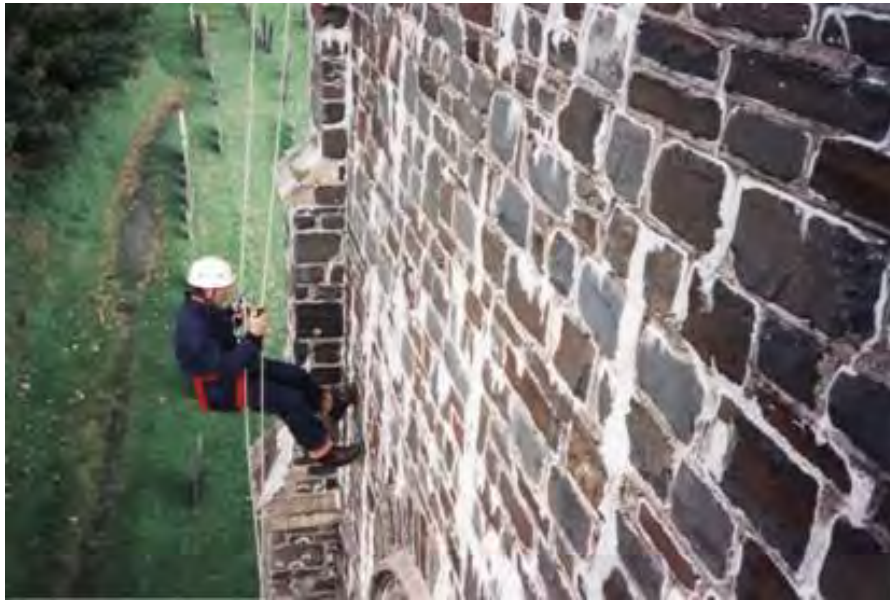
You can see the lime bloom here where the rain was washing through the joints.

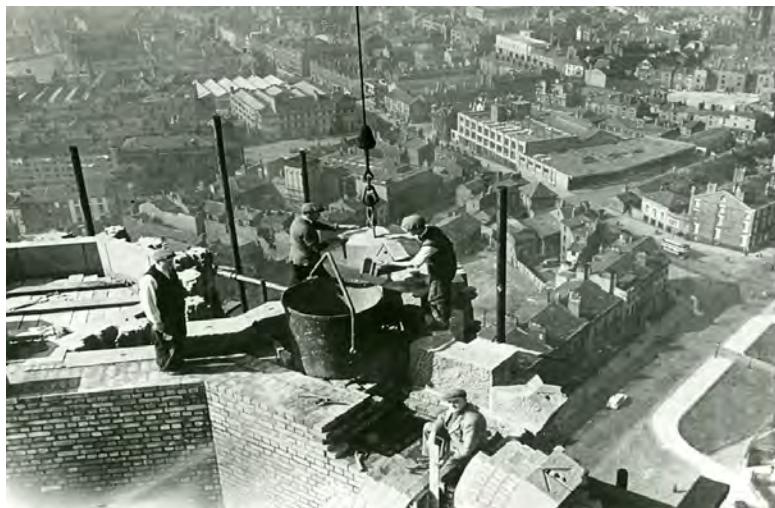
The other lovely thing to look at on these pictures is the slightly more relaxed attitude to health and safety. That was the finished joint. They used a 1:2:9 originally or something like that. These have dropped out.

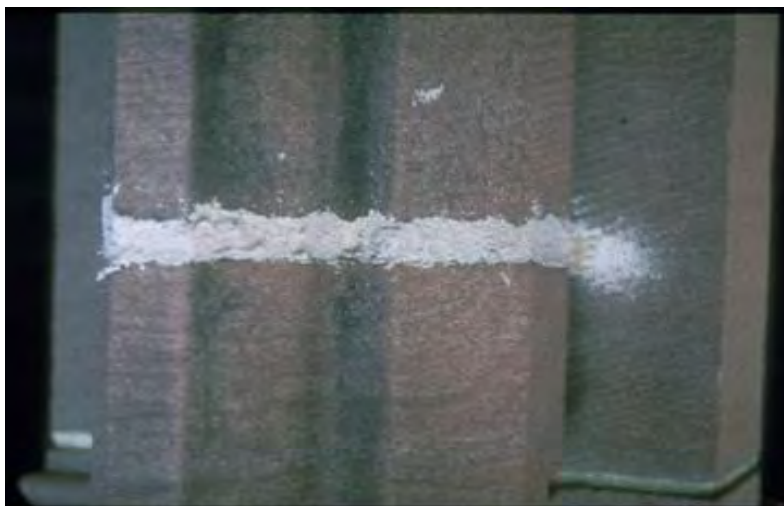
This was the mason's attempts at re-pointing – not altogether successful.

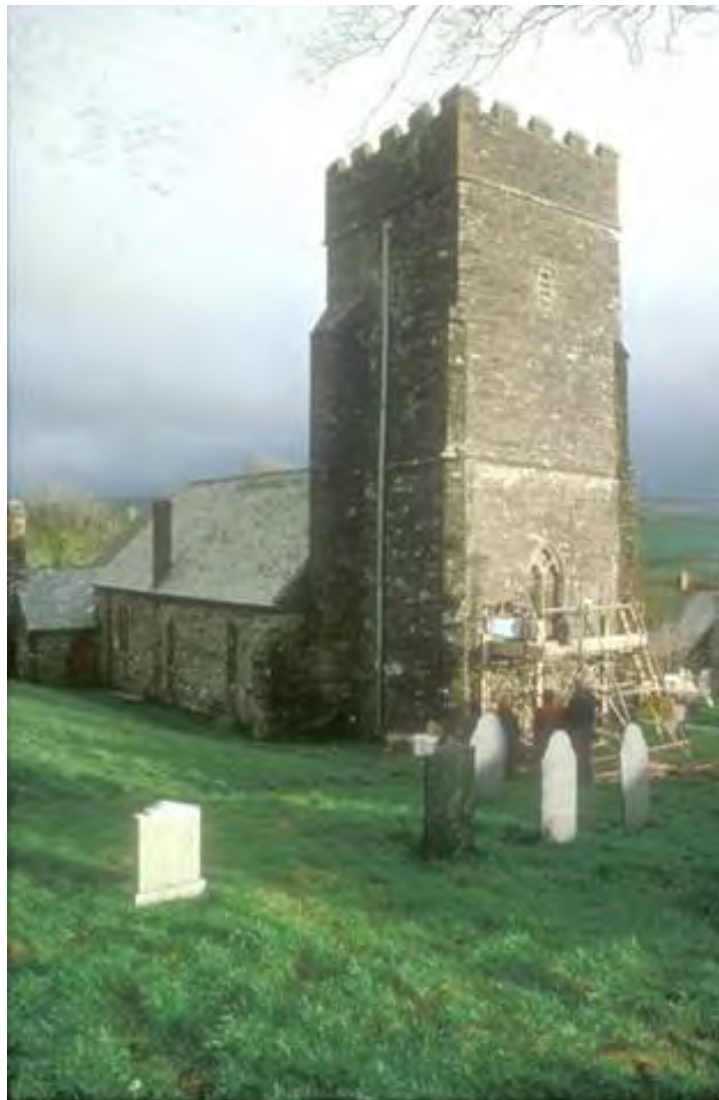
This is Holy Trinity, Challacombe, north Devon. It's very exposed, because it's on the edge of Exmoor.

We monitored this for a year before any work started. Then it was shrouded in scaffold and monoflex and allowed to dry down for 15 months. Invasive investigations were carried out to see the state of the core and it was found to be in a very poor condition. It was an earth mortar and it didn't look promising at all.

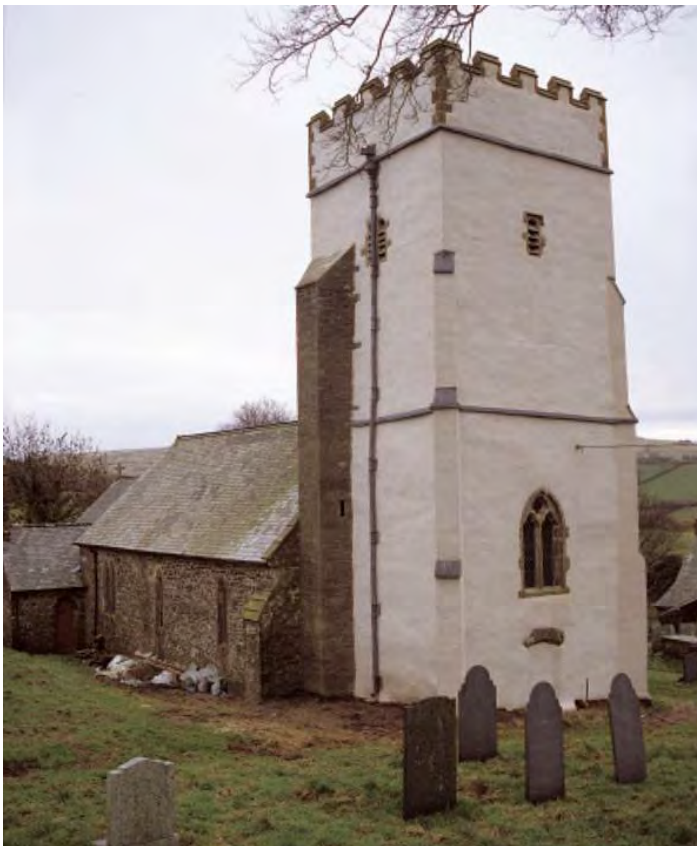
Monitoring revealed that the whole place was saturated bar one part of the east wall.

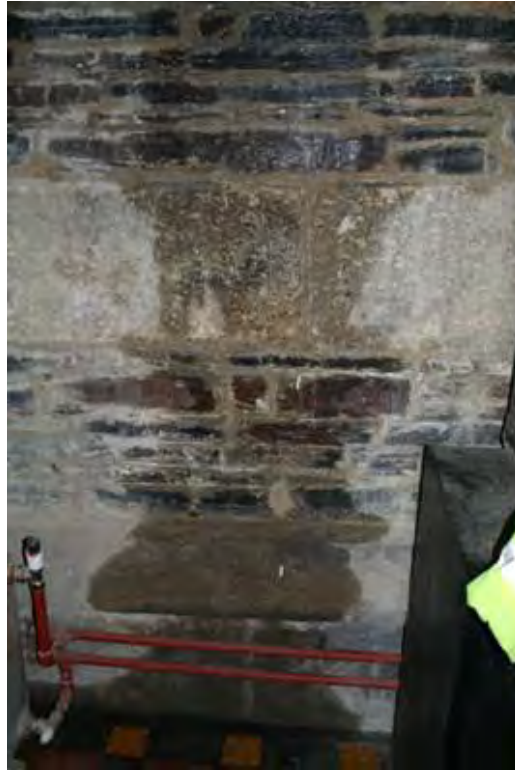
You can see from the picture there we have a lot of damp on the south elevation. It's running water here with salt damage on the inside. This tower has always been wet and Gilbert Scott suggested in 1860 that it should be grouted with liquid cement and cement plastered on the inside. By the end of this work the moisture level was down to about an average of 30%. Again, a couple of years later when we monitored, it shot up following heavy rain, but again the water didn't go to the inside and it settled down. The other good thing was that there was now an extremely well-prepared and skilled work force at the end of this project and they then worked on St. Petrock Parracombe, north Devon, again a church subject to significant driving rain.

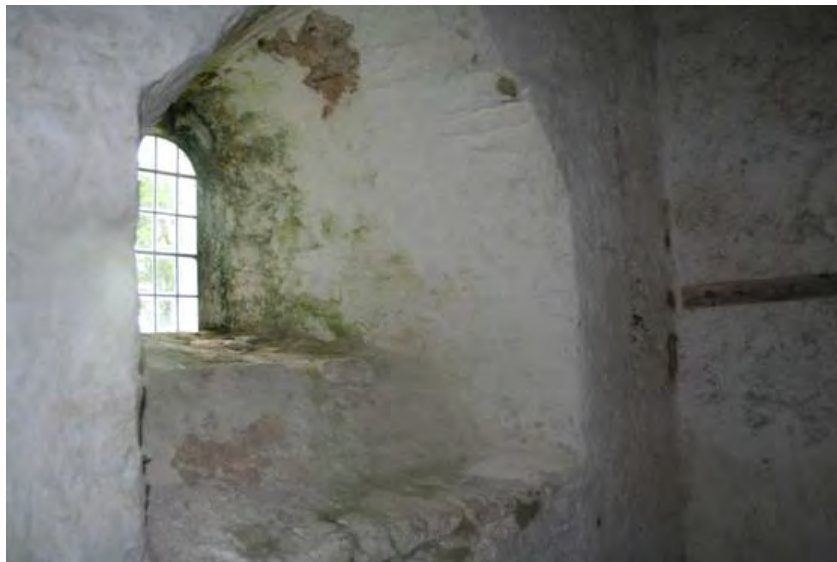
The tower is very exposed. These are the walls, about six feet thick at the base –the architect's report said that it had been running with water and it hadn't even been raining for a week. That shows the damp ingress and the salt that's coming through here. The tower was monitored in two phases for budgetary reasons and some of these images show the dowel monitoring and there's evidence of the grouting and the tubes being prepared before the grouting process. The first operation was to repoint which was carried out successfully with hydraulic lime. We went to visit in 2012 again and it was very dry apart from a few problems near the very top which was not related to the grouting, but moisture ingress above one of the concrete ring beams.

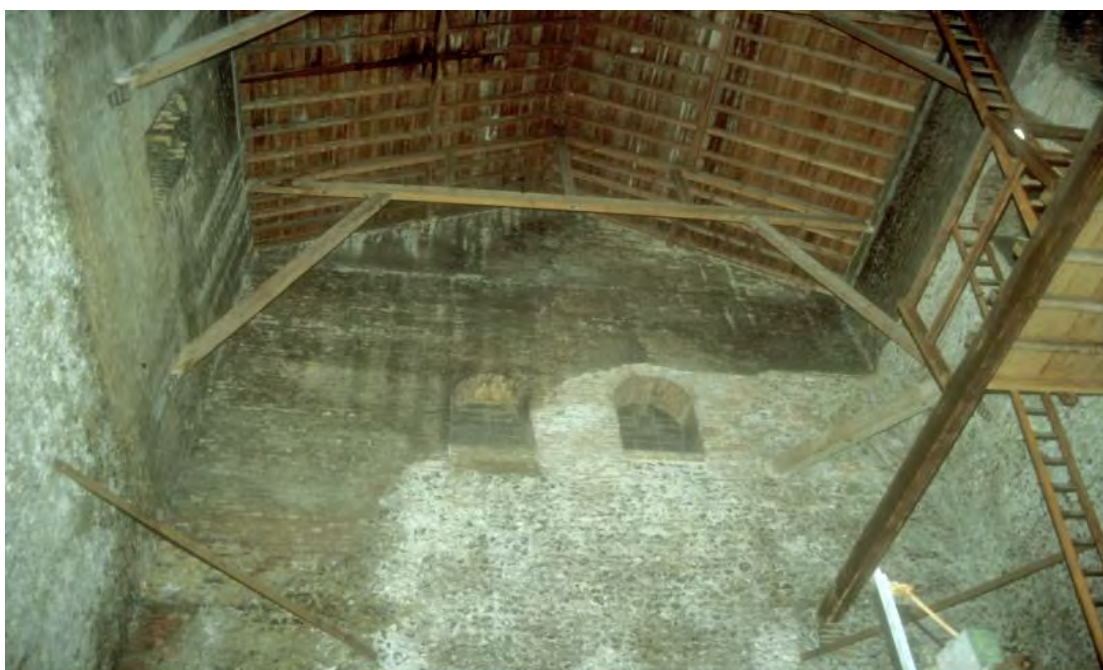
That's a view from the inside. That isn't actually all damp that you are looking at, it's just showing a difference in the colour following the mortar and changing building pattern.

We see again from the records that quite a few campaigns of re-pointing had been carried out and most of it was pretty hard and cementitious. So basically we've got a problem of a cement laden exterior, some softish sort of bricks, three or four different builds – quite complicated. We thought the first solution was to try and at least get rid of the cement. Essentially we carried out trials that showed it would take a complete day to remove about half a square metre of this cement. It was so tough – it was tougher than the flint and frankly it wasn't practical. The further you got, the worse it was. So removing that wasn't an option. So what we therefore tried to do was find out where the water was actually getting in. We had the scaffold up so, the contractor installed monoflex against that lift and waited for the rain to come from the south and we were able to observe whether any moisture went through. Eventually when we did the same on the west side, we put it over two lifts and eradicated the moisture ingress. Unfortunately, six months later, the investiture of the new Lord Warden of the Cinque Port was scheduled so I'm afraid our interest took a very poor second place and the scaffold came down. I've spoken to the new incumbent and the problems remain and that is something that will have to be tackled again in the not too distant future.

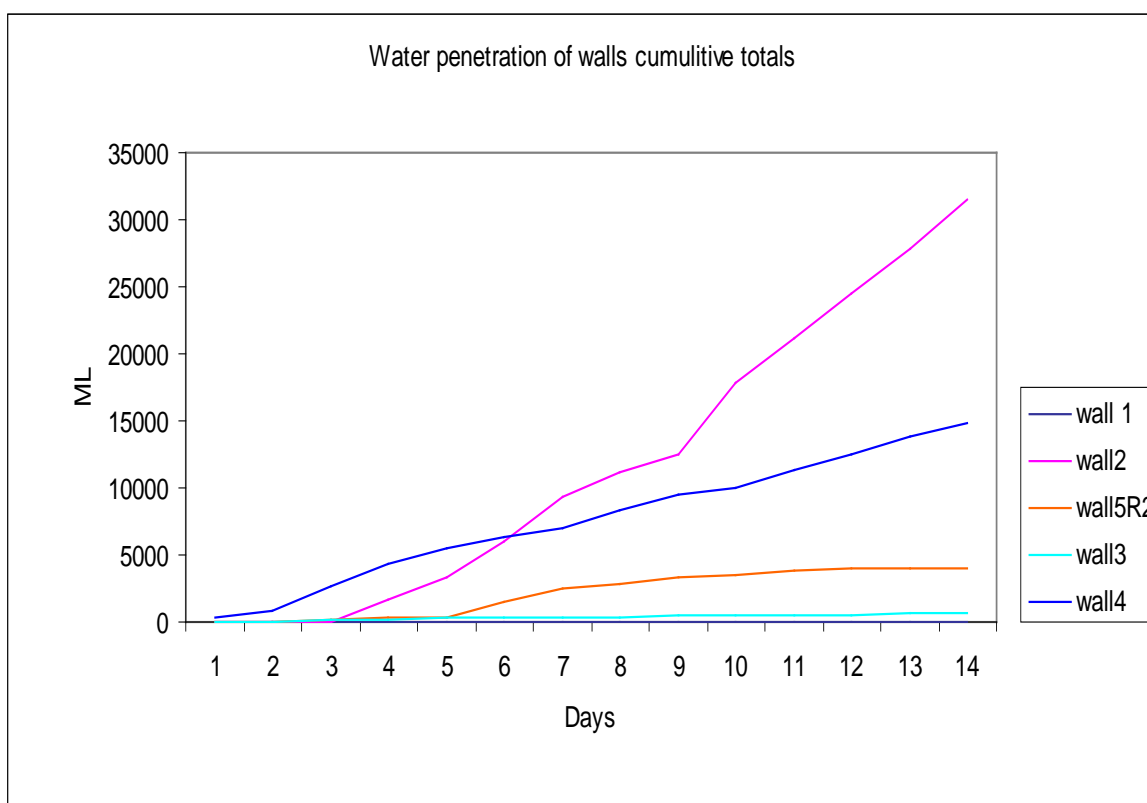
So we rebuilt the control and everything was left to cure again and we retested it and this is just a graph of the one where the smooth render didn't allow any water penetration over the time.

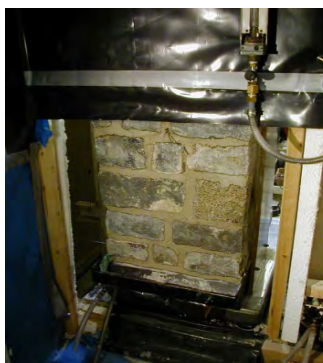
Wall 1

You see the two central walls, wall 1 and wall 2, those were the best practice walls. Wall 3 and wall 4, the voided walls and that's pretty much as seen in the chamber. And again there we go, rendered vs. unrendered walls.

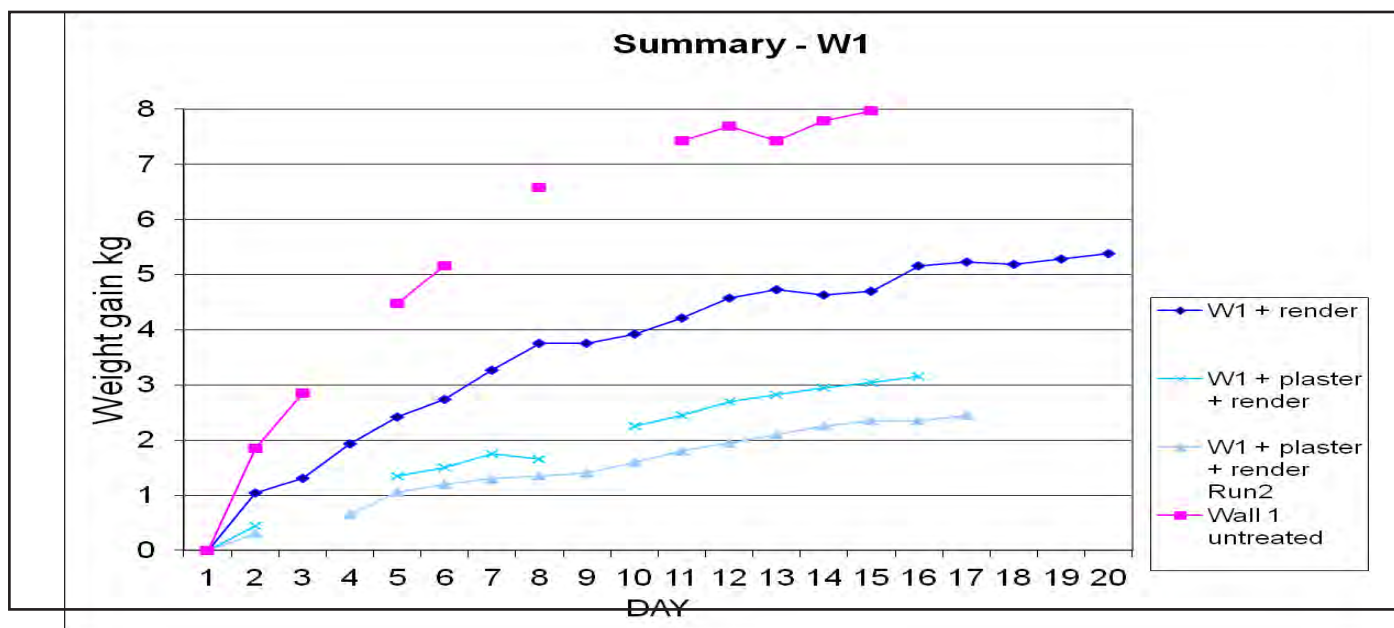
This is wall 1, one of the perfect walls. Here's the untreated wall, this is the weight gain over testing – it takes on 8 kilograms.

What happens if you render it? Significant reduction. What happens if you apply plaster as well as the render? Significant reduction. Now obviously wall 1 wasn't leaking, this is based purely on the weight gain of the panels.

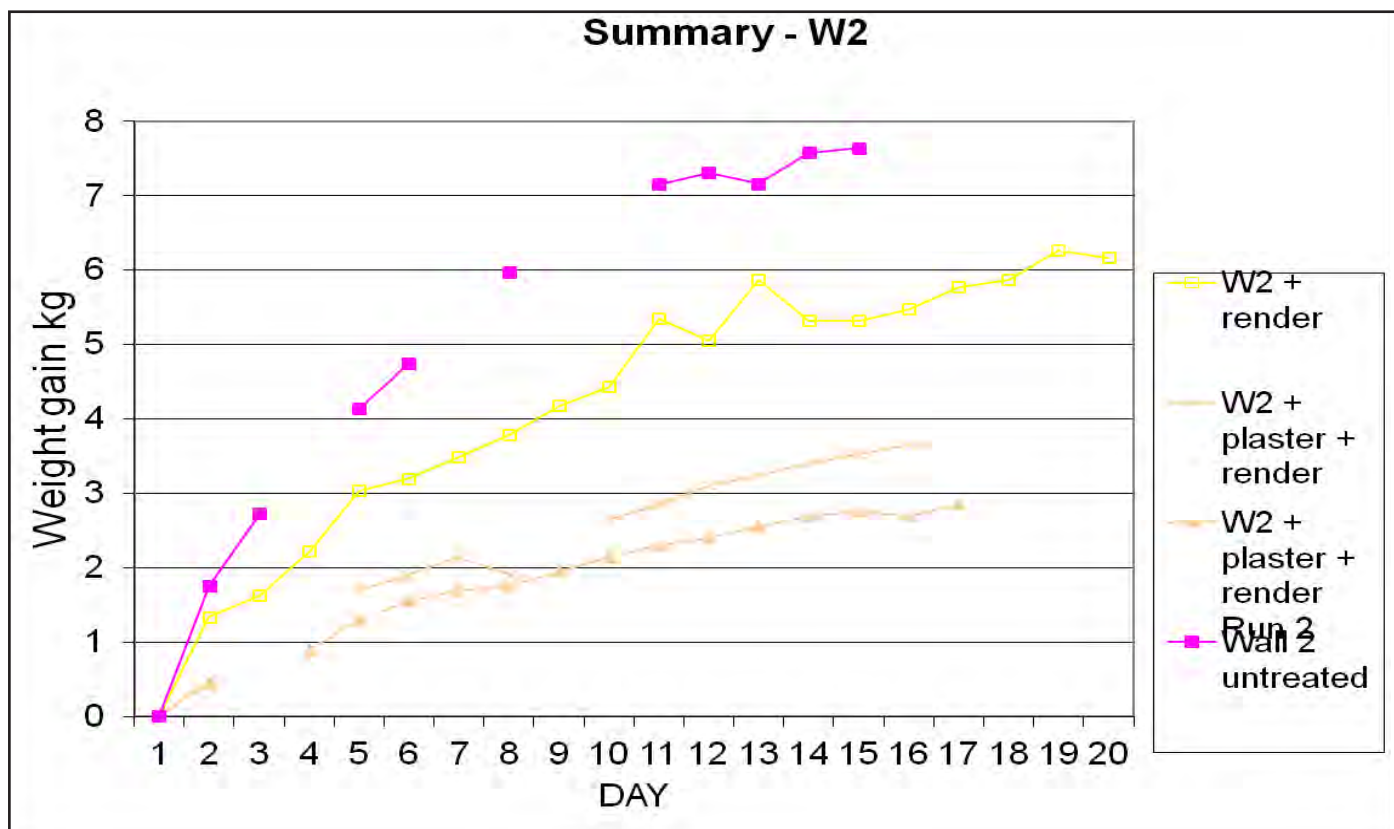
Wall 2, exactly the same trend. There's the untreated wall with render, with render plus plaster.

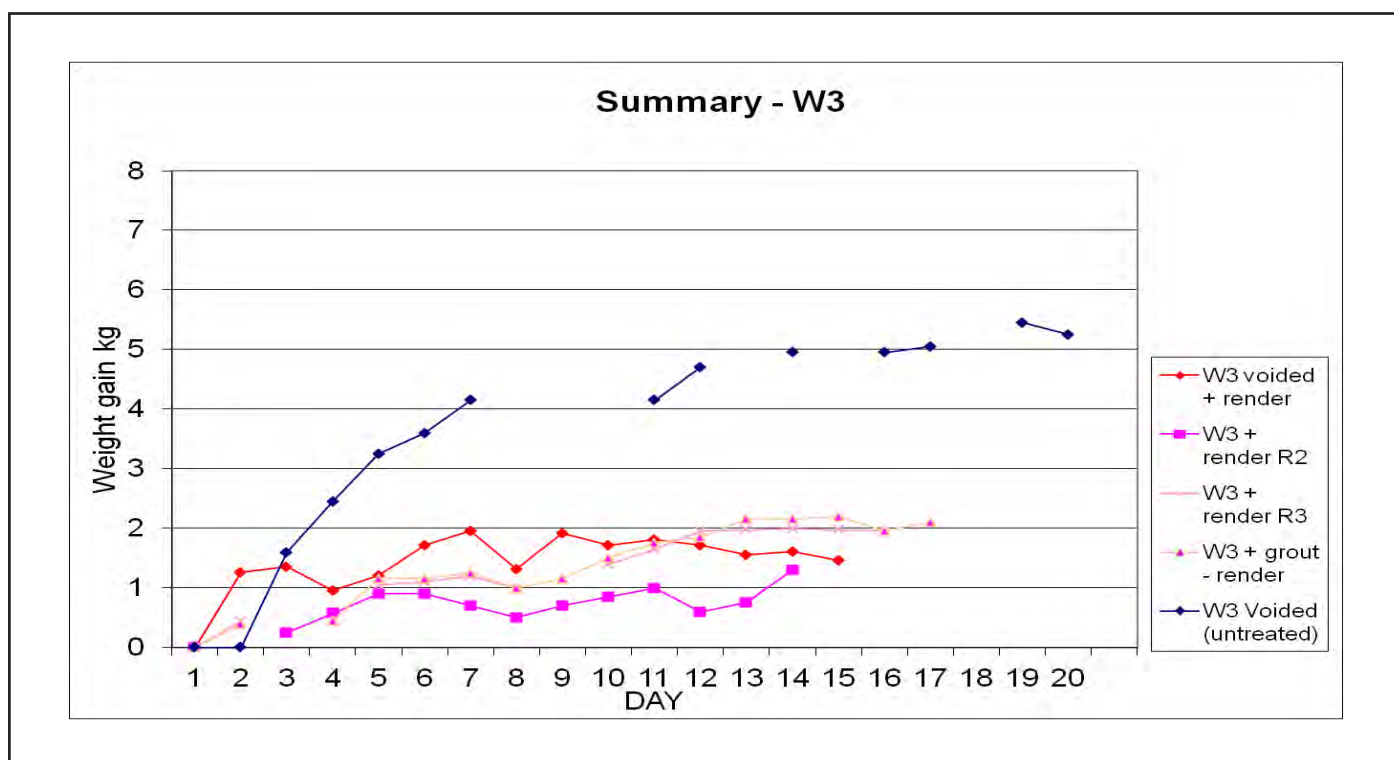
Wall 3 and wall 4 a little bit more complicated because of the difficulty in actually finding where the voids were really and you can see that adding render to these was very effective, adding grout – very effective.

Same with wall 4 render and grout both very effective. Obviously we applied the render first, then the render came off, then the grout went in. We didn't have render plus grout – render or grout.

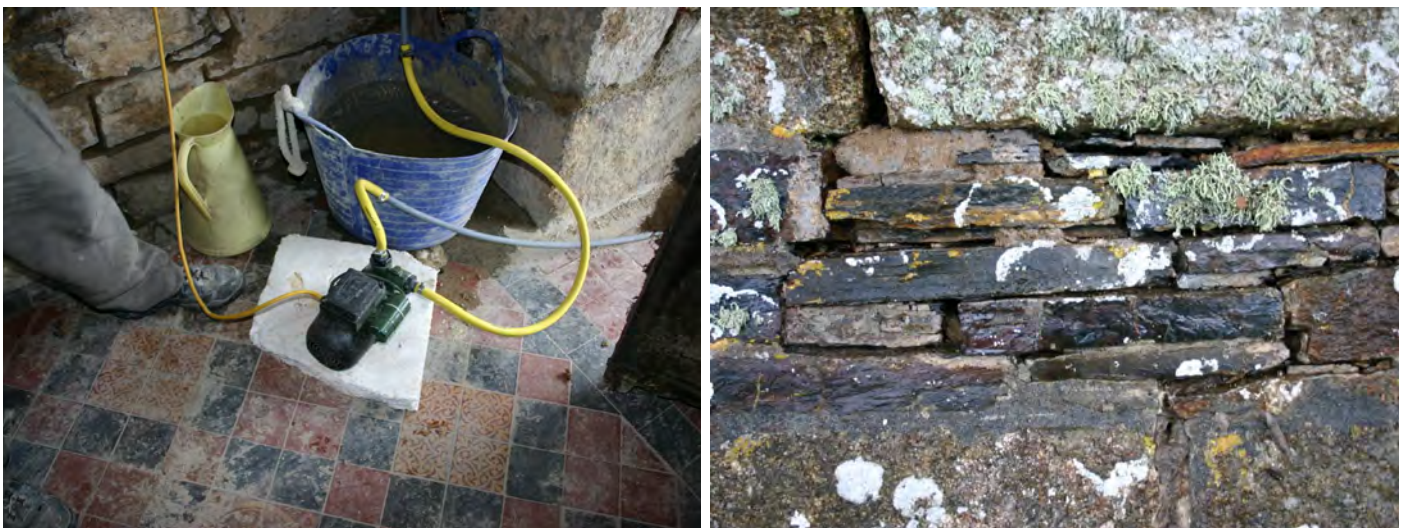
Because of the condition of this particular tower and the condition of the cement pointing, it's not sound enough to use as a barrier to escaping grout. We couldn't ever hope to stem the flow of the grout from the core to all these holes. So the decision had to be made that we would test, pre-wet, rake out, re-point in advance of grouting. Quite unusual, because you'll have to re-point from the ground up rather than coming down as is the traditional way. Because your grouting will always, start from the ground upwards. You never grout downwards. You could get air pockets, you could pick up loose debris in the core, bring it into a narrow neck and block. So always grout upwards. That loose material when you are going upwards goes into suspension, falls out of suspension quite quickly and your grout can carry on its passage through the wall.

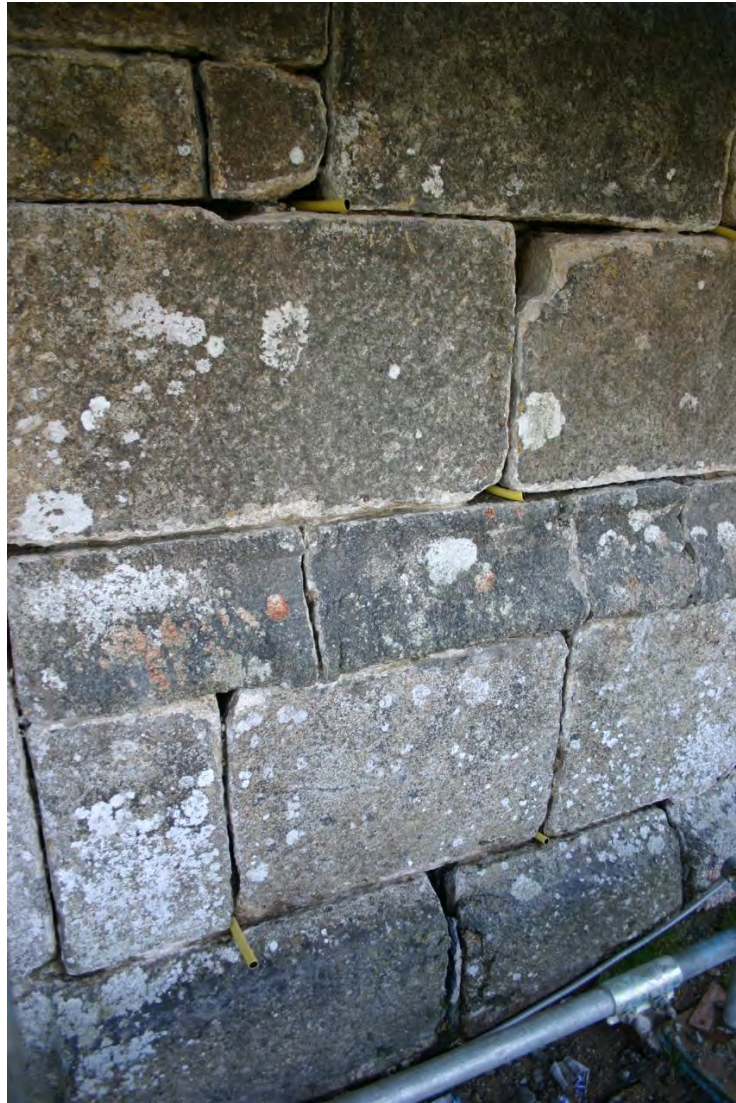
So at this stage we've raked out the joints and we pre-tested the wall with water. Where the water escapes at the bottom point we insert these little plugs. That's where we are going to introduce the grout, at the bottom of the void, in each one. Some of these interconnect; some don't, but that you'll have on your plan.

Now all the pointing is done. We've got these little bits of hose. They, by the way, are drilled to nearly a metre deep. If we drill with a 25 millimetre diameter masonry bit and then we put a smaller diameter, something like a 15 millimetre diameter hose, you'll see that if you feed that hose right to the back of the hole and then inject grout its going to feed back down the hole. In doing so it will pick up any fissures and voids within the length of that hole and feed into them.

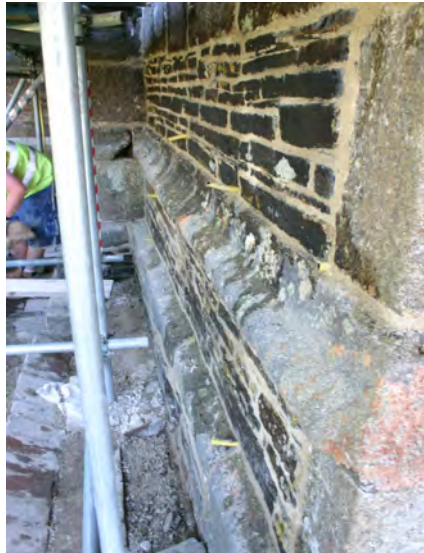
In this particular face, you can see that the cement mortar is in such a condition that it can retain the grout satisfactorily and a repair here and there as we get small leaks, so straight into the holes with the hosepipe.

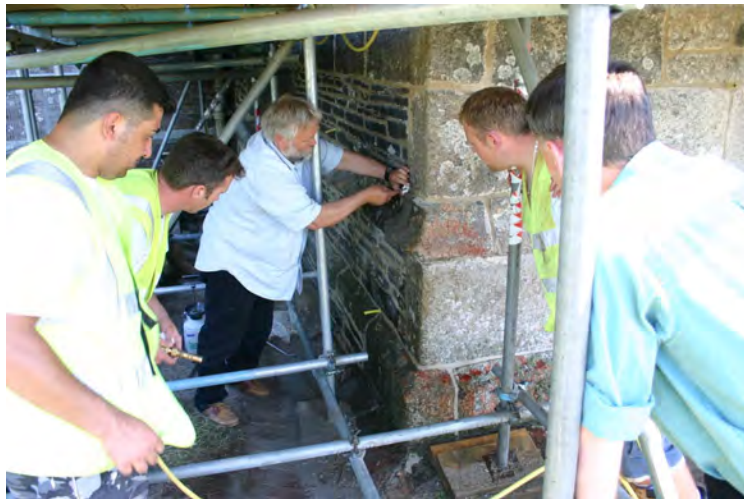
It had to happen didn't it! I won't tell you what British Waterways calls this, but it's a leak! Here's the governor, showing the boys how to stop the leak! As I said this was actually a very, very good team. So a simple cotton wool, stick it into the hole, de-water and on we go. And there it is in action, simple and very, very effective.

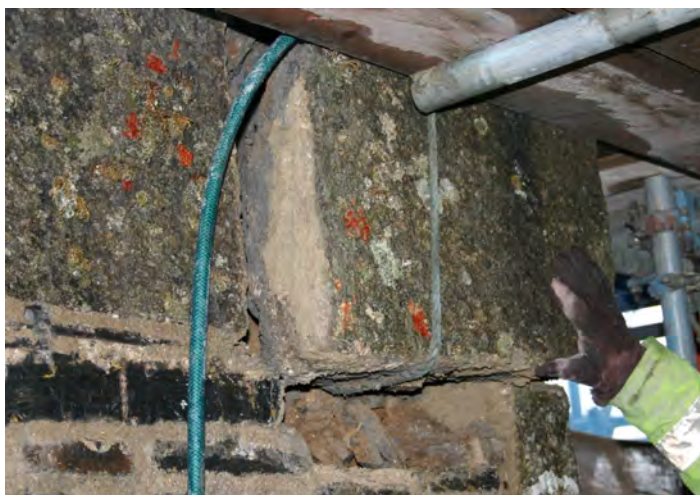
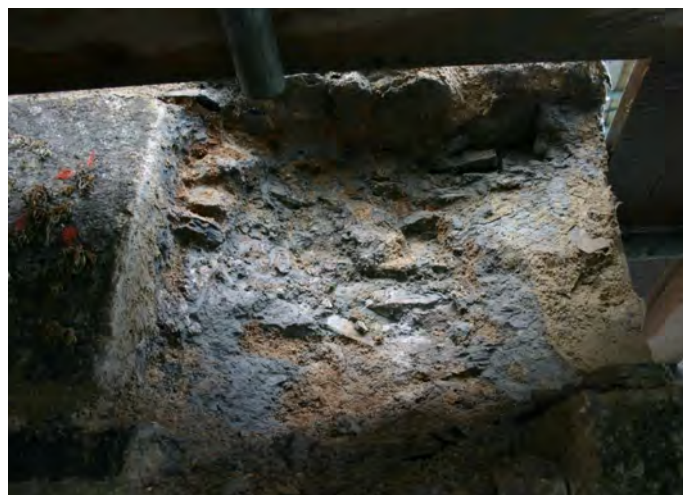
That stone has been displaced by the weight of the grout. Now we weren't being silly, we were being quite conservative with the height that we were lifting each day; and yet this moves. In a sense it's nice as it gives you a photo opportunity to show you how well the grout has got round the back of that stone – ain't that lucky! That's a very serious point as the grout has flowed around beautifully. Now you can see it at the back of the stone also.

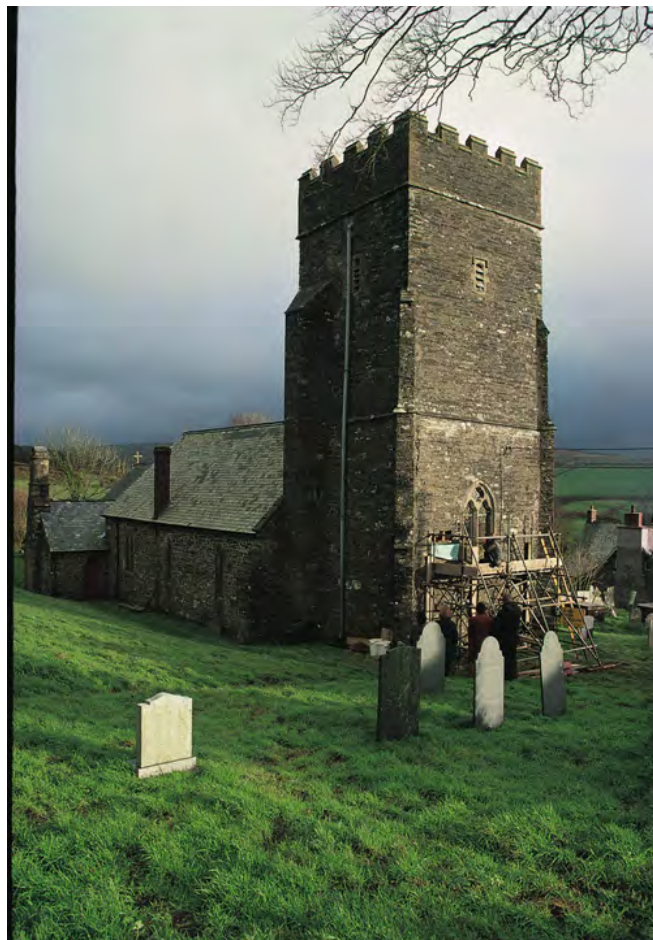
This is Holy Trinity Church, Challacombe, which I mentioned very briefly this morning. This is situated on the northern part of Exmoor, fairly close to the coast. It suffers acute driving rain problems. It's built with a locally shilley sandstone. This was its condition in 1994 when we were asked to go and have a look at it. There was a scheme to carry out various works but colleagues in the SW team managed to persuade the PCC that rendering was the solution to adopt in this instance. You can see the condition of the walls.
