ENGLISH HERITAGE

DAMP TOWERS CONFERENCE

18TH APRIL 2013

INTRODUCTION AND OVERVIEW OF THE DAMP TOWERS RESEARCH PROJECT

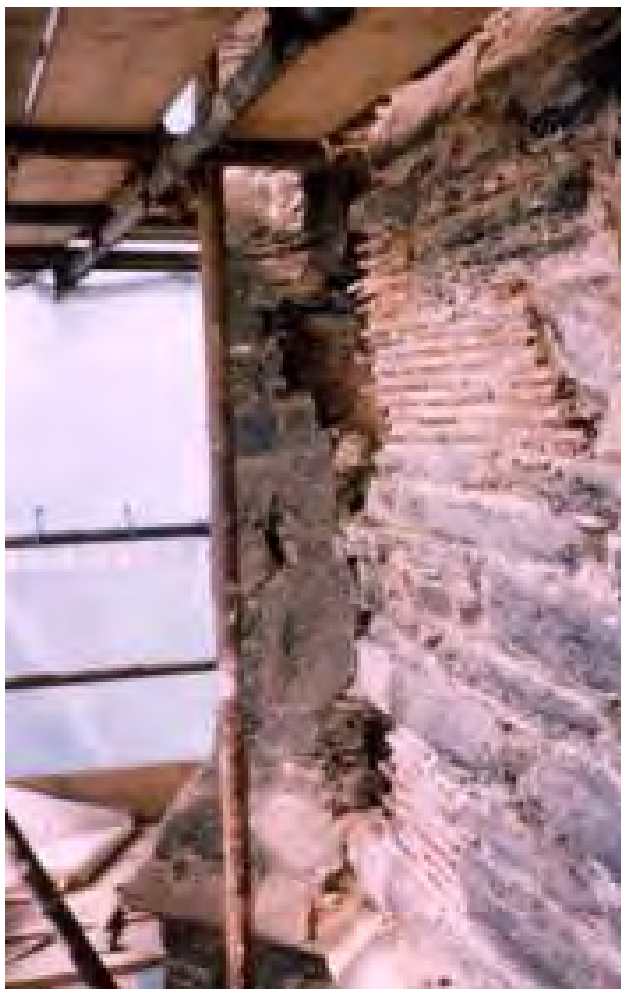
Whilst that was going on, it gave the architect a good chance to do a thorough survey and investigation of the walls. He found a purple replacement stone that had been added sometime in the 19th Century that seemed quite porous and not doing very well, so those were all removed and replaced with a tile creasing that you can see there.

He also found evidence under the string courses of some earlier render which was used as the basis for coming up with 6 different mixes for potential re-rendering.

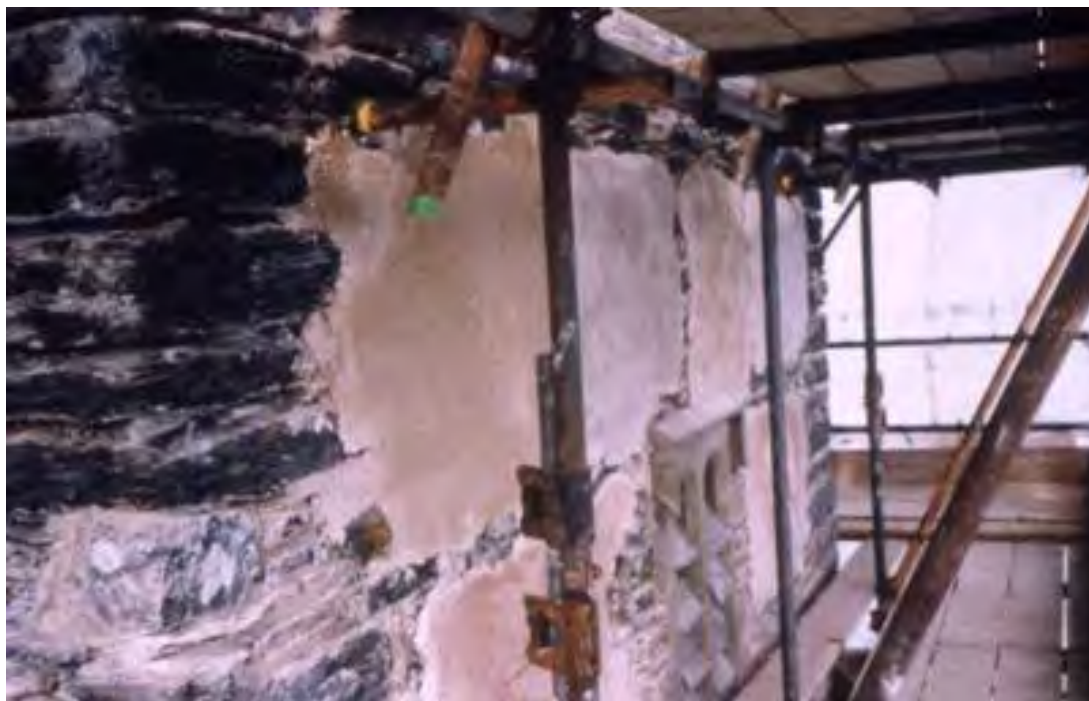
Broadly speaking when the project started off virtually the whole thing indicated saturation point. That's actually after only 10 months. The moisture levels were reduced down from an average of around 60% down to about 30% which is round about the time everyone felt confident enough to go about the render works.

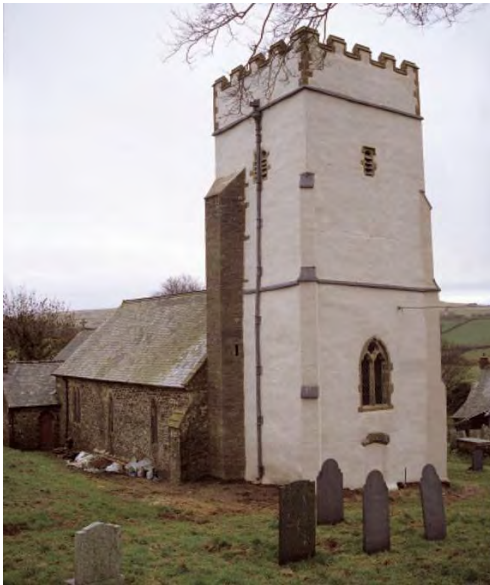
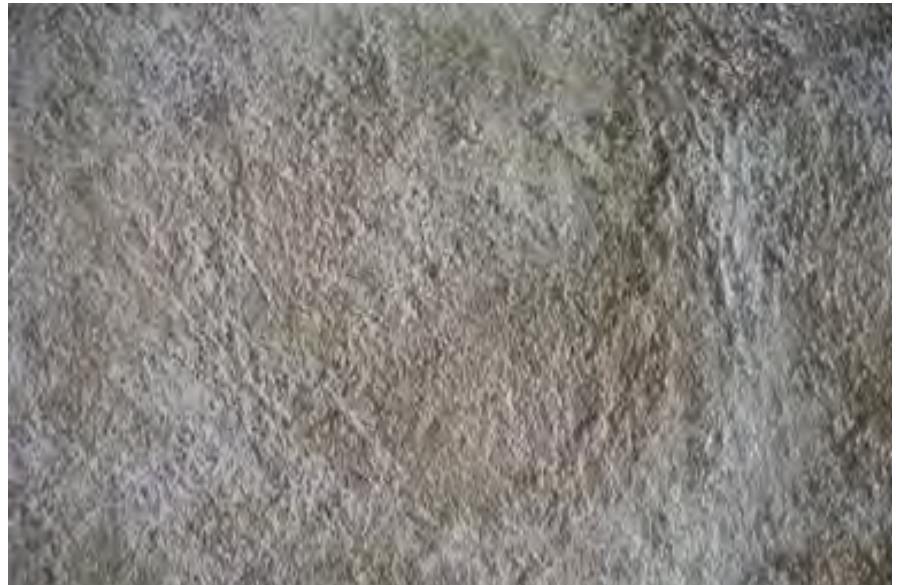
We kept the monitoring going and by this time the monitoring was between 25% and 30% which is as low as we thought we would ever get it.

The actual mix that was selected was the Somerset hydraulic lime, which used to be called feebly hydraulic, and the weakest of the lot. That was mixed in with a local, Bideford grit and stone dust, in portions of 2½ to 1. Rendering started in May with the dubbing coat, the second coat went on in June and the third in July – they were all applied green on green. Two months were spent tending this, keeping it sprayed, so it dried down very, very slowly and then 5 coats of limewash were added. This was the finished result.

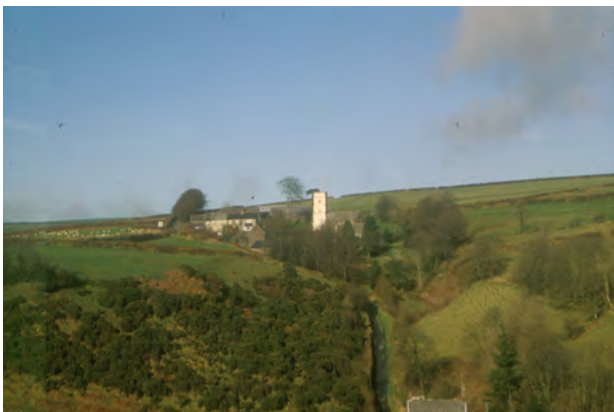
That's as it appears in the landscape. It's our view that these towers are meant to be obvious beacons for the local parishioners to go and do their celestial duties, but certainly in the west country a lot of these towers, particularly those visible from the coast were regularly lime washed as an aid for navigation.

And that's as it appears 6 years after it was finished. Obviously it suffered the ravages of the south west climate, but it's on the west elevation. There is a loss of a bit of limewash.

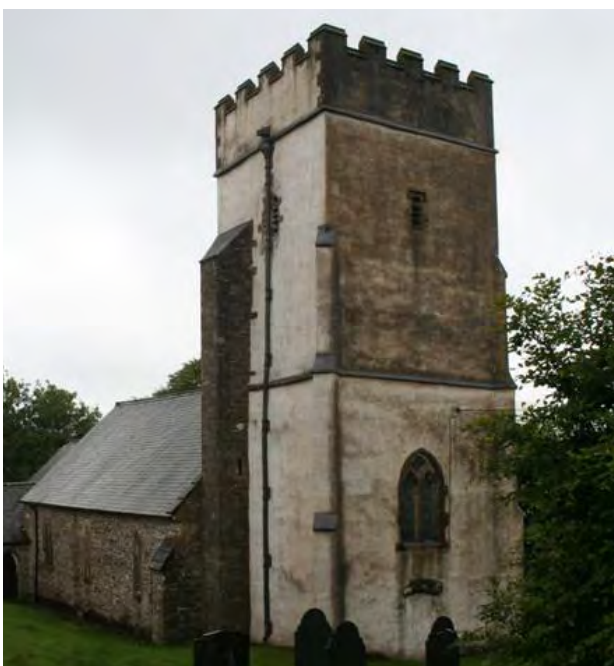
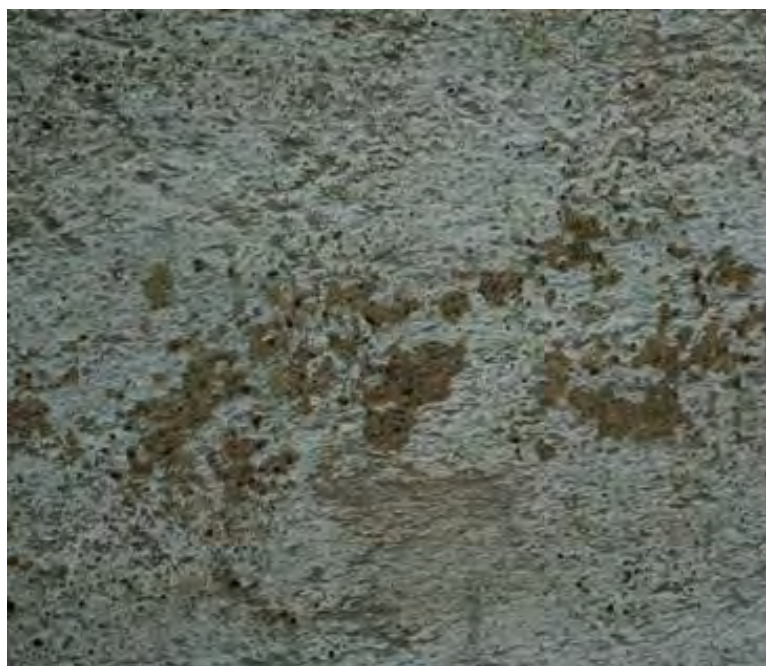
I hope you can see the lovely texture on the finished render. The architects kept the monitoring going and we still had the average level of about 27%. We were measuring this in 2006–2007, during the month of May. It was tremendously wet and the moisture level went up to 68–70% on the western elevation, but came down pretty quickly afterwards and as I said this morning, despite this actually being a thick covering, a render isn't a barrier, moisture did percolate through to the core. The core had been repaired properly – it was solid and any water then flowing through had evaporated away to the outside air.

That's the inside and we've almost completely lost the greenish hue – very pleasant.

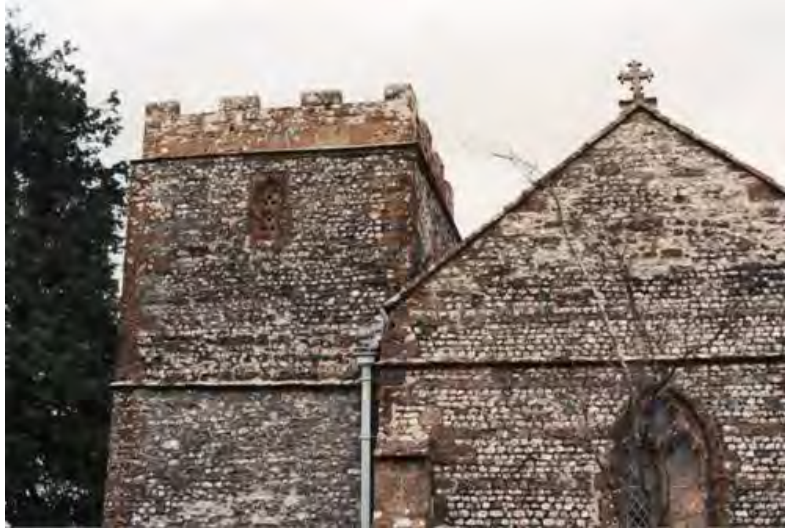
This is the other church that I mentioned before, this is in fact in Dorset. Allegedly this is the wettest parish in the county. The church sits quite high up on a hill. It's exposed to significant, direct rainfall, it has got a long history of moisture penetration problems. I think in the 1980s all the panelling had to be removed because of severe dry rot. The decision was made to render. That was carried out in about 1990, but the rendering actually followed grouting because of the extent of voiding which they found, they grouted it first and a few months later it was rendered. It was rendered in a putty lime mix and had a very good contractor working on it. He found traces of old render which he analysed and replicated. Unfortunately, it failed the following winter. The assumption was that there was something wrong with the render and basically the frost got it. It was done again a couple of years later and it failed a second time. So after this we were asked to come and have a look to see if we could offer any advice. The obvious thing to do was to discuss the matter in depth, but also carry out a few basic tests and essentially what you're seeing here is the phenolphthalein being used.

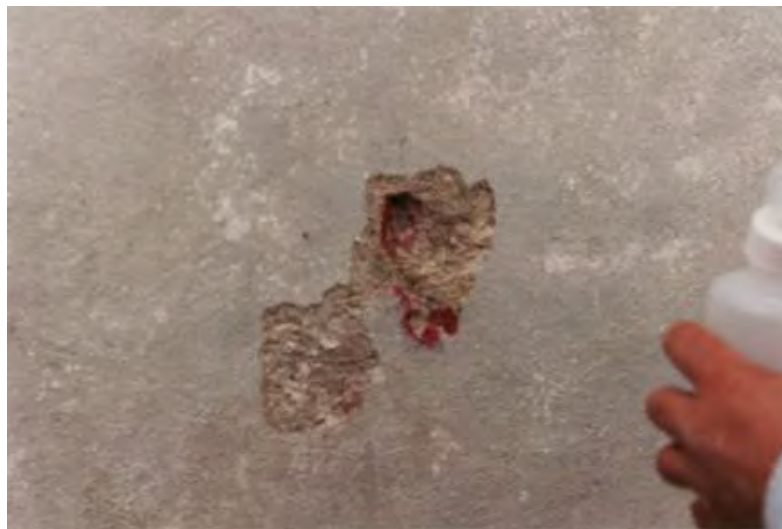
Phenolphthalein will identify uncarbonated parts of the render and as you can see from that maroon colour there clearly is a lack of carbonation. The interesting thing was that the render that had actually sat on the flint seemed to be reasonably well carbonated. It was the render that was over the joints that was uncarbonated, so naturally it was something to do with the walls of the church. I think our conclusion was that following rendering you have hundreds of gallons of water in the core of the wall and that water is obviously going to transpire or diffuse out over time and this is what we think was going on here, and this is what caused a perfectly good render mix, well applied, to actually fail, after grouting.

The architect went over there to see exactly what had been done and as a result again that was shrouded in scaffolding. The old joints were knocked out; the old render was taken off, and it was allowed to dry down. Monitoring took place again to test the moisture levels.

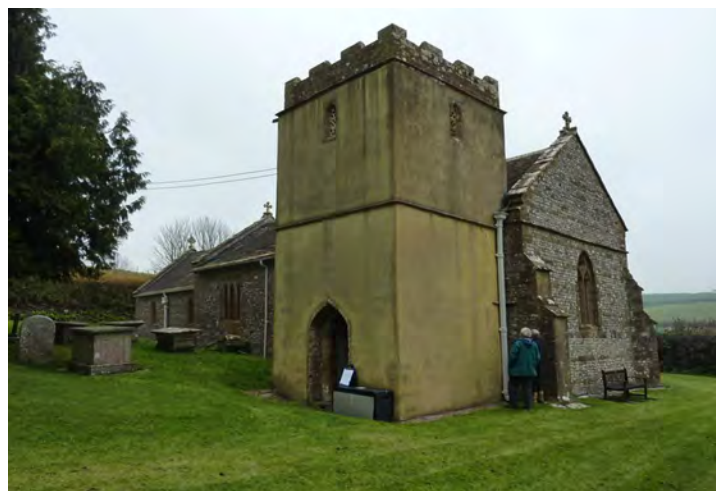
That's what it looked like at the end of last year, slightly similar to Challacombe in that it's beginning to suffer the ravages of the weather. The weathering was not holding back all the moisture so we're beginning to get the algae deposits, never the less very attractive and very effective.

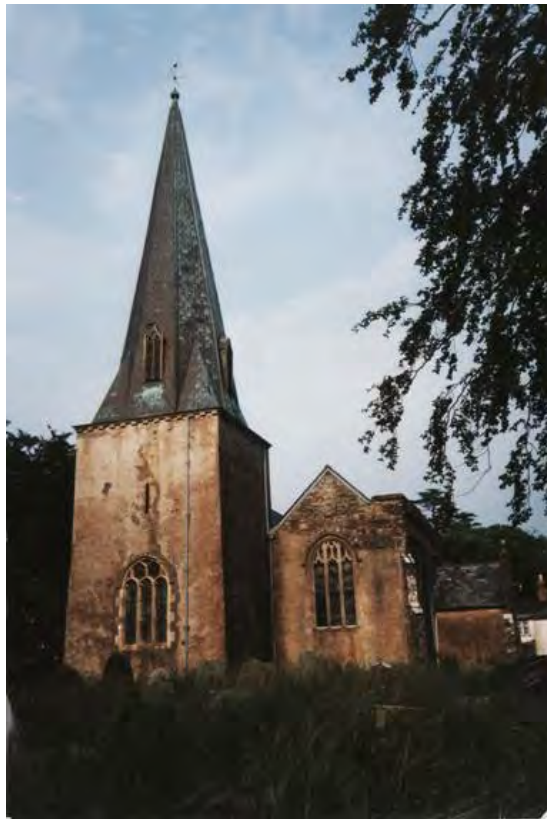
Kings Nympton, north Devon. Quite elevated and very vulnerable to driving wind and rain from this elevation. It had been rough cast rendered in 1995. Basically it was rendered again, using putty lime which they blended with a little bit of the Somerset feebly hydraulic lime. I would have thought it made little difference to the fact it's non hydraulic because the percentage is quite small. Anyhow, it's been there for 15 years, very successfully. There are some minor bits of loss there where there's a bit of splash back and the frost has got it, but otherwise another commendable piece of work.

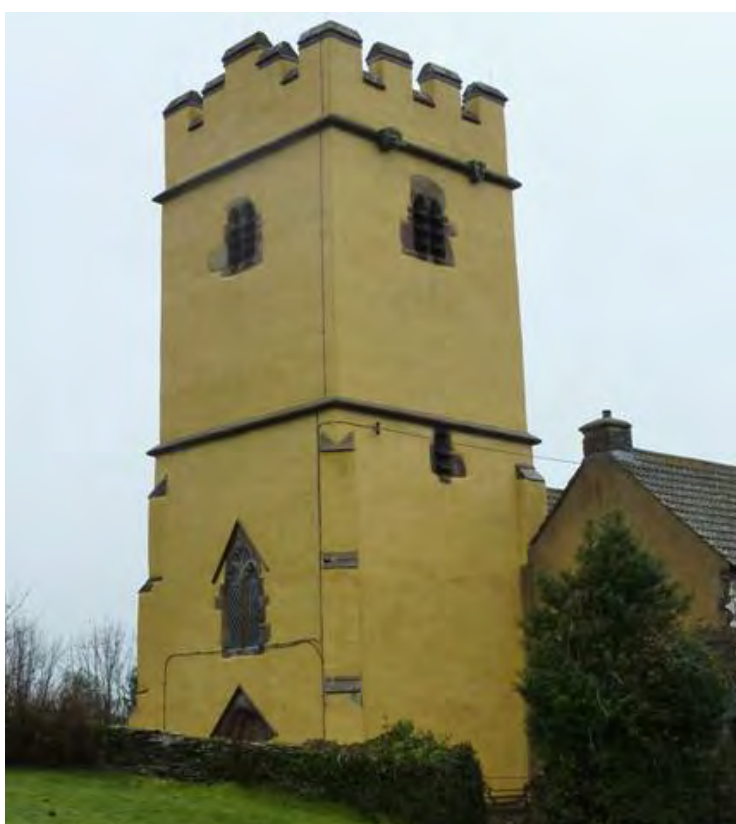
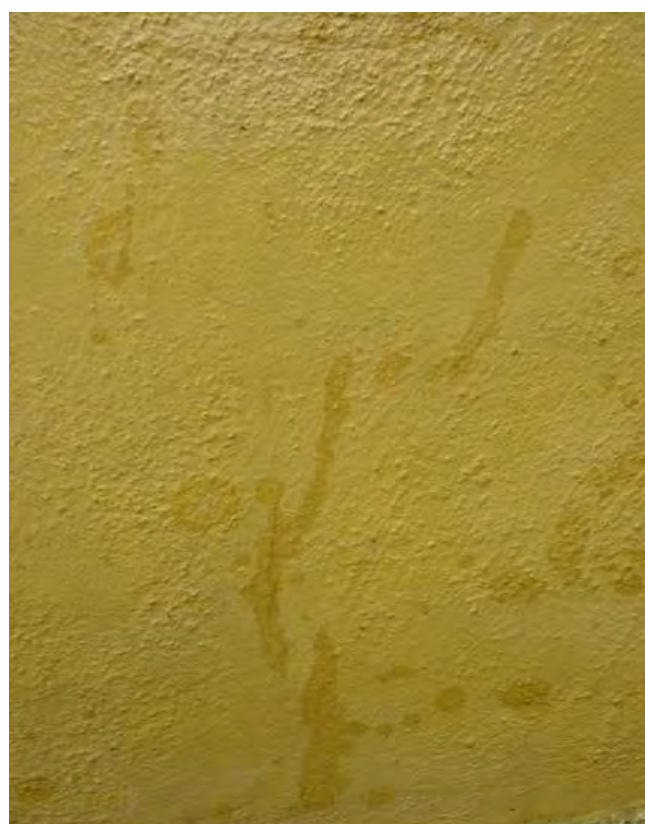
Anyhow, the finished job – very attractive. They've tended it again for a good 6 weeks, spraying it continually to make sure that it dried out as slowly as possible. The PCC wanted a very bold and dramatic colour scheme which they got in five coats of limewash. Here, you've got moisture appearing on the external face of the render. Presumably we think that this may just be the tower drying out because having been grouted we have hundreds of tons of water finding its way out – better coming out through the external elevation than the inside, as far as we were concerned. Perhaps nothing to worry about at the moment, but it will be very interesting to see how this one fares.

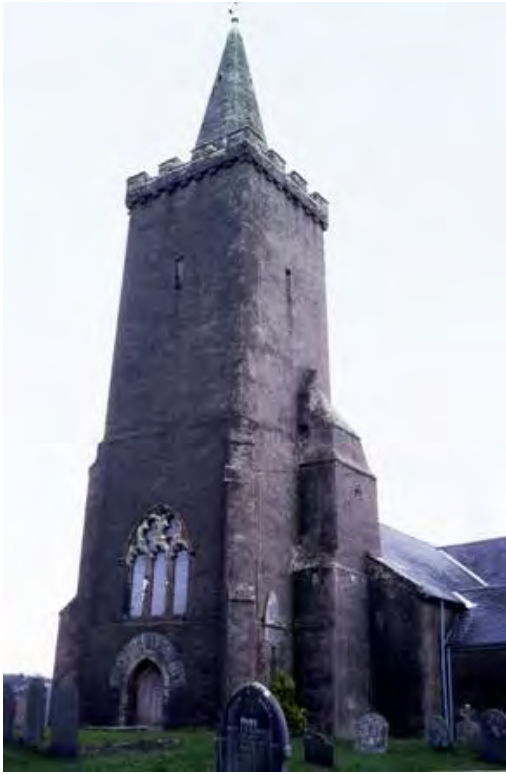
1998

As I say different types, different techniques. We've got the rough cast render on Rattery which Iain looked at in 1988. Water is still getting in and it has problems up here in the gutters. That actually is a nice dry tower that we visited in 2012, that's absolutely fine.

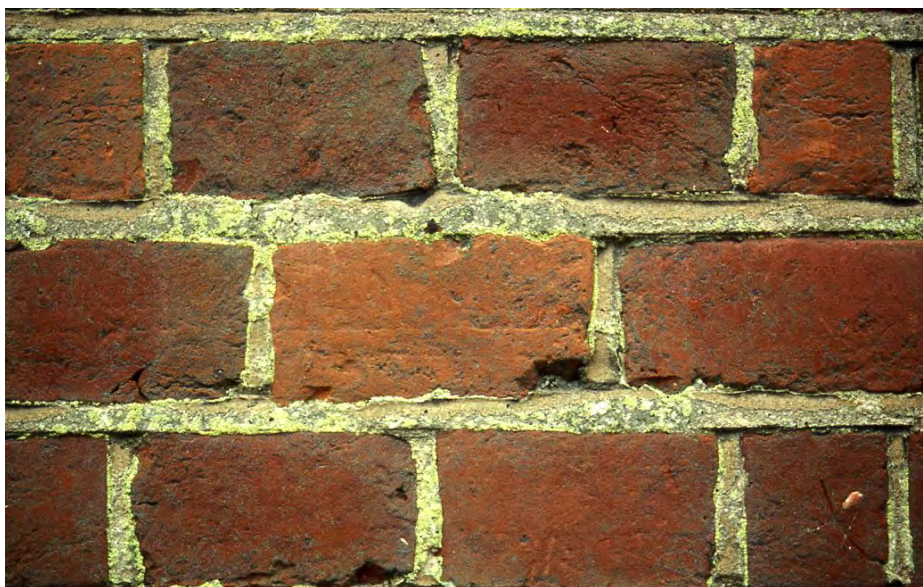
Now then let's whip that out, lets put some cement pointing in the end of that drain in the wall as I refer to it, and see what happens.

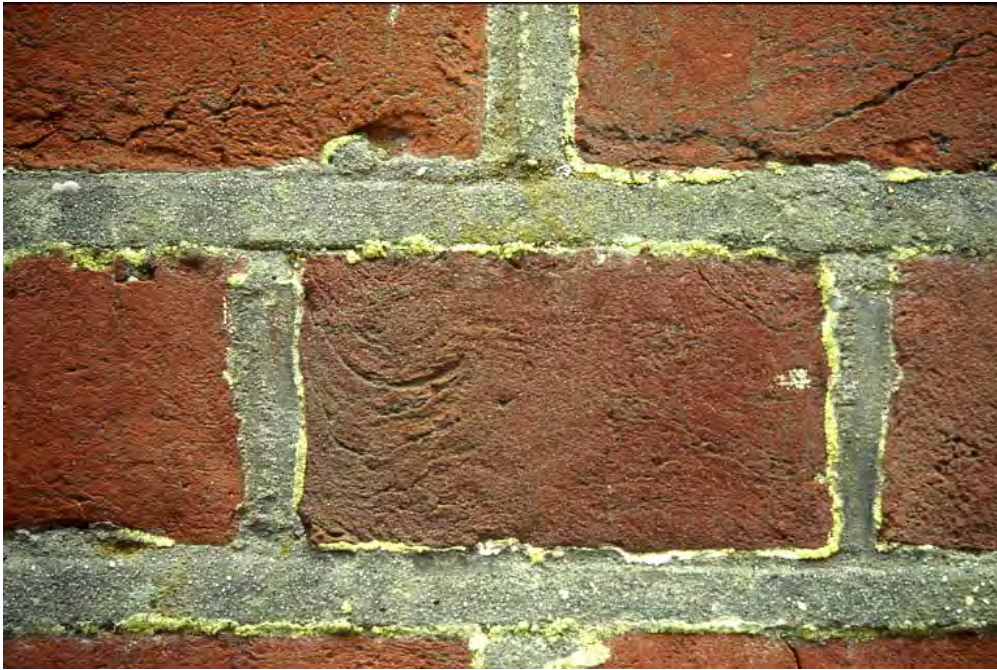
This is literally three paces from the last photograph. It's the same elevation. Same brick, same everything. The only lichen you can see is at the junction between the cement and the brick. It's not on the cement, it's on the brick, its keeping the arris of that brick in a wet condition, its carrying salts with it no doubt, so we're going to get a bit of a breakdown of that arris. We are also going to get a bit of frost damage on the arris, which is why they're going to round off and why that cement will eventually drop out. It is as simple as that. I think that these are some of the most graphic images that I have ever seen to show how a joint should work and how cement is a problem to us.

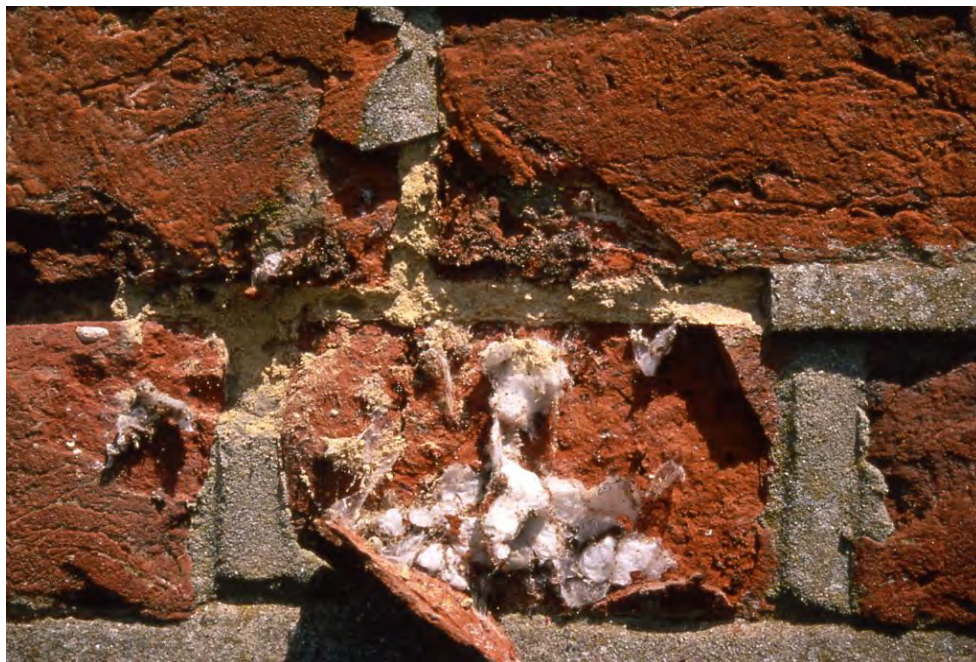
Same site, still at Fort Brockhurst, I apologise for the fact that this is brick and perhaps you should be concentrating more on stone. The principles of what I'm speaking of here apply to both. So here we have lenses of brick attached to cement pointing carried out by the military. Just a flick of the little finger and off it drops; those are not salts, they are spiders and little nests. You can see that the original mortar is of a good depth! There's nothing wrong! Why did they re-point that in the first place? That is always the question. If it is cement and you think it's got to come out, test it. Can you get it out without doing damage to the fabric? If you can't, leave it alone. Nature will take care of it in fullness of time.

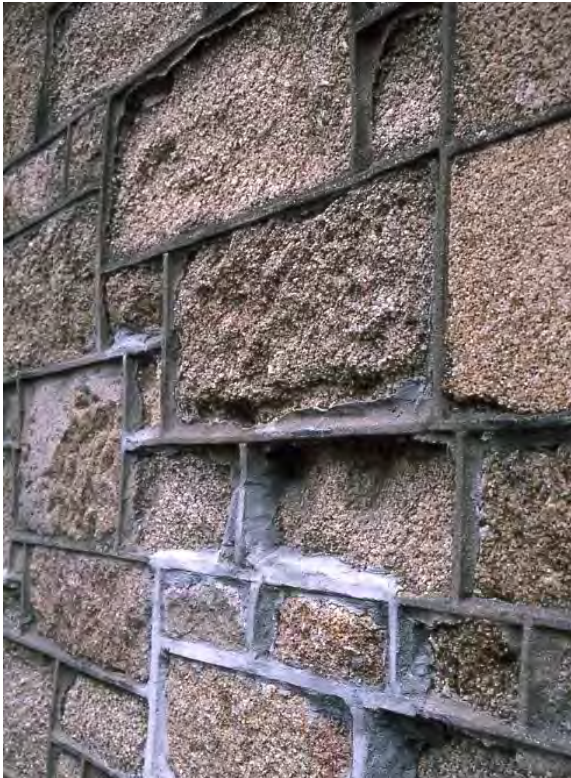
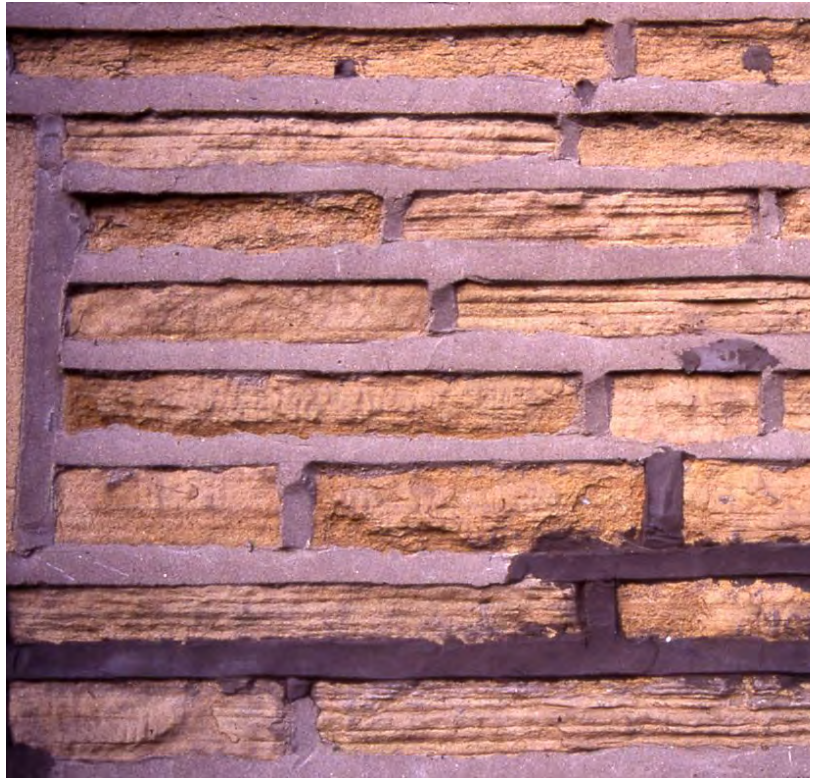
Granite: a great material I know, but cement sees it off. It's instantly repairable this, not a problem!

This was actually quite amusing. This was in Bradford and it was British Waterways training that we doing at the time. I was speaking to the workers about the errors of strap pointing and how wrong it was. One of the operatives said to me “why do you keep on about our strap pointing? It’s a tradition.” I asked how far this tradition went back in time. “10 years that I know off” he replied. That put me in my place!

It’s visually awful isn’t it?

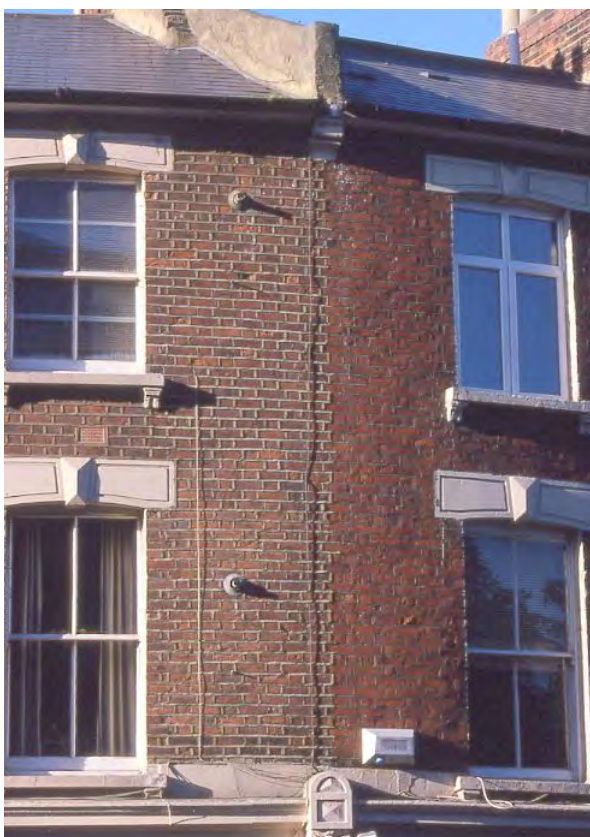
Same elevation, re-pointed / not re-pointed. Look at the difference. On the right there we can see the brick, the colour of the brick, nice bit of shadow, all I can see is pointing on the left. It shouldn’t be that way. It has a secondary role to play, visually as well.

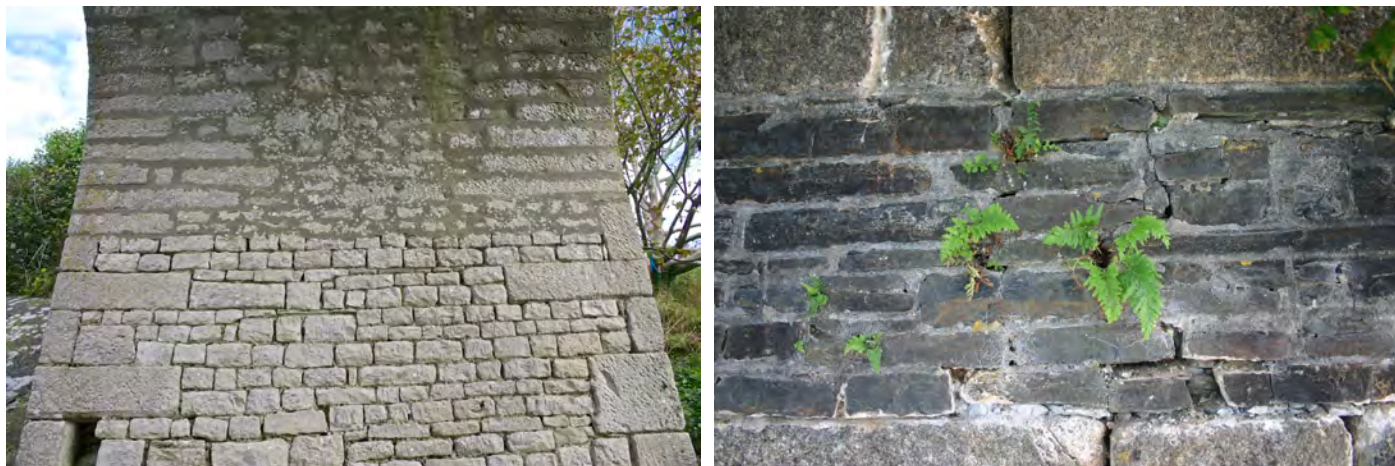
A nice bit of Portland stone being ruined! Cement again flush pointed simply because of a bit of water was percolating through, and we'll stop that Hah!! And they certainly did, to the detriment of the fabric itself.
