Historic England

Purbeck Marble

Conservation and repair

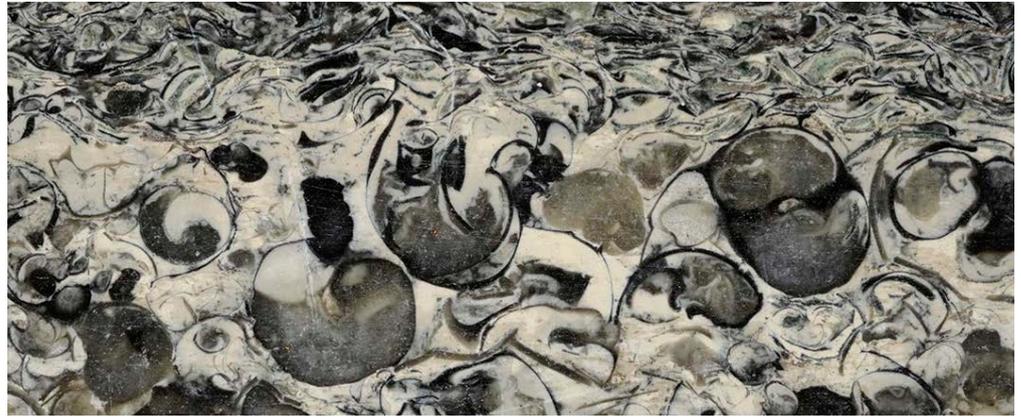
Figure 3: The polished finish of Purbeck Marble showing the detail of *Viviparus carinifer* (the freshwater snail).

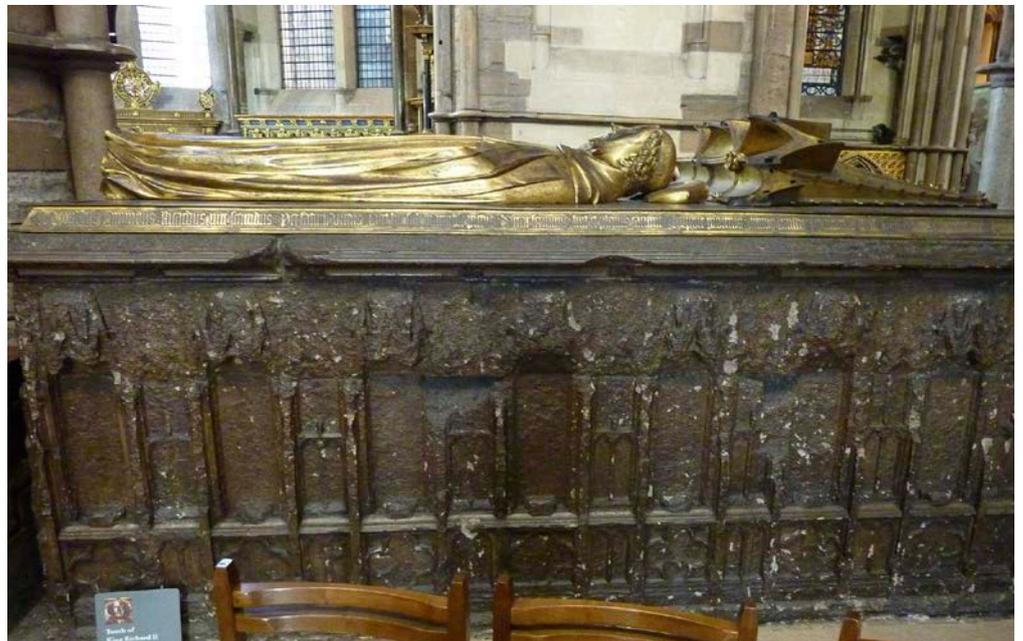
Figure 5: The monument to Richard II (1367–1400) and Anne of Bohemia (1366–1394) in Westminster Abbey is constructed from large slabs of Purbeck Marble set on edge. The nature of the stone means that carving is intricate but does not have fine detail. Discolouration is due to a conservation treatment, known as 'induration', applied in the 19th century.

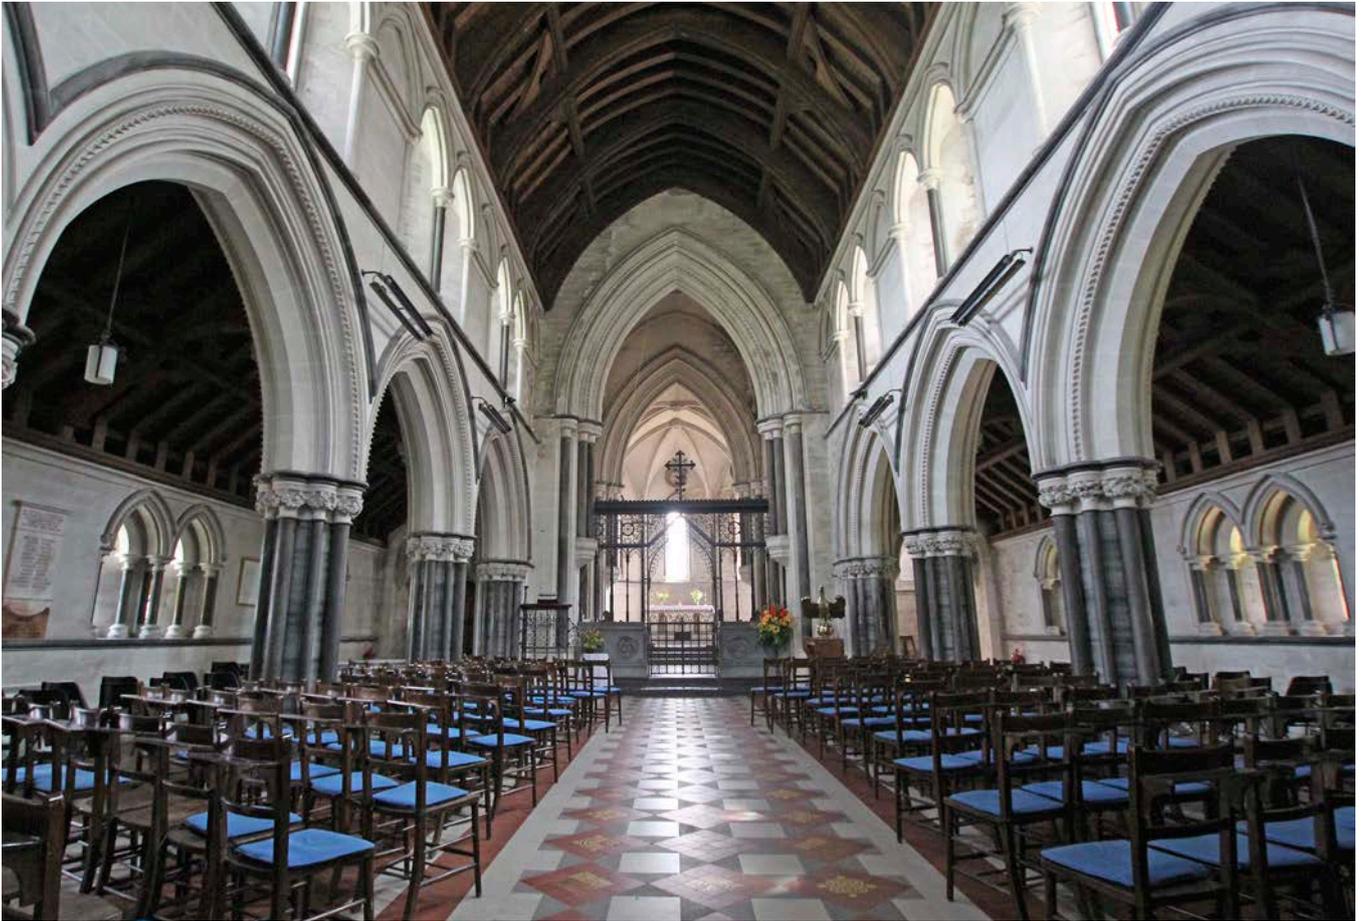
Figure 7 (above): At St James' Church, Kingston, Dorset, Purbeck Marble has been used for columns, abaci, string courses and hood moulds to provide contrast with the pale Portland Stone ashlar and arches.

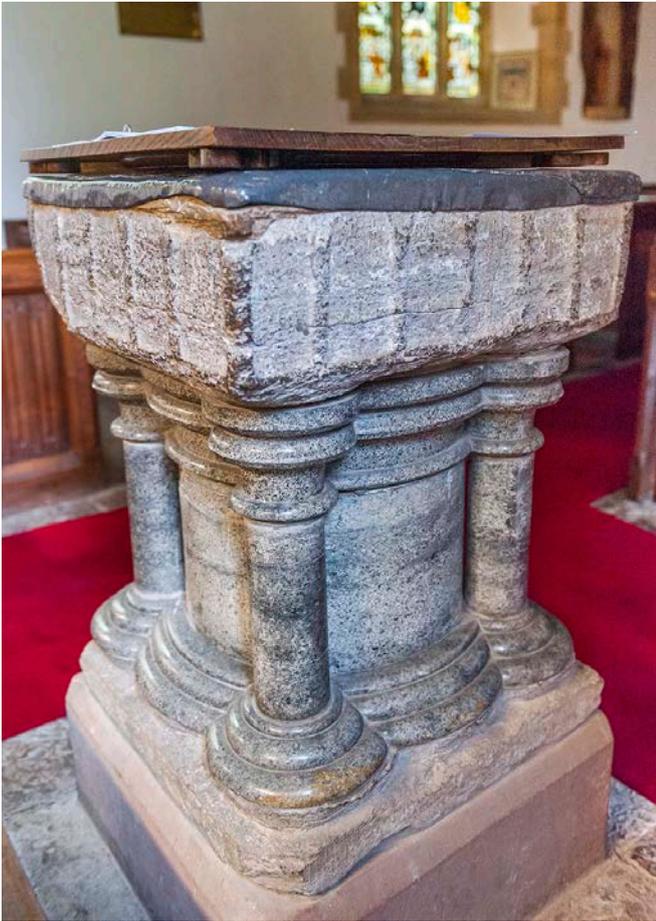
Figure 9 (left): A typical 13th century font at St Nicholas, Brushford, Somerset is constructed entirely from sections of Purbeck Marble laid in their natural bed.

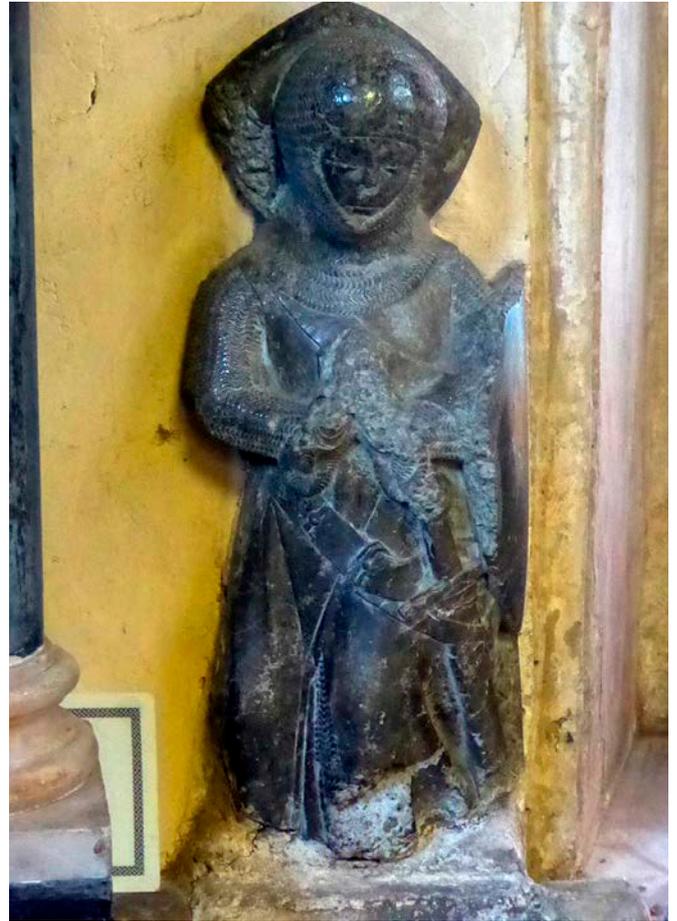
Figure 10 (right): An 18-inch effigy of a knight from the 13th century thought to be of Robert de Roos. Now at St Mary's, Bottesford, Leicestershire, it was brought to the church from Croxton Abbey. The effigy would have originally lain on top of a chest tomb. Though detailed, it is flatter than comparable alabaster effigies because of the difficulty of carving Purbeck Marble.

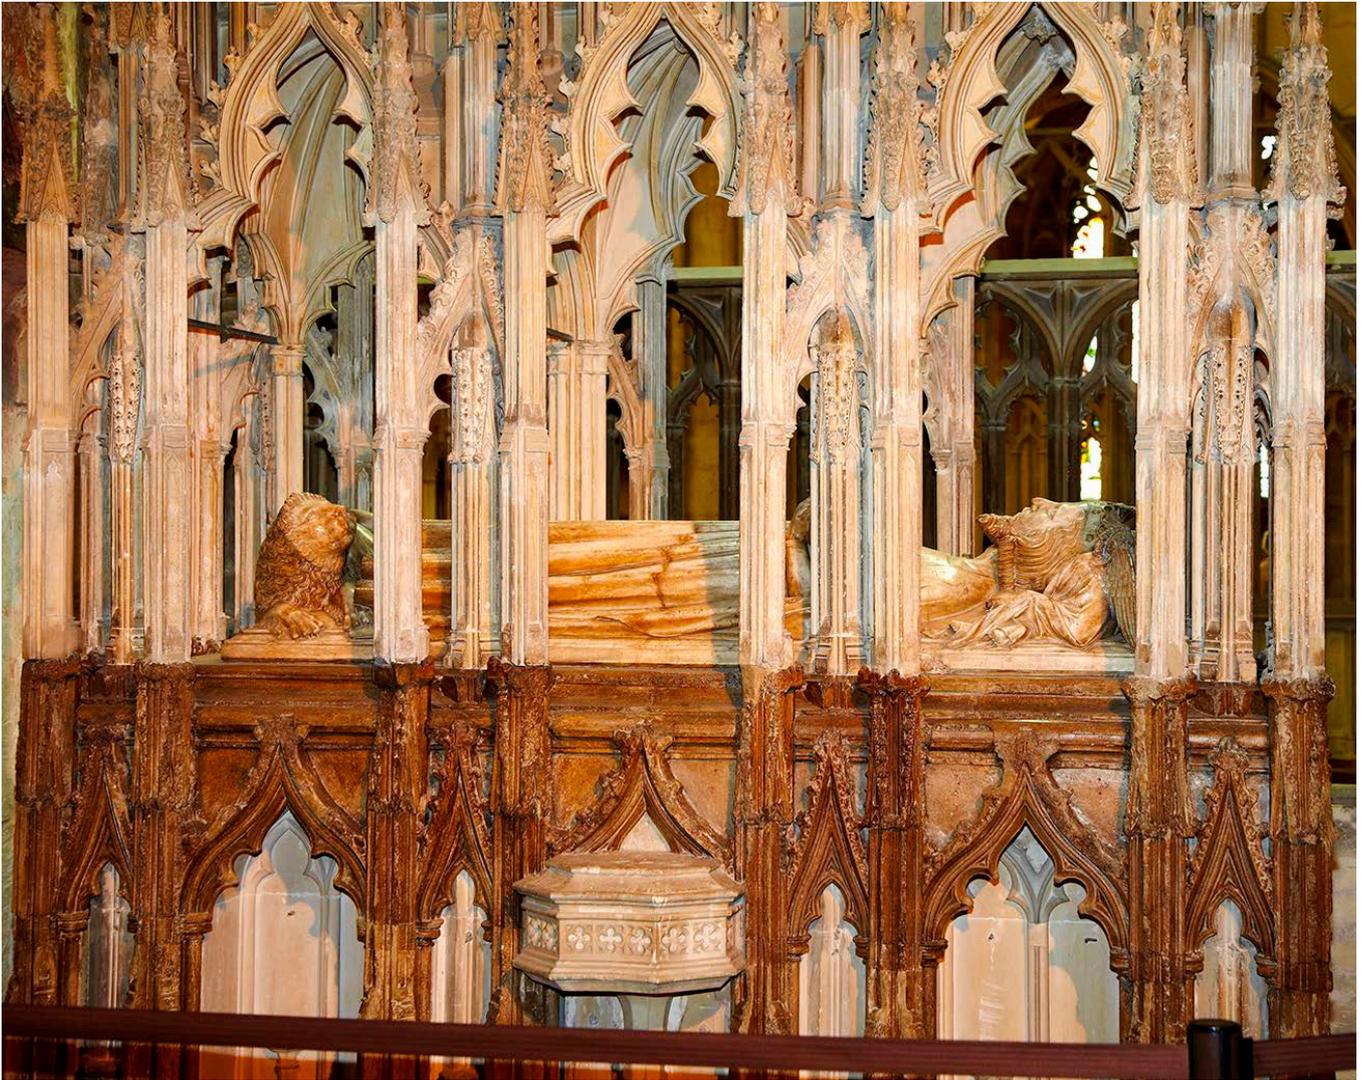
Figure 11: A monument to Edward II (1284–1327), dating from the 1330s, in Gloucester Cathedral. The base is carved from Purbeck Marble in exquisite detail. The dark brown appearance is due to discolouration from repeated applications of beeswax.

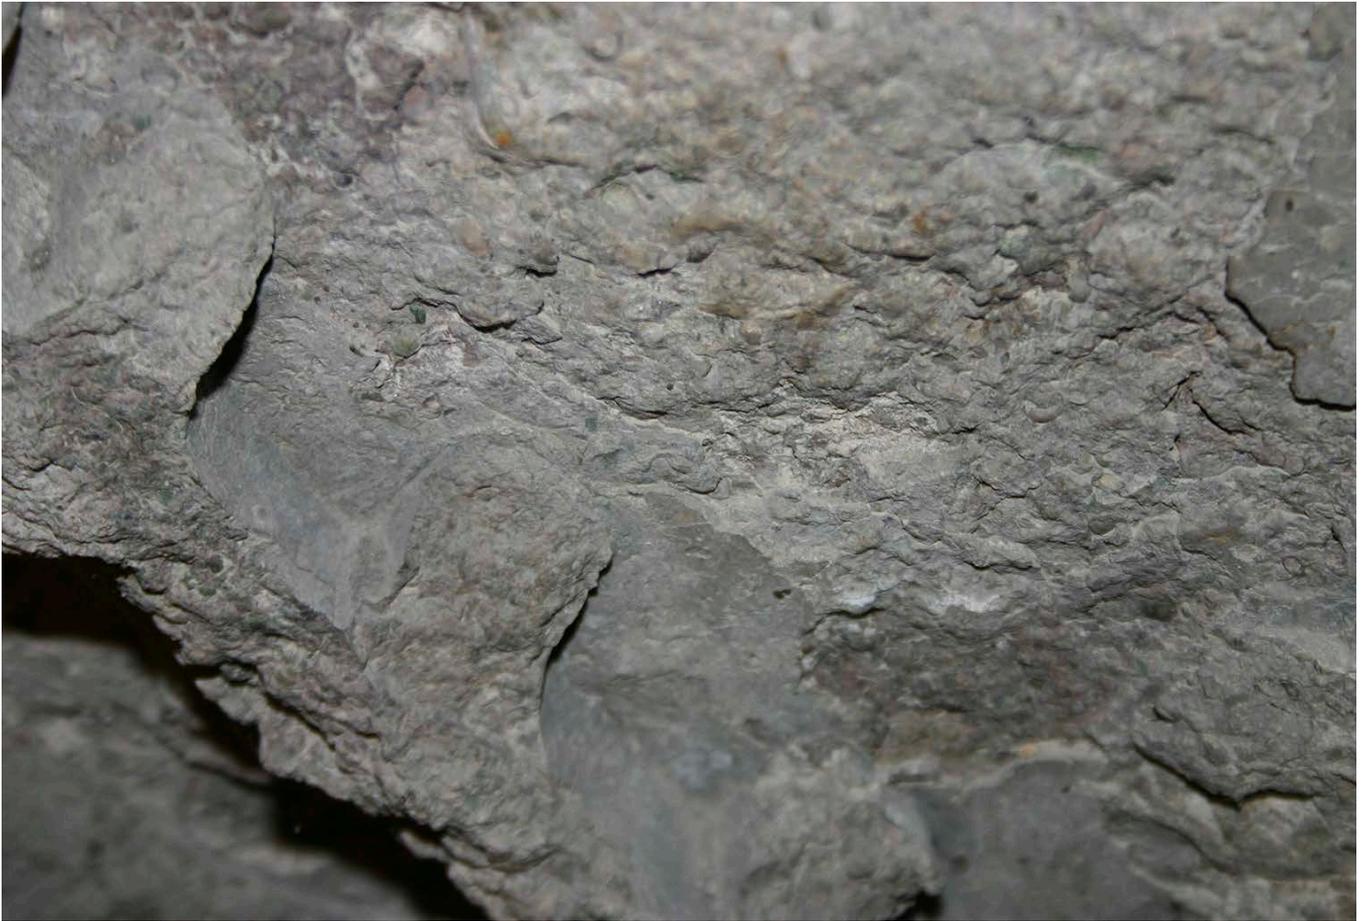
Figure 14: Monument to Archbishop William Greenfield (died 1315), St Nicholas Chapel, York Minster showing localised flaking of surface.

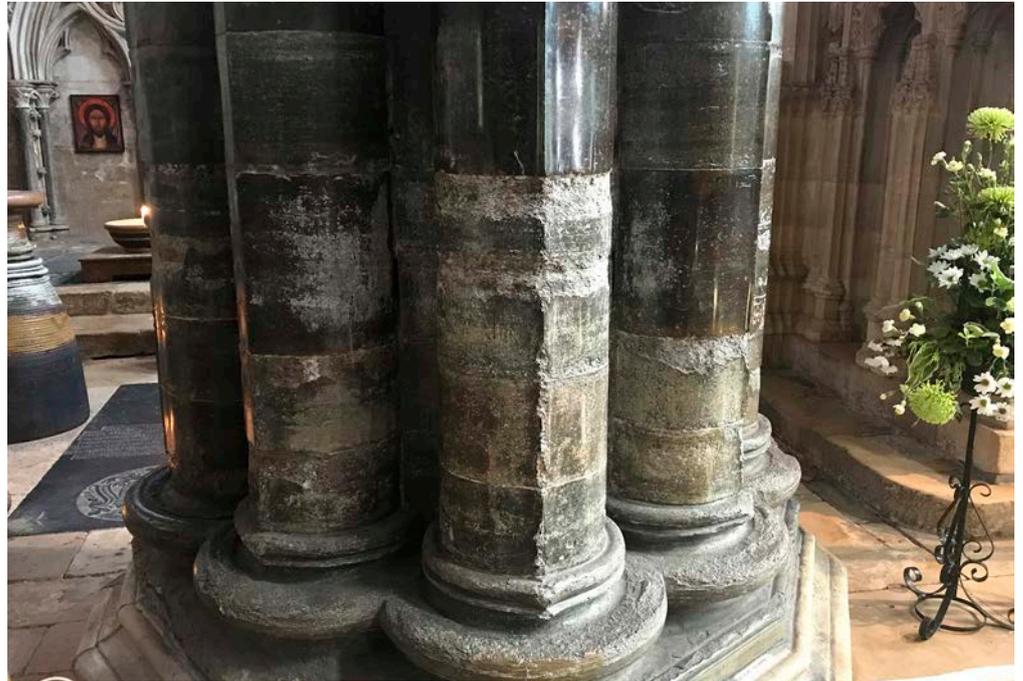
Figure 17: A compound pier built of blocks of Purbeck Marble in Lincoln Cathedral laid in their natural bed. The blocks at low level have suffered damage as a result of rising ground water. This will have been exacerbated by the sealing of the surface of the stone with wax.

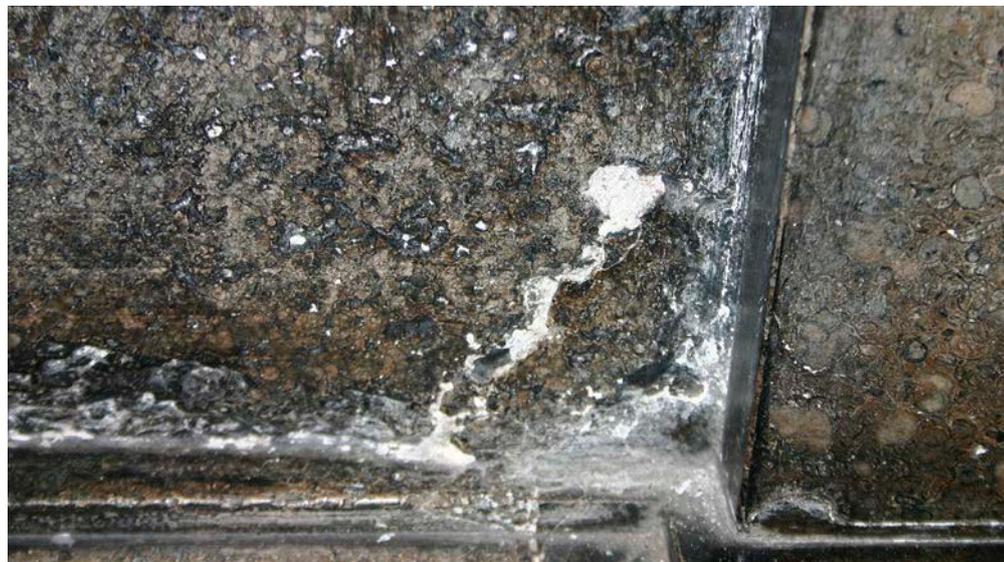
Figure 18: Localised damage due to sub-surface crystallisation of salts on the side panel of a medieval monument.

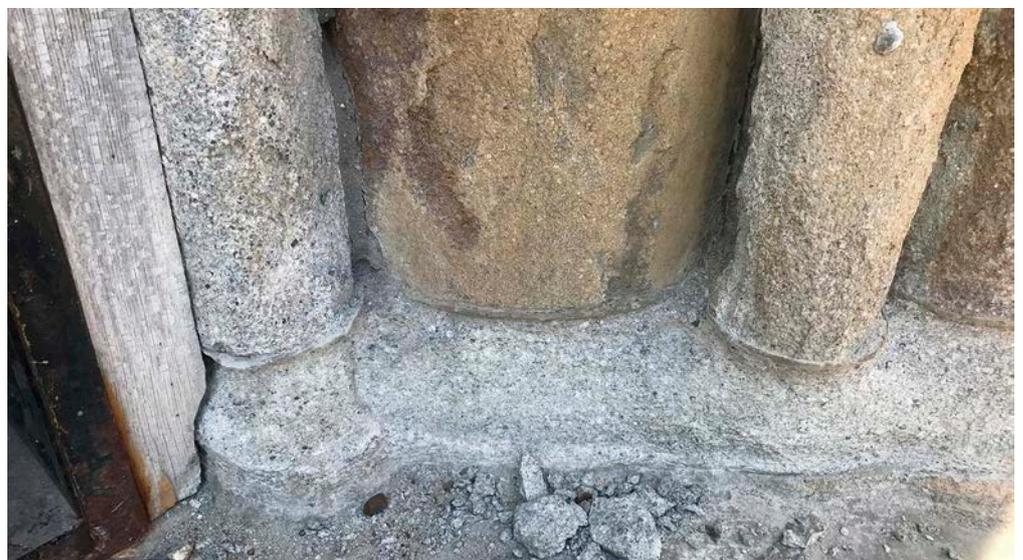
Figure 19: Damage to low level external Purbeck Marble as a result of salting of the adjacent roadway next to Norwich Cathedral cloisters.

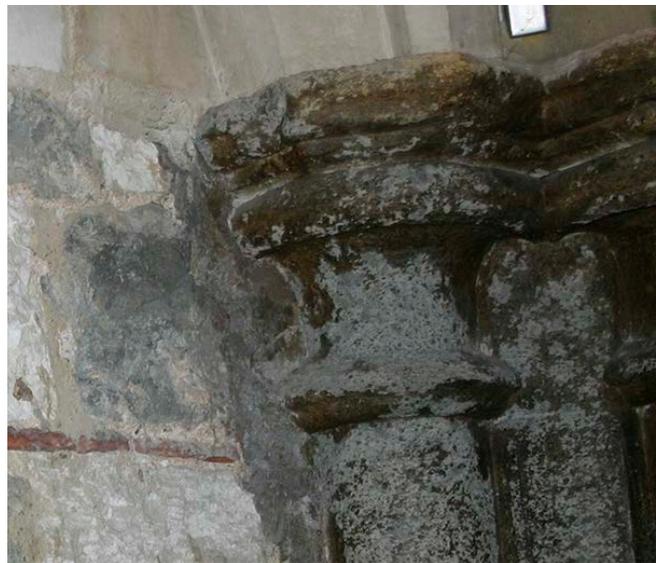
Figure 20: The deterioration of the wax coating here is a result of environmental factors. Fluctuations in humidity affect the stone behind the coating leading to the deterioration of both.

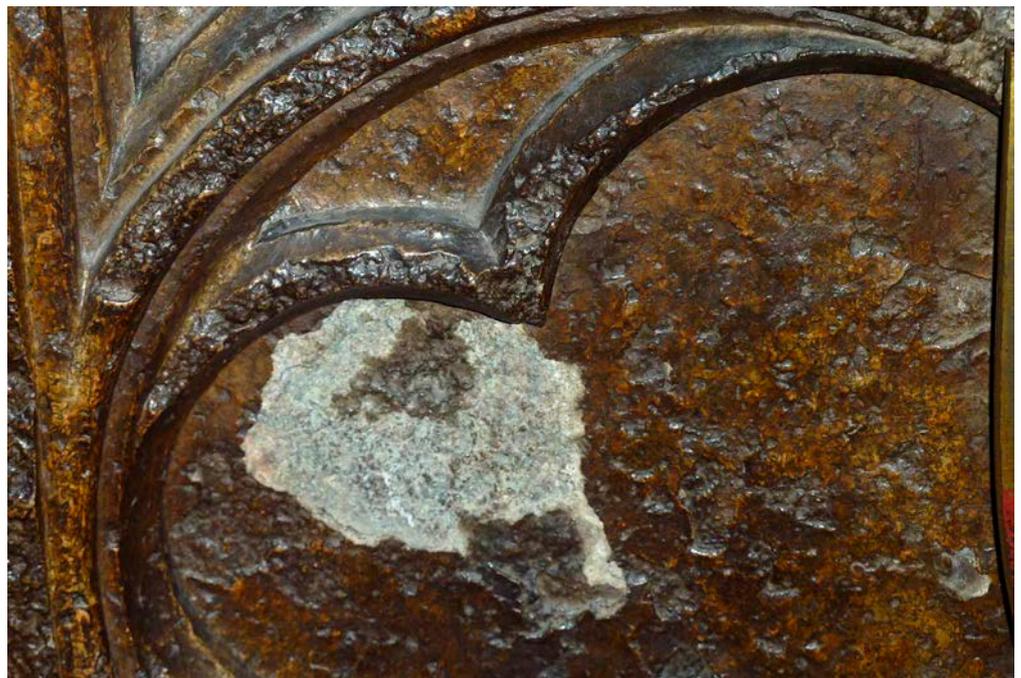
Figure 21: The detachment of shellac coating reveals the original colour of Purbeck Marble behind.

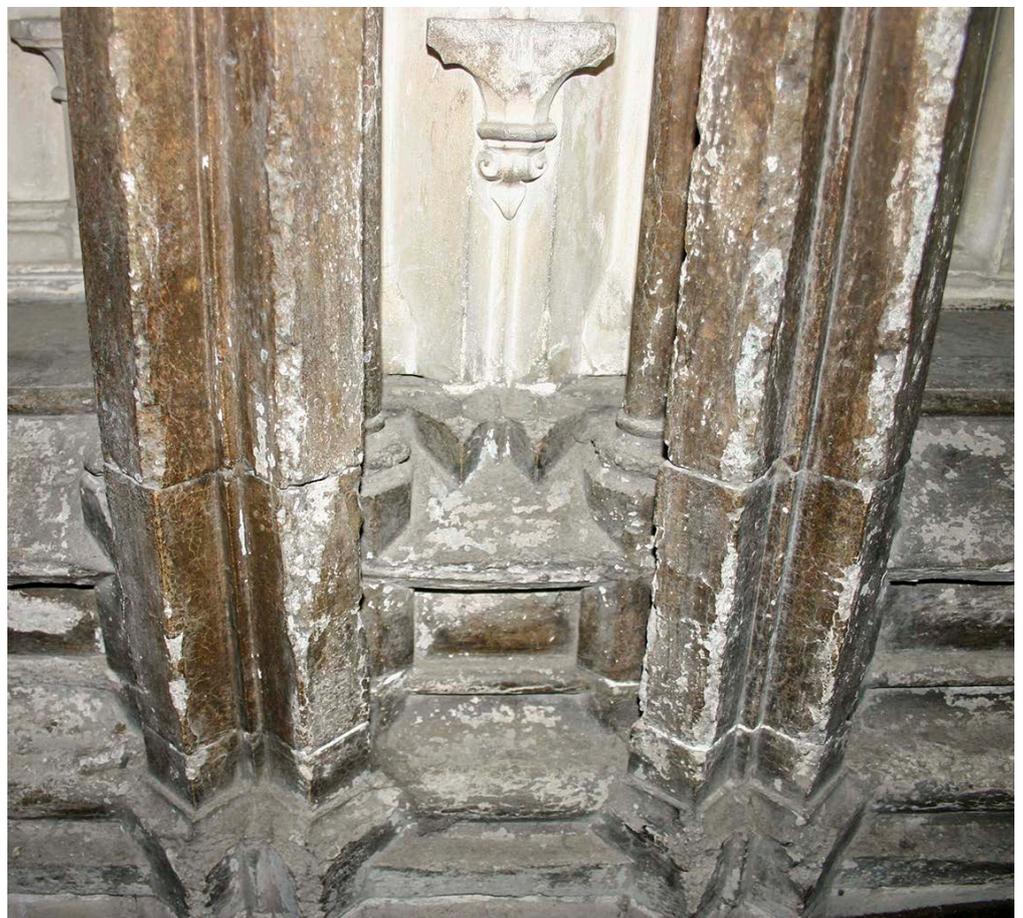
Figure 22: A monument to Edward II (1284-1327), dating from the 1330s, in Gloucester Cathedral. Low-level abrasion and surface deterioration due to combination of visitor action and rising moisture.

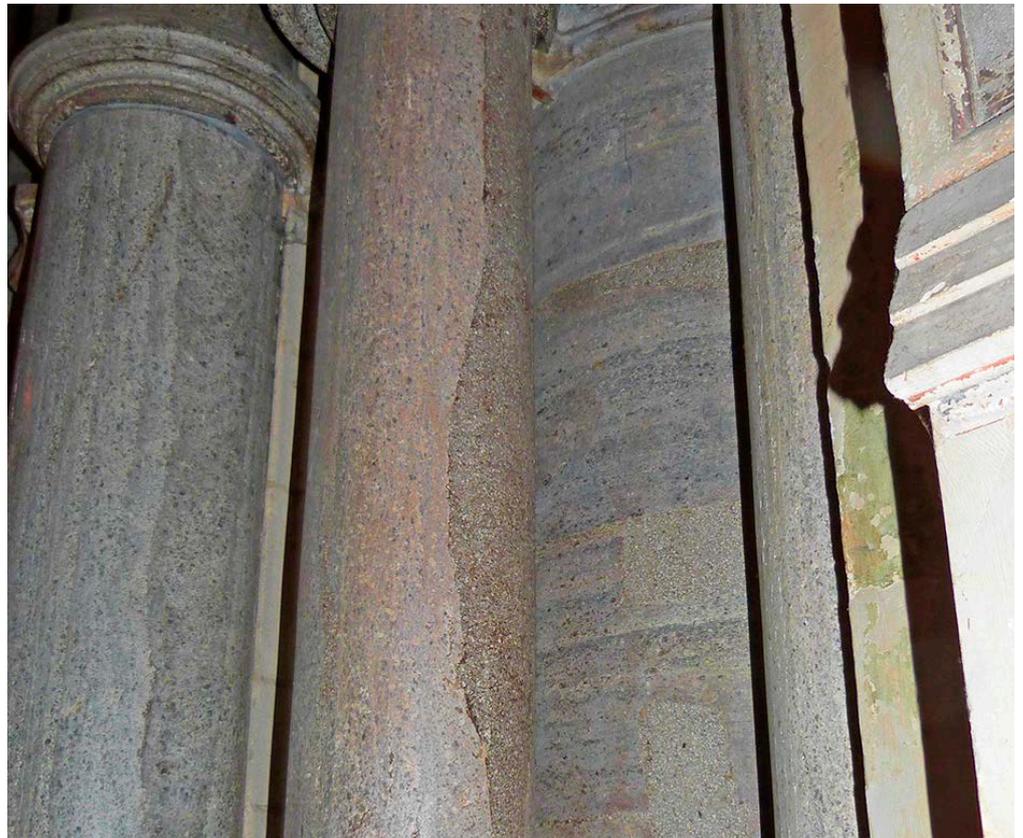
Figure 24: Cementitious repairs to columns carried out using the Bacon method at Ely Cathedral. Although they achieved a fairly good match in colour, the repairs show the difficulty of obtaining the correct surface texture and finish.

In the late 19th century, John Bacon (Clerk of Works at Ely Cathedral) used shellac as a binder for a plastic repair, rather than as a surface coating (see Kennedy 1995). His method was described as follows:

Where only the surface is broken, a piece of sound Purbeck Marble is crushed to the size of small shells or stones of which it is composed, and a fine sieve used to separate the dust. The aggregate is mixed well with shellac and resin and heated over a fire. The decayed parts of the pier are removed and the mix applied to the surface which has been heated by the application of burning charcoal with the aid of a pair of bellows.

The repair is then rubbed with a piece of hard York stone, then with second grit then with snake stone reducing it to a complete smooth surface after which when perfectly dry it is rubbed over with linseed oil which after standing for a night is rubbed clean. Then a paste of spermaceti [a waxy substance from the head cavity of the sperm whale] and beeswax in equal parts dissolved in oil of turpentine over a fire is applied to the surface and well rubbed in with rags.

In general, these repairs have survived well, but they are in a stable, warm, dry environment.

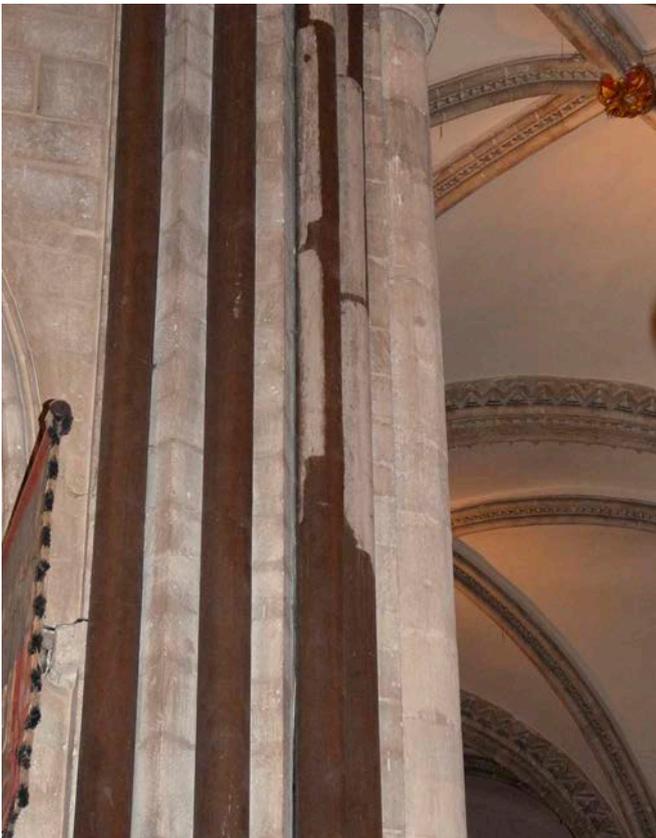
Figure 25 (left): Scagliola repairs at Canterbury Cathedral were applied to match the dark brown surface of the Purbeck Marble as a result of discolouration of a wax surface coating. However when the surface coating was removed, the repairs now appear in stark contrast to the original pale colour.

Another method of repair was attempted at Canterbury Cathedral, where a technique referred to as 'scagliola' (pigmented gypsum plaster mixed with animal glue) was used in the mid- to late-19th century. In fact recent investigation has revealed that this treatment was not true scagliola, but a simpler homogenous mortar repair. It comprised lime and sand, with linseed oil probably incorporated into the mix and also applied to the surface of the repair.

Although this initially made the repair hydrophobic, the mortar softened on prolonged contact with water, presumably because the linseed oil degraded and was no longer acting as a hydrophobic agent. The mortar also included iron oxide pigments to match it to the brown Purbeck Marble (although this was not the colour of the original stone, but a product of the cross-linking and darkening of an applied coating). As the extant original Purbeck has either decayed or been cleaned (by removing the applied coating), the repairs, though remaining generally sound, now stand out because of the colour difference.

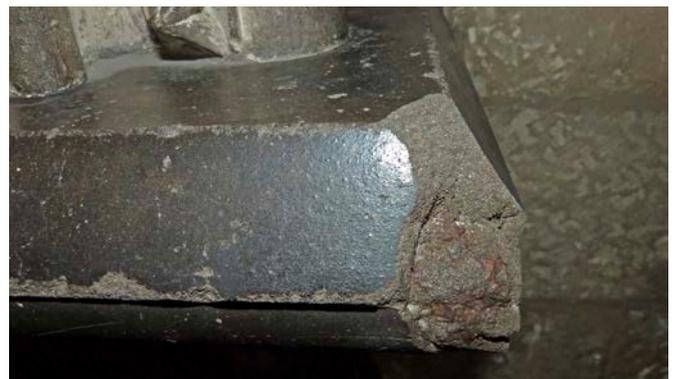
Figure 26 (below): A cut-away detail of the scagliola repairs which reveals the original deteriorated surface and the extent of the repair.

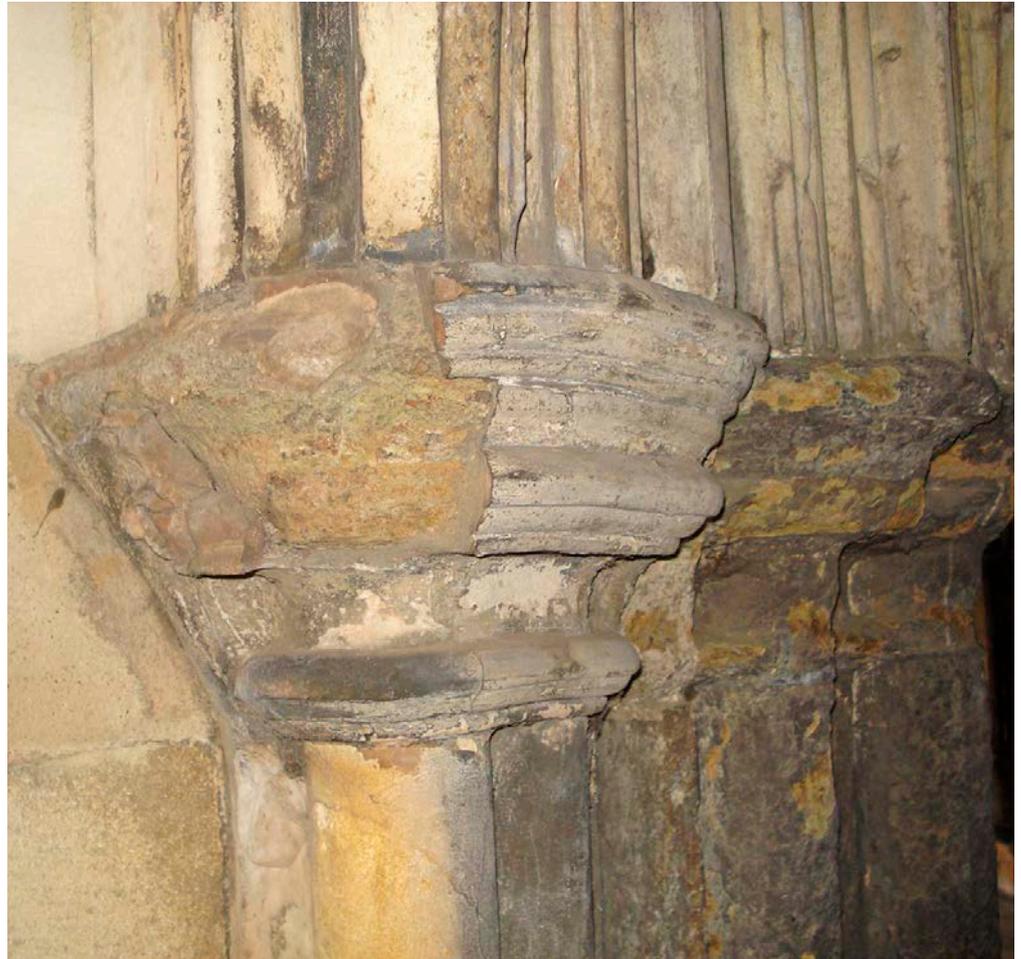
Figure 27: An example of multiple repairs to a capital in Norwich Cathedral cloisters using perhaps three different mortars, none of which provide a good aesthetic match. Note the unrepaired capital behind.

Unsuccessful repairs may alter the appearance of the original structure, as was the case with the columns, bases and capitals of the cloister at Norwich Cathedral. Repairs were crudely carried out in Roman cement mortar, which did not visually match the Purbeck Marble and obscured the detail of the underlying mouldings. Other unsuccessful examples include where repairs to a circular column have been faceted or where repairs have been found to sound hollow when tapped, thus indicating a degree of detachment from the substrate.

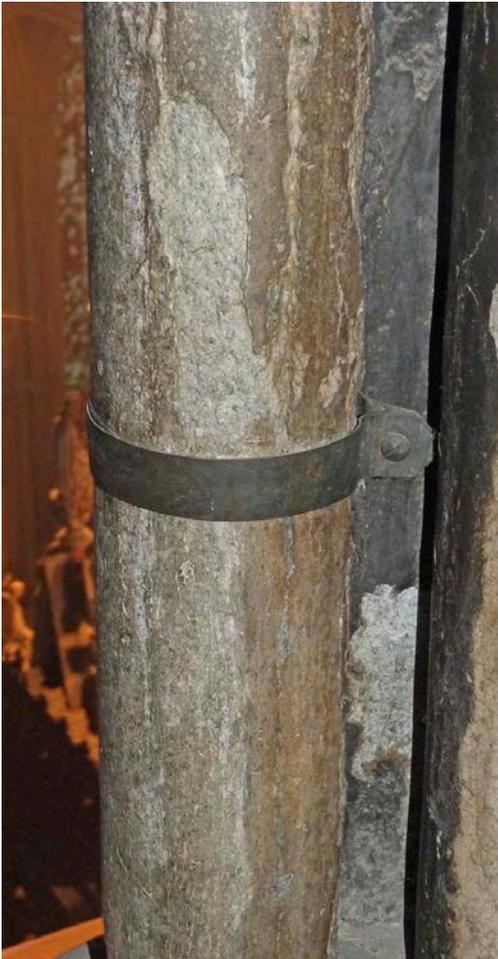
Figure 28 (above): An example of using a copper band to provide medium to long-term security for a column at Ely Cathedral. Signs of cleavage are evident.

Structural repair was usually restricted to vertical splits along bedding planes in shafts and columns. It generally involved either pointing up the fissure or applying some form of collar as a brace against further splitting.

Both approaches proved problematic. Pointing up the fissure only temporarily solves the problem, as the splits often continue to grow. Applying a collar or brace prevents further splitting, but is visually obtrusive.

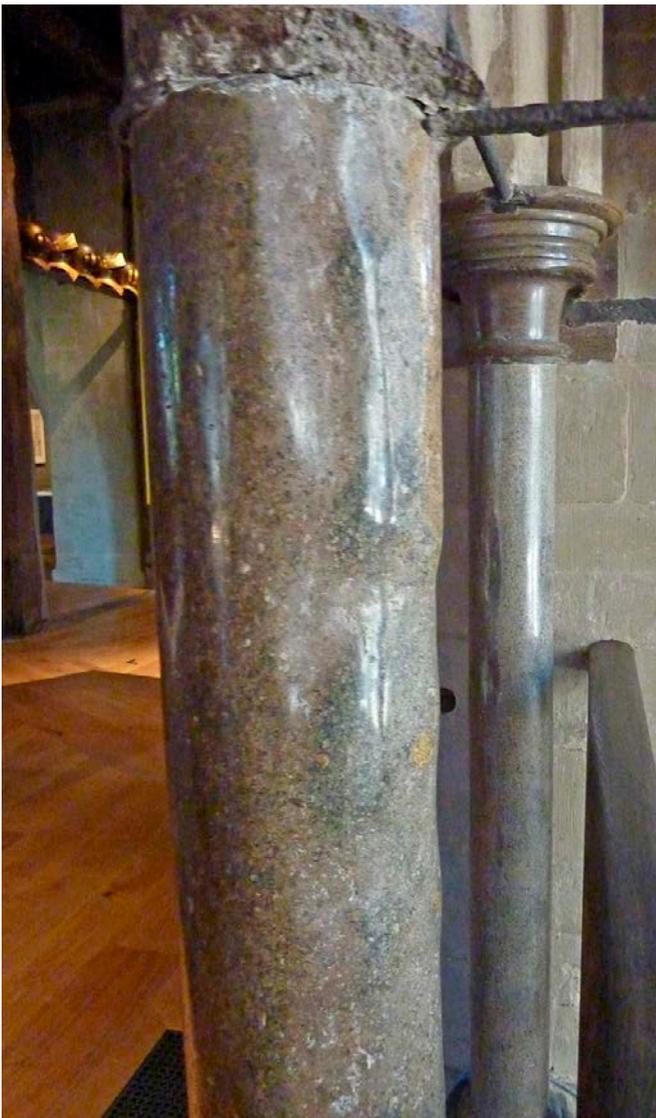
Figure 30 (left): Deteriorated material has been removed and the surface polished, but this has left the column with an undulating topography that is very obvious in reflected light.

In some cases, decayed material is removed and the surface buffed to a high polish with no attempt to retain the cylindrical shape of the shafts. Although this preserves some of the desired qualities of the Purbeck Marble, the variable topography of the surface can be visually disturbing.

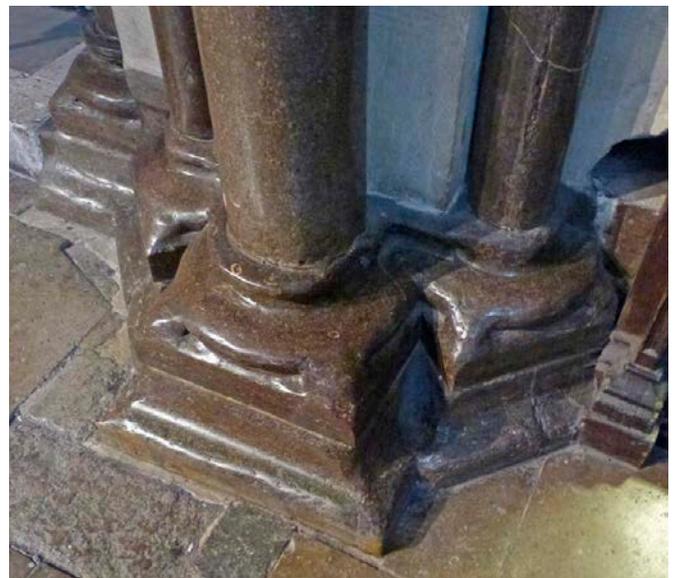
Figure 31 (above): A Purbeck Marble column base in Canterbury Cathedral reworked (in the 1930s) to remove decayed material and then polished. The surface is now sound but the detail of the form has been lost.

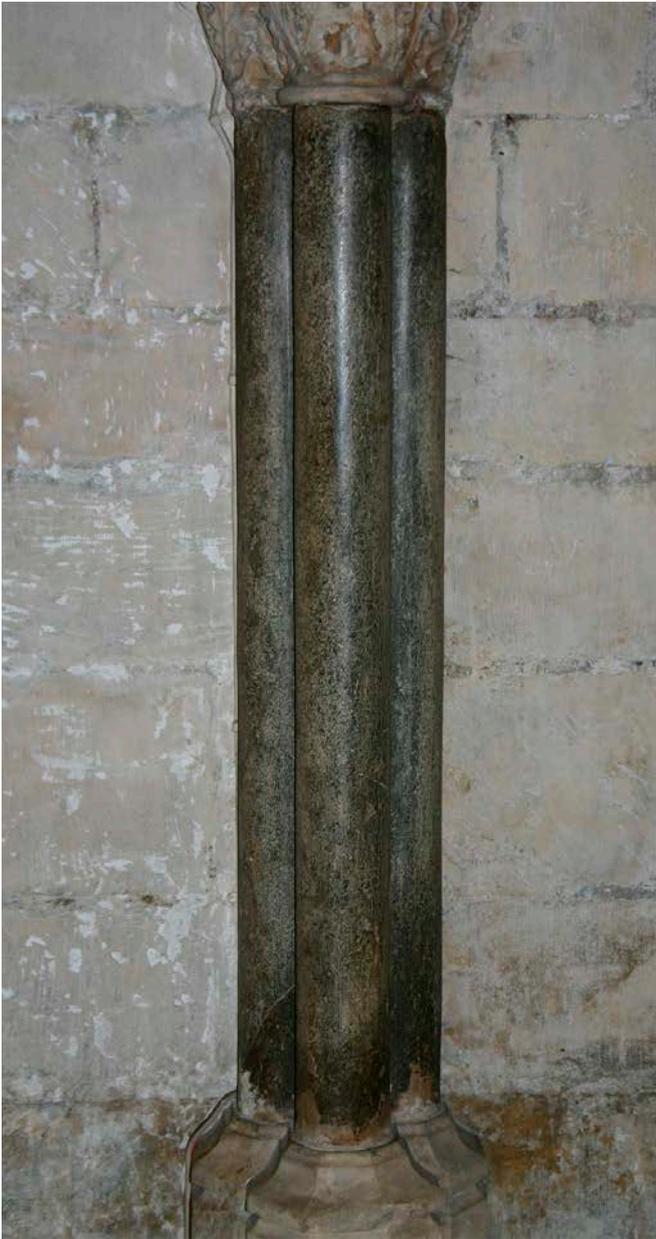
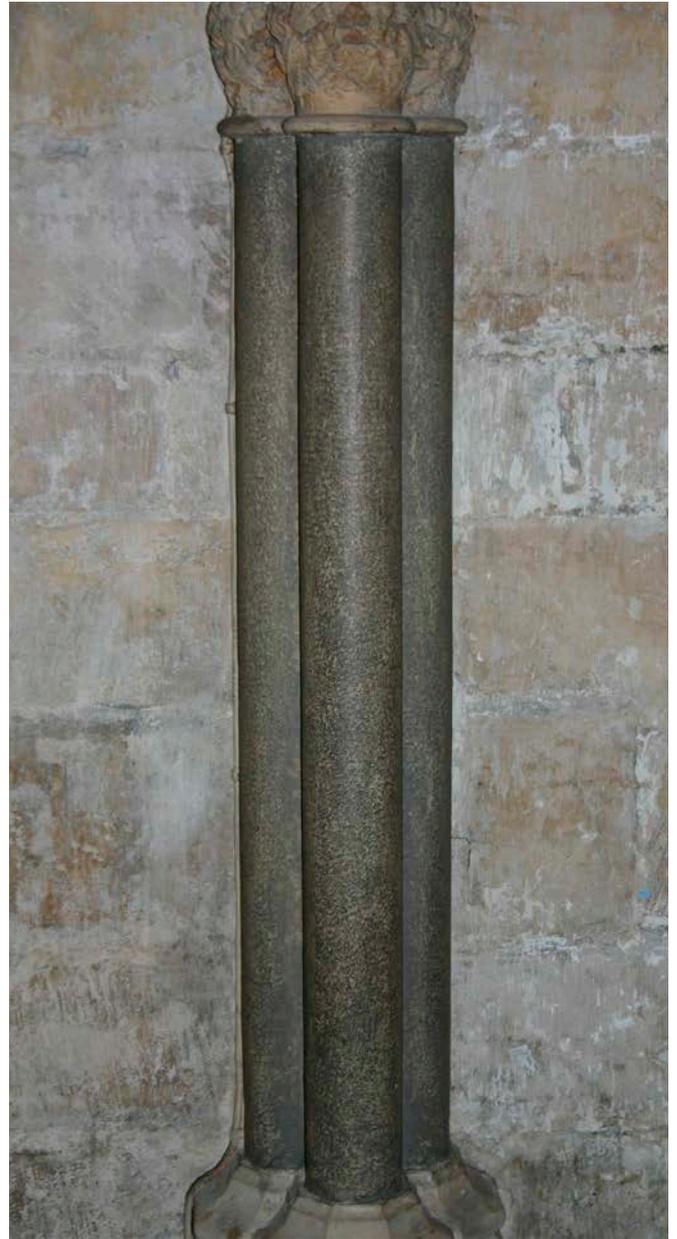
Figure 33: Zouche Chapel, York Minster: a polished Purbeck Marble column cluster (left) and replacement Bath Stone column cluster painted to look like Purbeck Marble (right). The painted stone has a good colour match, but lacks the depth of sheen which a polished Purbeck Marble surface provides.

If new Purbeck Marble is not available for replacement, limestone columns can be painted to resemble Purbeck Marble. This solution was used in the north transept and Zouche Chapel in York Minster. It was so skilfully done, it is hard to see the difference.

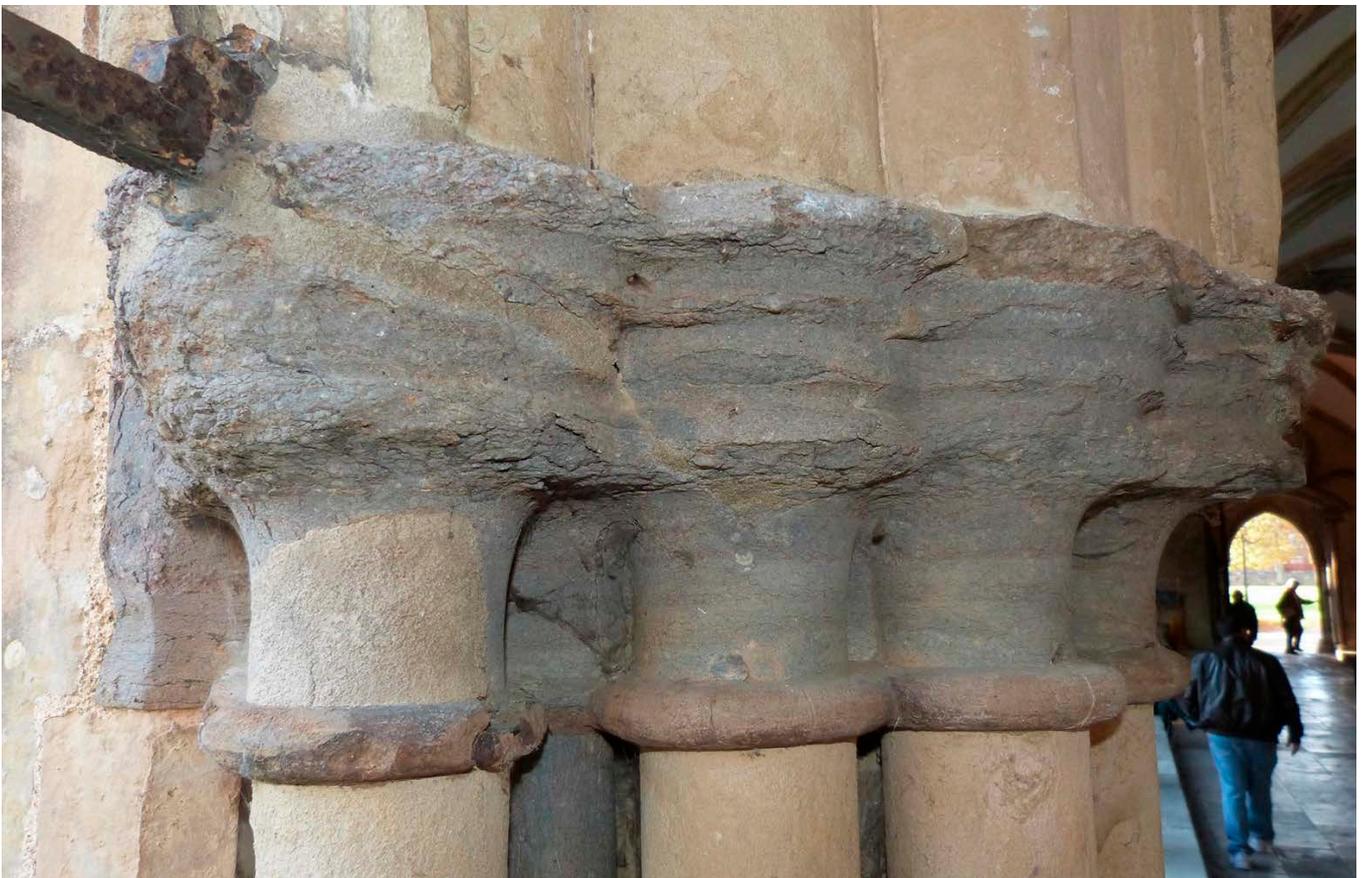
Figure 34: Capitals of a column cluster in Salisbury Cathedral showing a variety of issues including ongoing decay, poor previous repairs and (repaired) damage from the expansion of an iron bar.

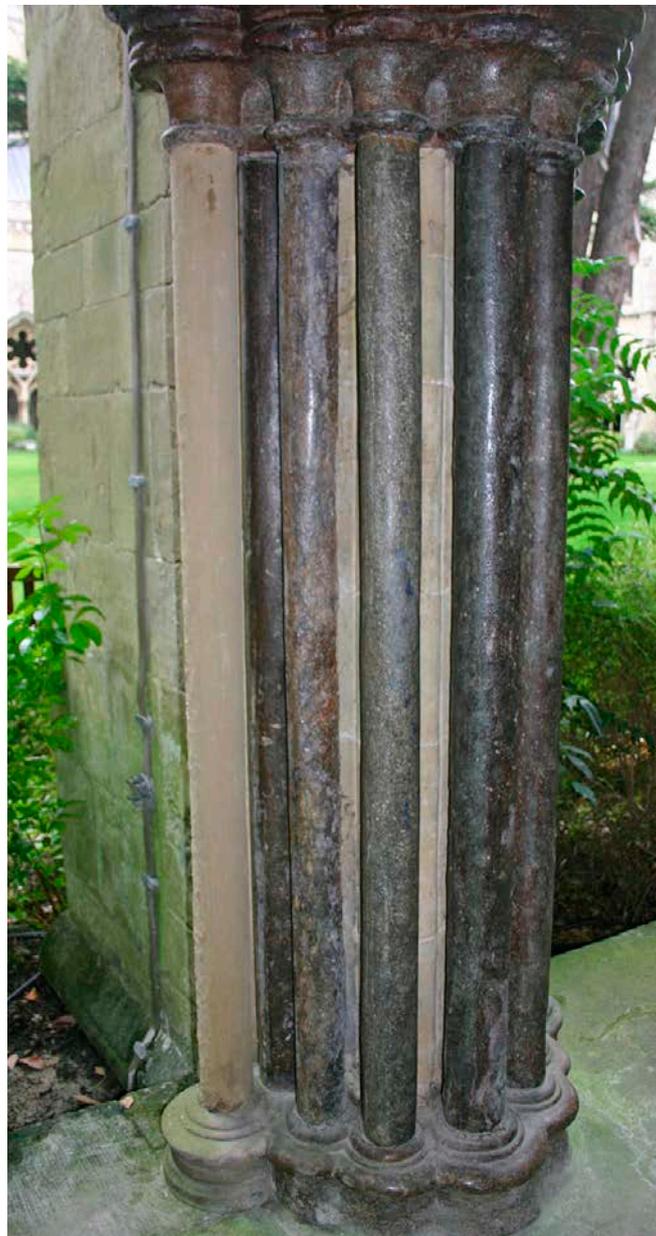
Figure 37: This column cluster in Salisbury Cathedral cloisters was subject to a variety of trials in 1993, but assessment of the results has been limited because there has been a subsequent programme of replacement and re-coating with microcrystalline wax.

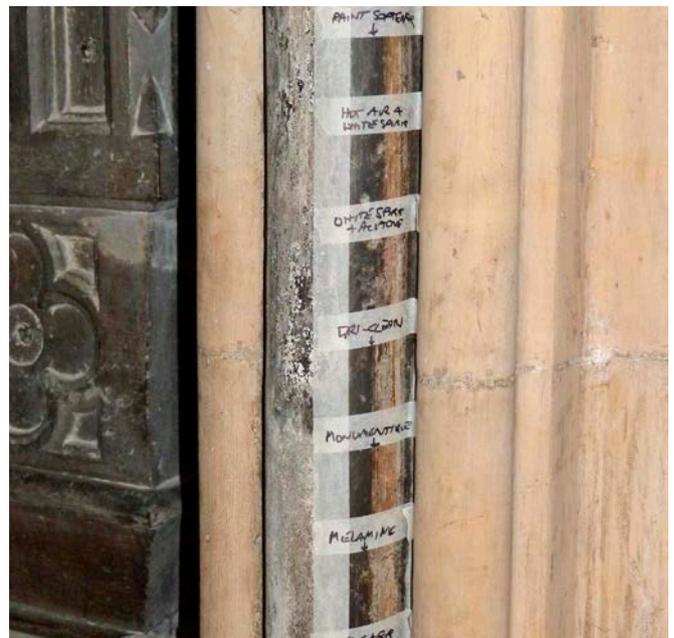
Figure 38: Cleaning trials on a Purbeck Marble column on the north choir aisle at York Minster involved a variety of methods including sponges, poultices and solvents.

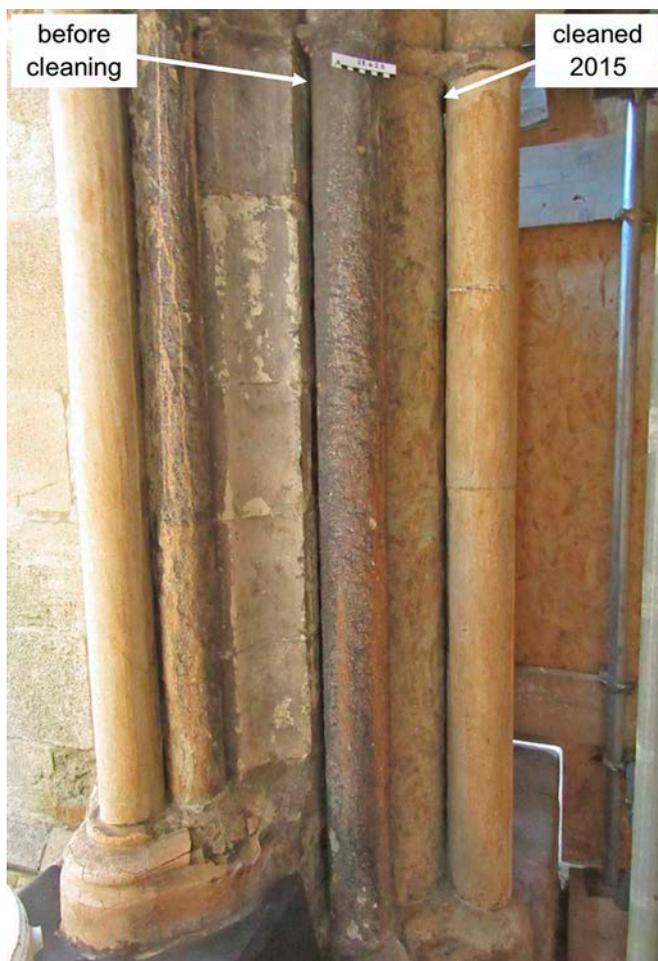
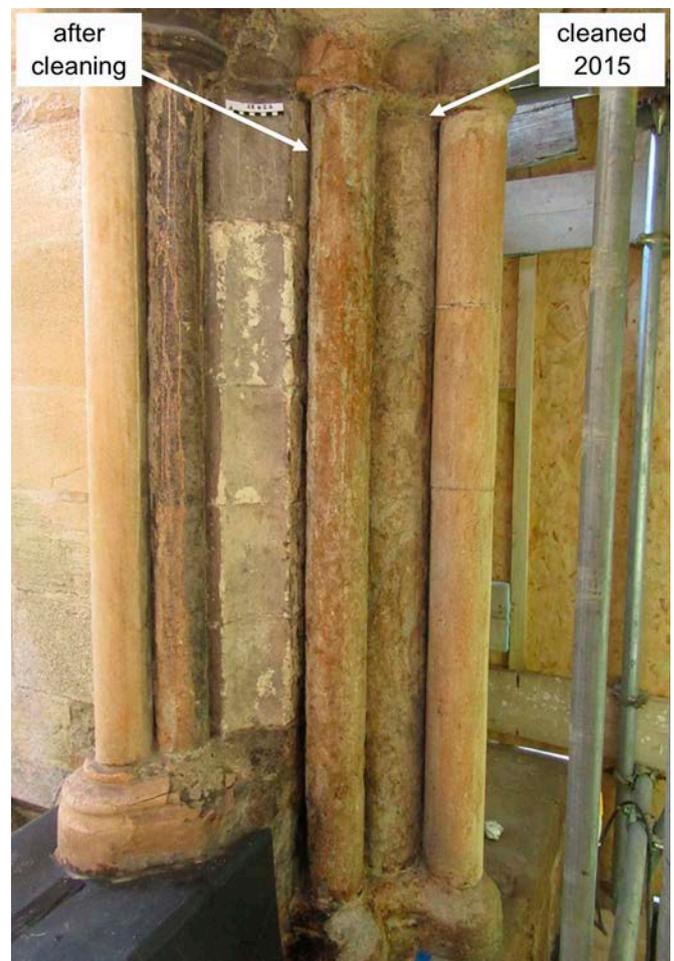
Figure 39: At Norwich Cathedral cloisters, the heavily soiled and coated columns were cleaned using a poultice of synthetic latex and EDTA. Dwell time had to be carefully controlled to avoid over cleaning and all the poultice material had to be removed using dry steam.

- applying a natural latex poultice, with or without ethylenediaminetetraacetic acid (EDTA). As it cures, the latex adheres to and retains the surface dirt; it can then be peeled off. However, it is not suitable for friable or rough surfaces, as loose sections of the substrate will also be removed and fragments of latex can be left behind in cracks and crevices. Latex containing EDTA should be avoided on highly polished marble as it will tend to etch the surface
