Historic England

Purbeck Marble

Conservation and repair

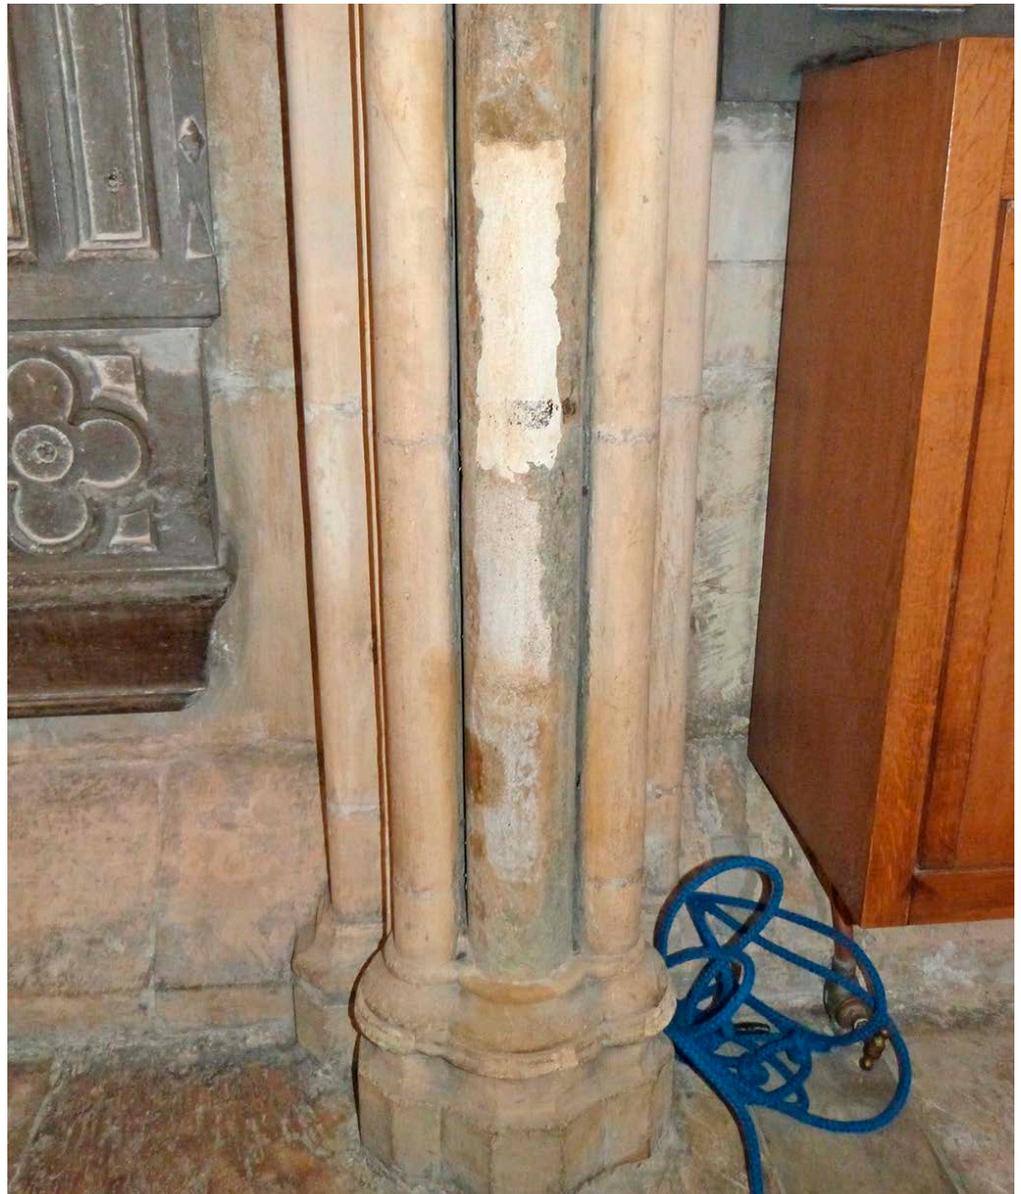
Figure 40: Removal of surface coatings can often reveal previous repairs beneath. These in the north choir aisle at York Minster may be inappropriate either in appearance or composition and will need to be re-done.

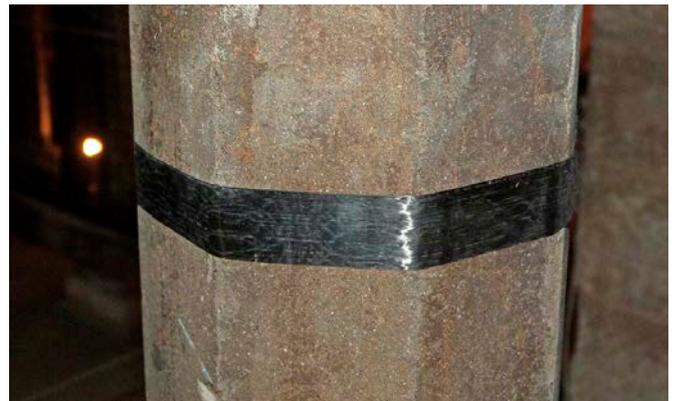
Figure 42: Canterbury Cathedral triforium: carbon-fibre tape provides stability for columns that may be splitting. The tape can then be disguised by covering with resin and crushed Purbeck Marble.

A neat method for stabilising a split is to use carbon-fibre ribbon (usually 25–50mm wide), which can be cut easily but is extremely strong in tension. This will not close up a split, but it will prevent it from developing further.

- apply an acrylic resin (for example, Paraloid B72 5% [weight/volume] in acetone) to the area of Purbeck Marble where the ribbon is to be located
- while the resin is still tacky, wrap the ribbon around the column with a minimum overlap of 100mm
- pull the ribbon tight and connect the ends with epoxy resin. It is helpful to secure a small length of timber with epoxy resin to the free end of the ribbon. This can be used to provide tension and then be cut off once the adhesive has set
- the ribbon can be disguised by applying epoxy resin to the surface and then covering it with Purbeck Marble dust or other aggregate/pigments while still tacky

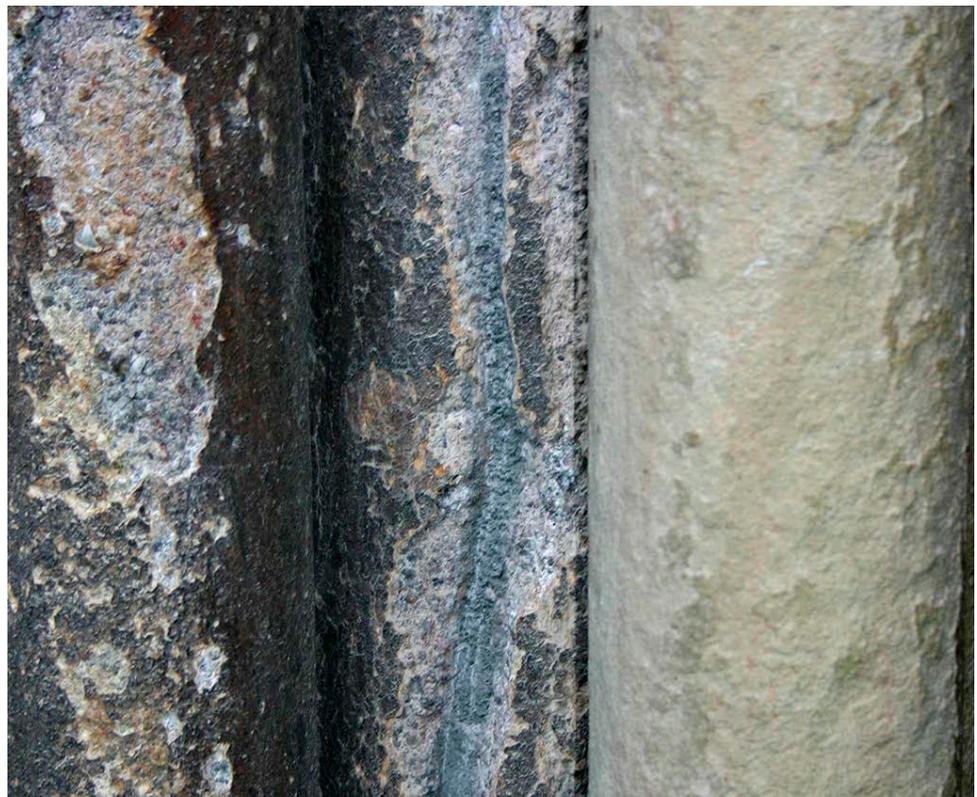
Figure 43: Completed grouting of a split in a column in Salisbury Cathedral cloisters.

- plug the outer part of the fissure with a removable sealant, such as cotton wool or clay
- insert small diameter (3–4mm) plastic tubes through the sealant at intervals (perhaps 100mm) along the fissure
- use a syringe (with a hypodermic needle to fit the tube) to inject grout into the lowest tube, and continue until the grout appears in the tube above
- remove the syringe, plug the lowest tube and repeat the process on the tube above until the fissure is filled
- once the grout has set, remove the tubes and the temporary sealant and make good with mortar to match the Purbeck Marble

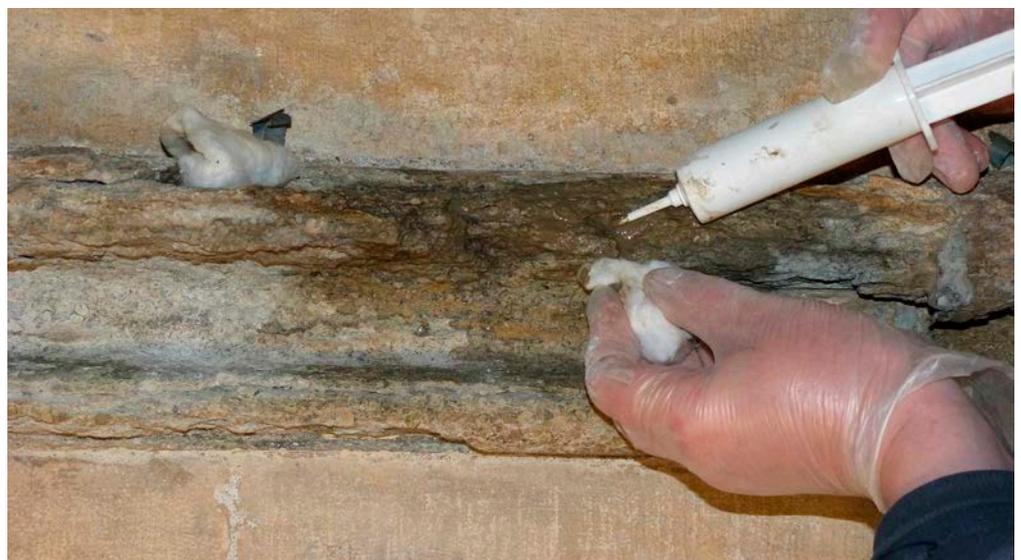
Figure 44: Using dispersed lime injection mortar (mixed 1:1 with trass) to secure spalls of an internal Purbeck Marble string course at York Minster.

- securing individual spalls with dispersed lime injection mortar. Dispersed lime is a natural lime putty (not synthetic like nanolime) with a very small particle size. For the injection mortar, it is mixed with a surfactant to allow good flow characteristics. Because of the small size (and therefore high surface area), dispersed lime is very reactive. It is normally mixed with a small amount of water, pigments and perhaps a powdered pozzolan (such as trass) and injected behind and around the friable sections, using a hypodermic syringe with a 2mm needle. Excess mortar can be removed with a small spatula once it has set. This material may not adhere well to surfaces that retain hydrophobic coatings, such as wax. Consequently, such coatings should be removed beforehand if possible.

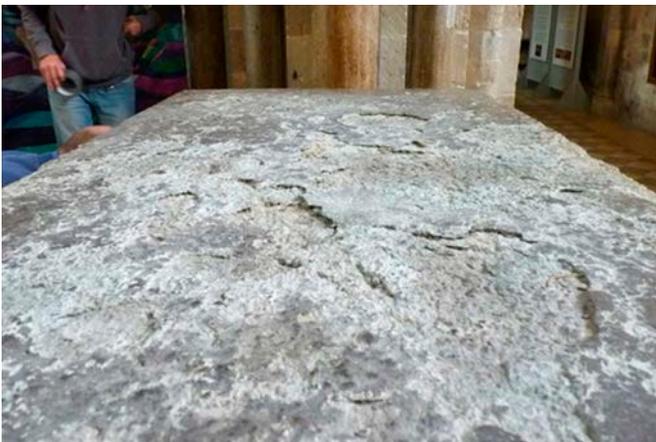
Figure 45: The top of a chest tomb at Chichester Cathedral before (above) and after (right) consolidation of spalling Purbeck Marble with dispersed lime injection mortar.

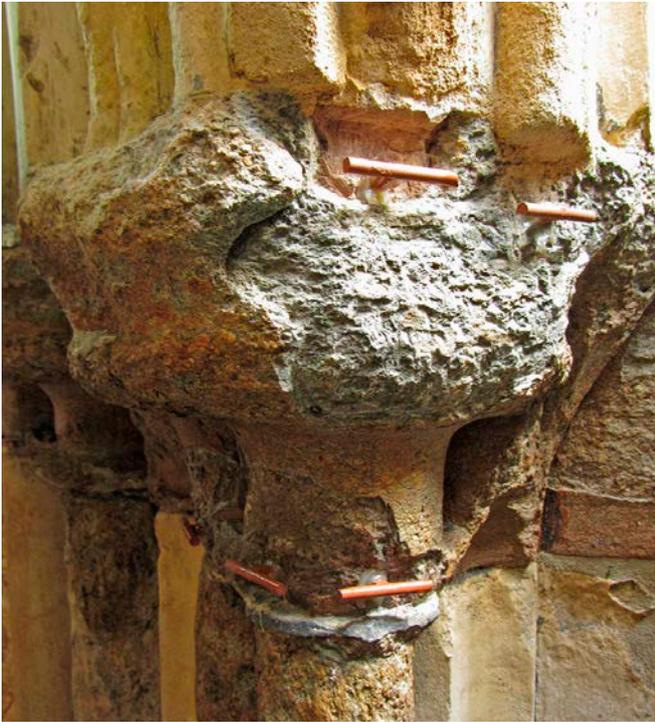
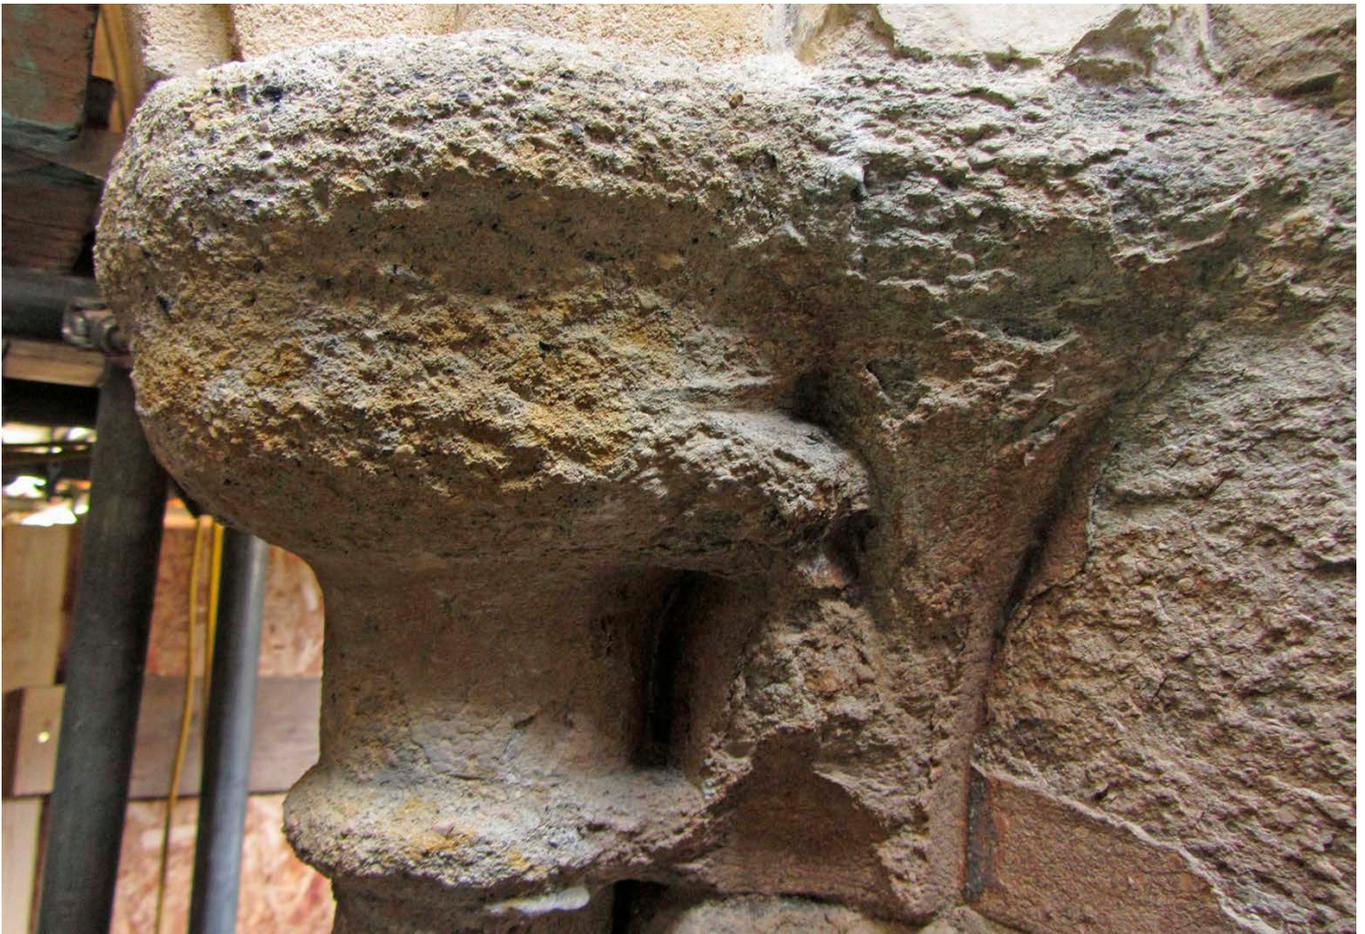
Figure 47: Repairs to Purbeck Marble capitals in Norwich Cathedral cloisters:
(top left) A Purbeck Marble capital prepared for repair with loose material removed and ceramic armatures in place.
(top right) Repairs of a Purbeck Marble capital completed using mortar based on lime putty.
(bottom) Repairs to a Purbeck Marble capital completed with pigments blown onto the surface.

In some situations, mortars may require additional support, which is best provided by using ceramic 'T' armatures. Ceramic is preferable to stainless steel (or other metal) because the mortar has better adhesion to a porous armature and the two materials have more compatible physical properties.

Dry earth pigments (raw umber, burnt umber, raw sienna, burnt sienna, yellow ochre, terre verte and ivory black) can be used to tone in repairs. While the mortar is still wet, small amounts of pigment are scooped onto a metal spatula and blown directly onto the surface to mimic the colouring of the stone. As the mortar cures, the carbonation of the lime fixes the pigments to the surface.

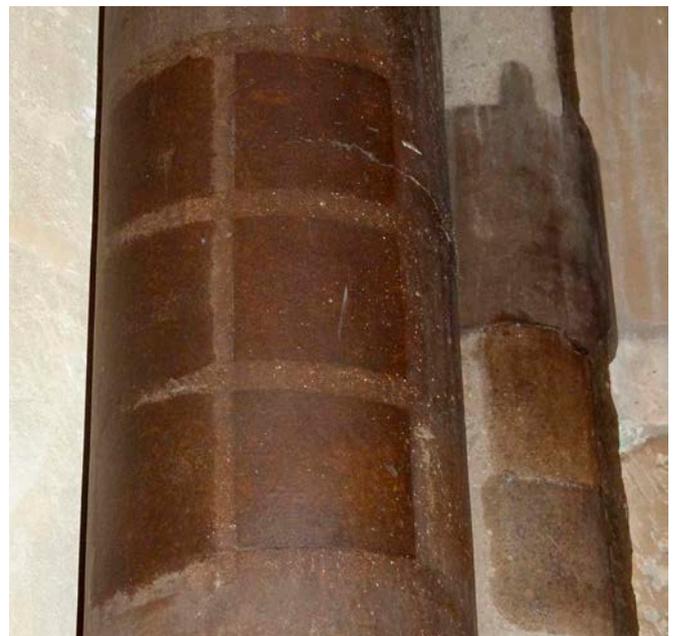
Figure 48: Trials of various coatings in Canterbury Cathedral; including beeswax, microcrystalline wax, linseed oil and goose grease.

Wax can also be applied to surfaces that already have other existing treatments. Indeed, it can be effective at filling micro cracks in previous treatments. Other materials, such as linseed oil and goose grease, may also be appropriate if it is essential to use an authentic traditional treatment.

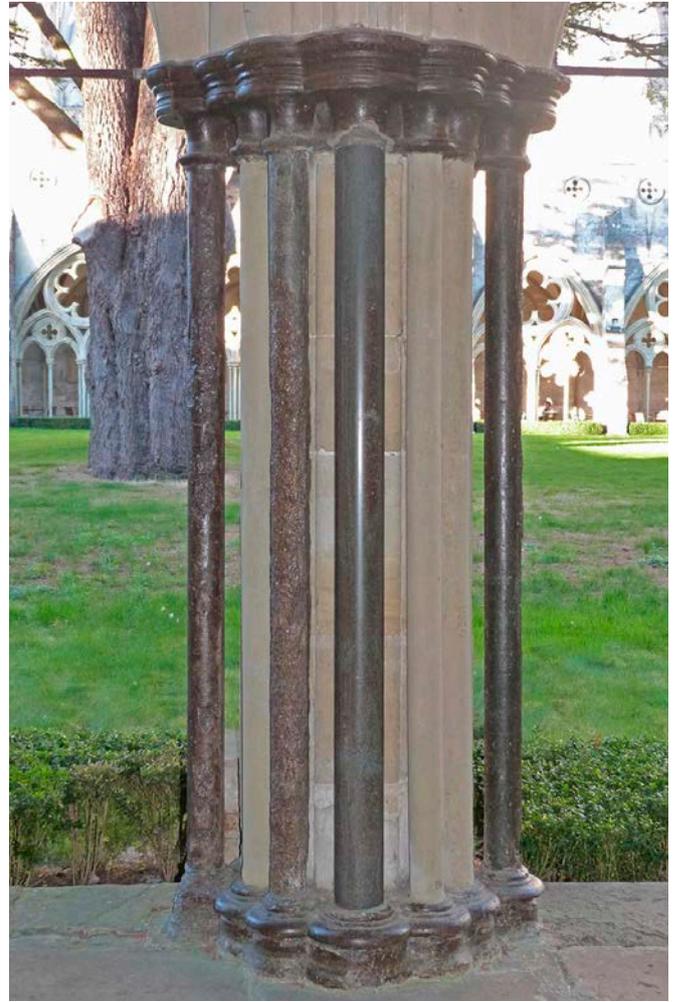
Figure 50: A new Purbeck Marble column in Salisbury Cathedral cloisters inserted and treated with pigmented wax.

Visual contrast will be a problem with any replacement material, but the disparity between old stone and new seems particularly obvious with Purbeck Marble. In situations where visual harmony is more important than ‘honest repair’, small amounts of earth pigment can be added to the wax to reduce this disparity.

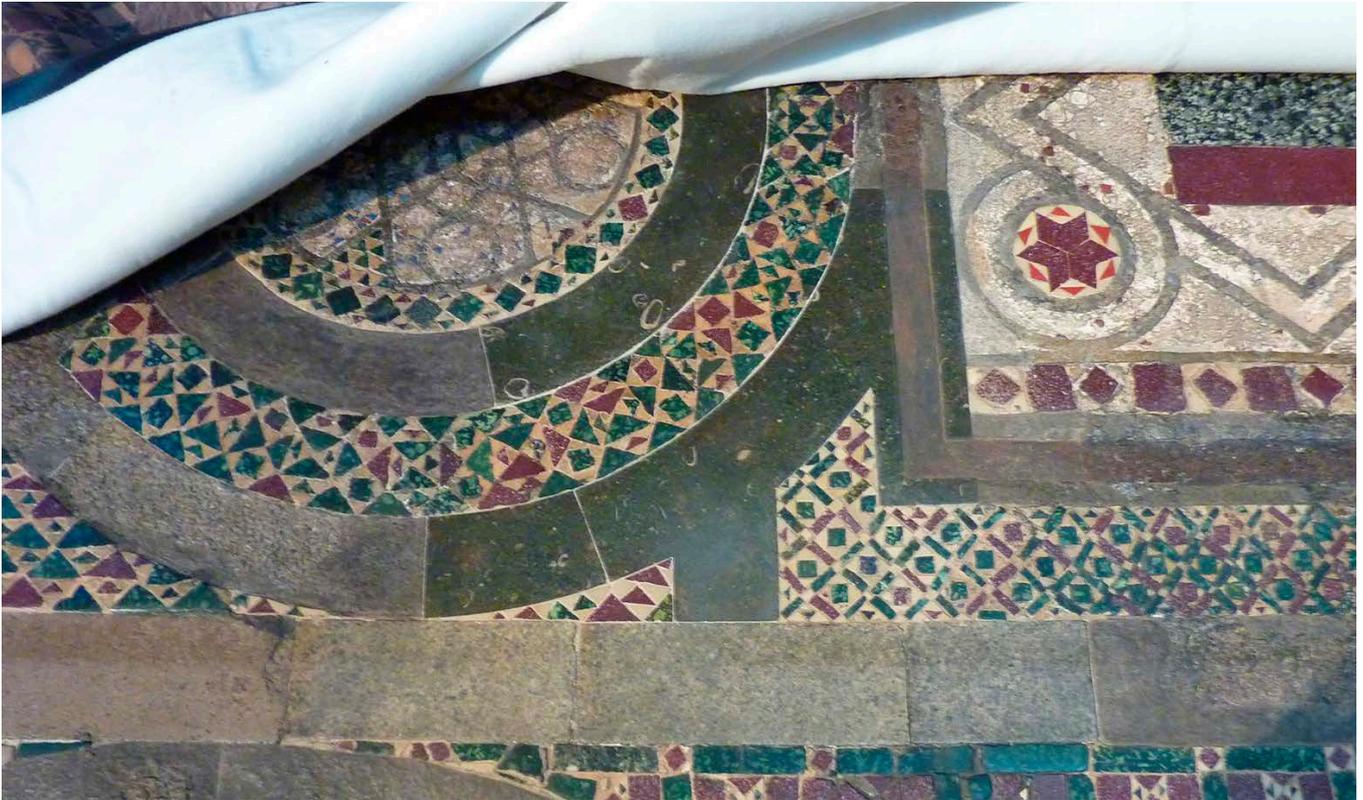
Figure 51: Insertion of new Purbeck Marble into the framework of the Cosmati pavement at Westminster Abbey.
