Historic England

Energy Efficiency and Historic Buildings

Insulating Solid Ground Floors

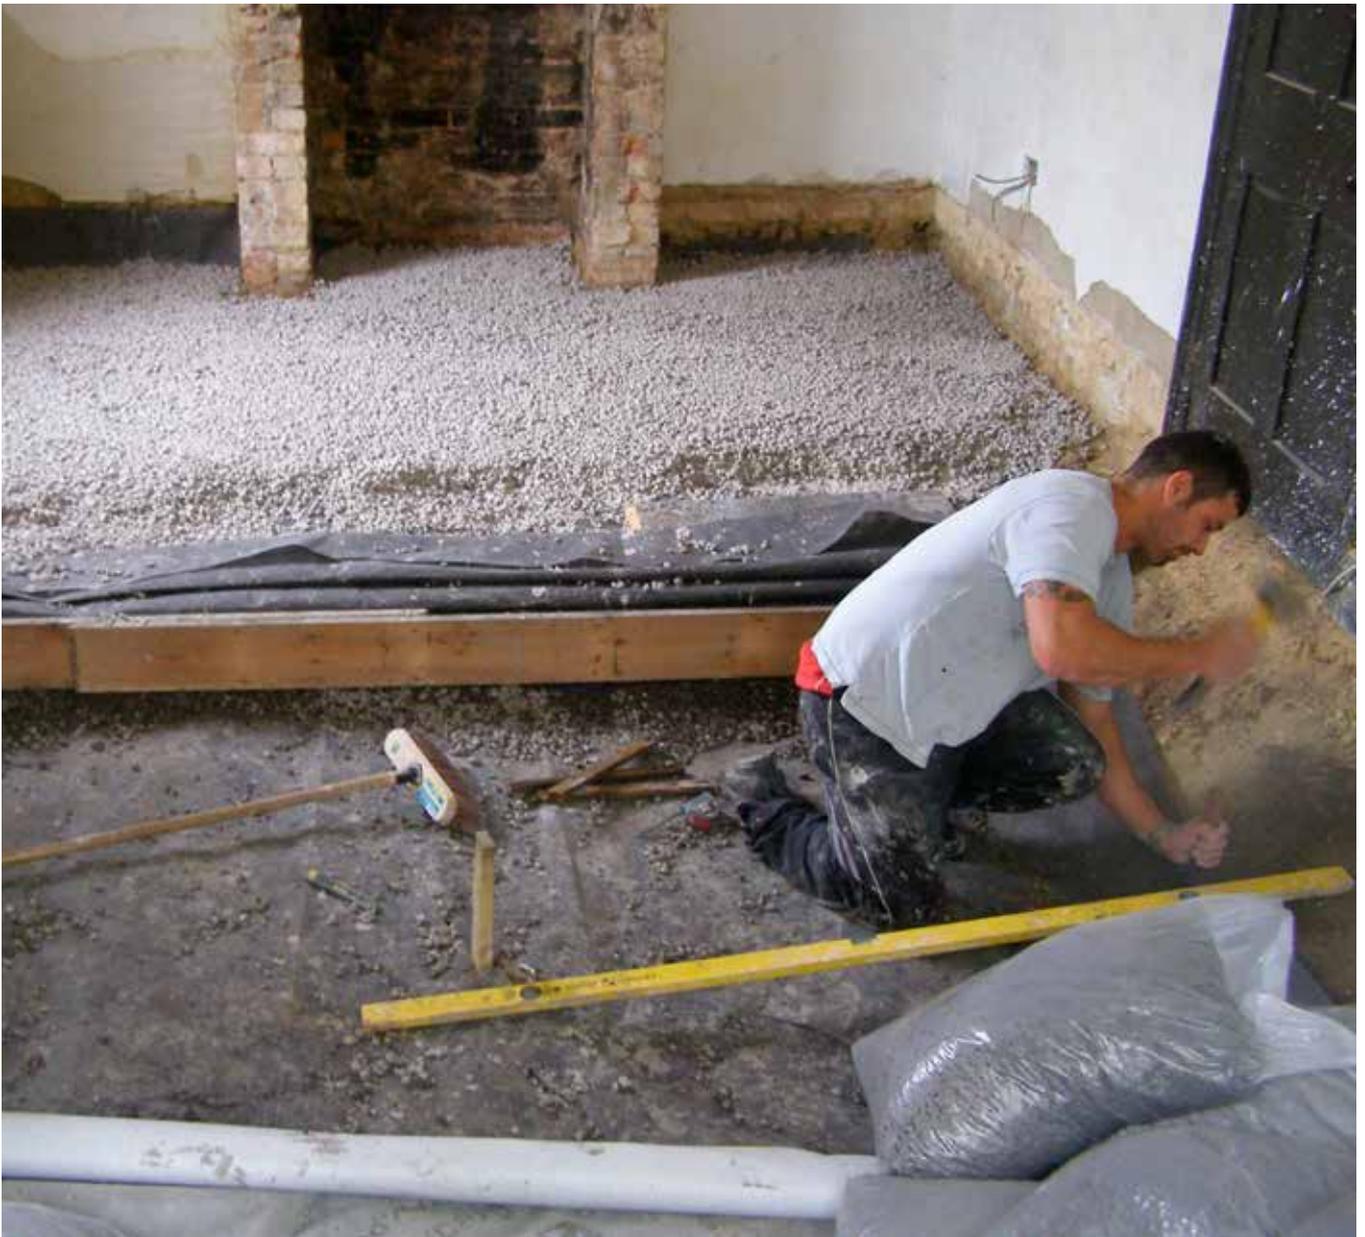
Front cover

An insulated hydraulic lime floor being laid.
© Matthew Clements/Mike Wye and Associates.

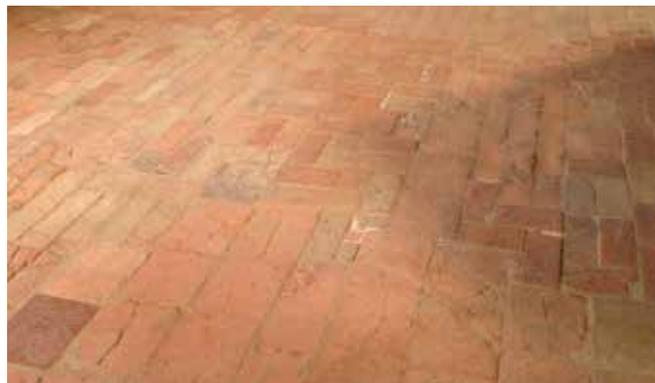
Figure 1

By the 14th century brick floors were being laid.

By the 14th century brick floors were being manufactured and imported. Large tiles of clay were also being used for flooring, such as 'pamments' and flooring 'pantiles'.

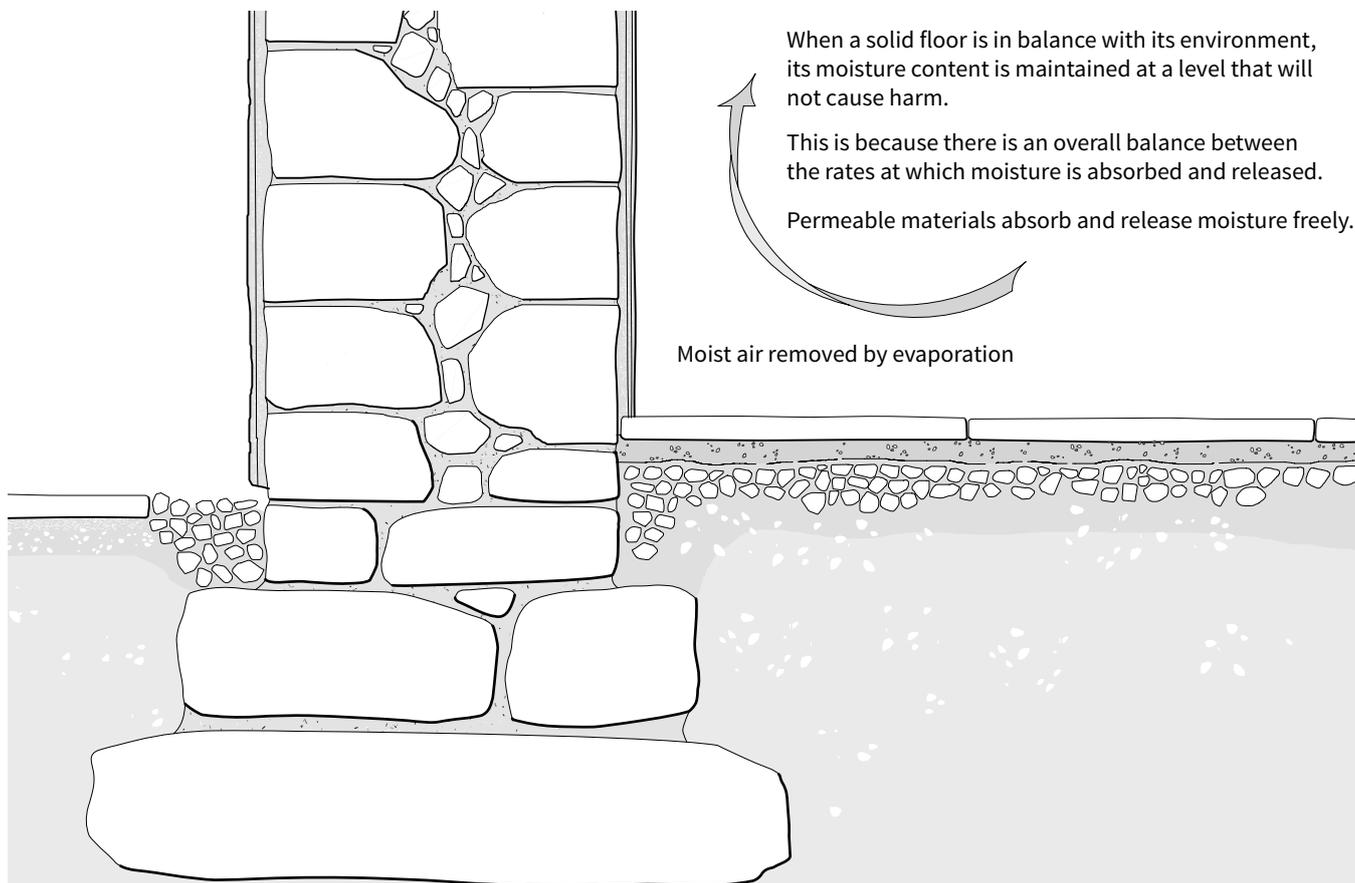
Figure 2: Uninsulated historic floor in equilibrium with its environment

A permeable solid floor can be in equilibrium with its environment when moisture is able to easily evaporate uniformly with an adequate amount of ventilation.

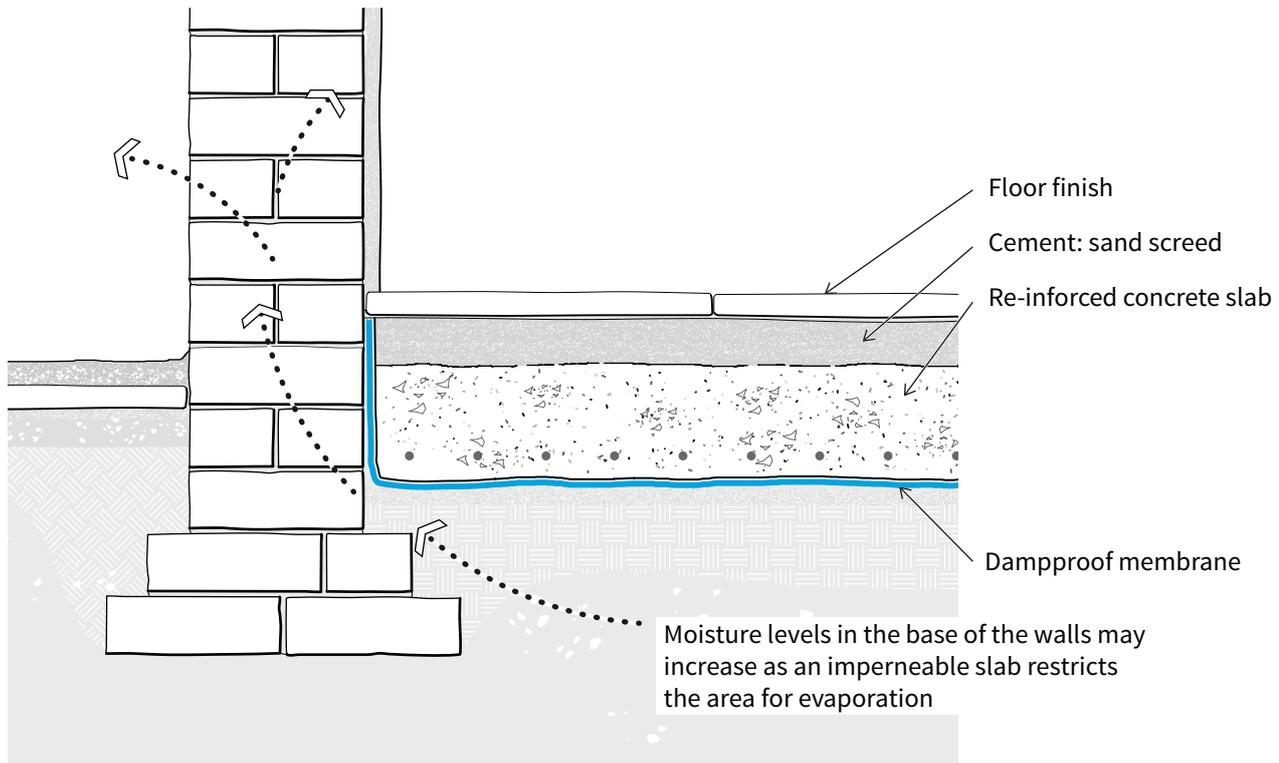
Figure 3: Suspended timber floor replaced with uninsulated concrete slab & dampproof membrane

Many suspended timber floors have been removed in the past and replaced with un-insulated concrete slabs installed over a damp proof membrane. This can in

some cases drive moisture into the walls that would otherwise have permeated through the floor and evaporated in the ventilated sub-floor area.

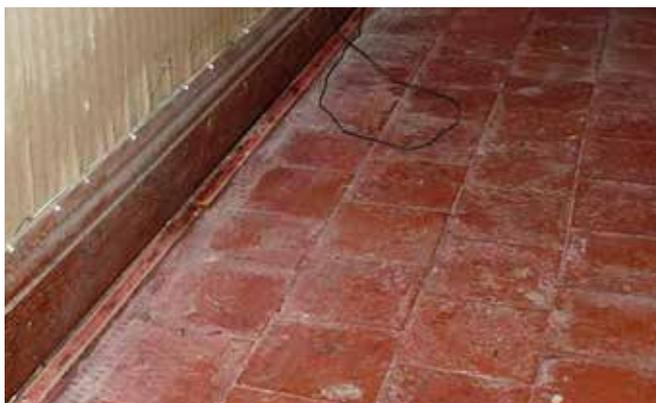
Figure 4
Salts appearing on the surface of a solid floor that has been very damp.
© Janice Gooch.

Taking up and relaying an old brick, stone or tiled floor on a new concrete sub-floor with a damp-proof membrane can cause salts within the old floor materials to migrate to the surface resulting in white efflorescence on the floor surface. These

salts in turn can absorb moisture from the air and create a damp floor purely by their hygroscopic action. They have an affinity for water, and readily absorb moisture from the air or from other substances. They try to achieve equilibrium with their surroundings by taking up or releasing moisture. Changing moisture levels occurring with fluctuations in heating can result in the re-crystallisation of the salts which exacerbates problems of damp. The crystal growth in the pores can also severely erode the original materials.

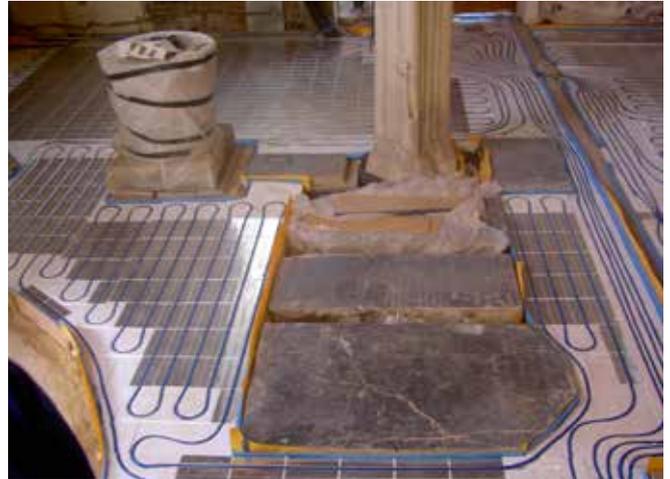
Figure 5
The addition of an insulation layer is an essential part of an under-floor heating system.
© Jupiter Heating Systems.

However, an under-floor heating system will greatly increase the difference between the floor temperature and the ground temperature below, perhaps by as much as 10-15 degrees C. This will significantly increase the potential for heat loss through the floor and the installation of an insulation layer below the heating system should therefore be regarded as an essential part of such a system.

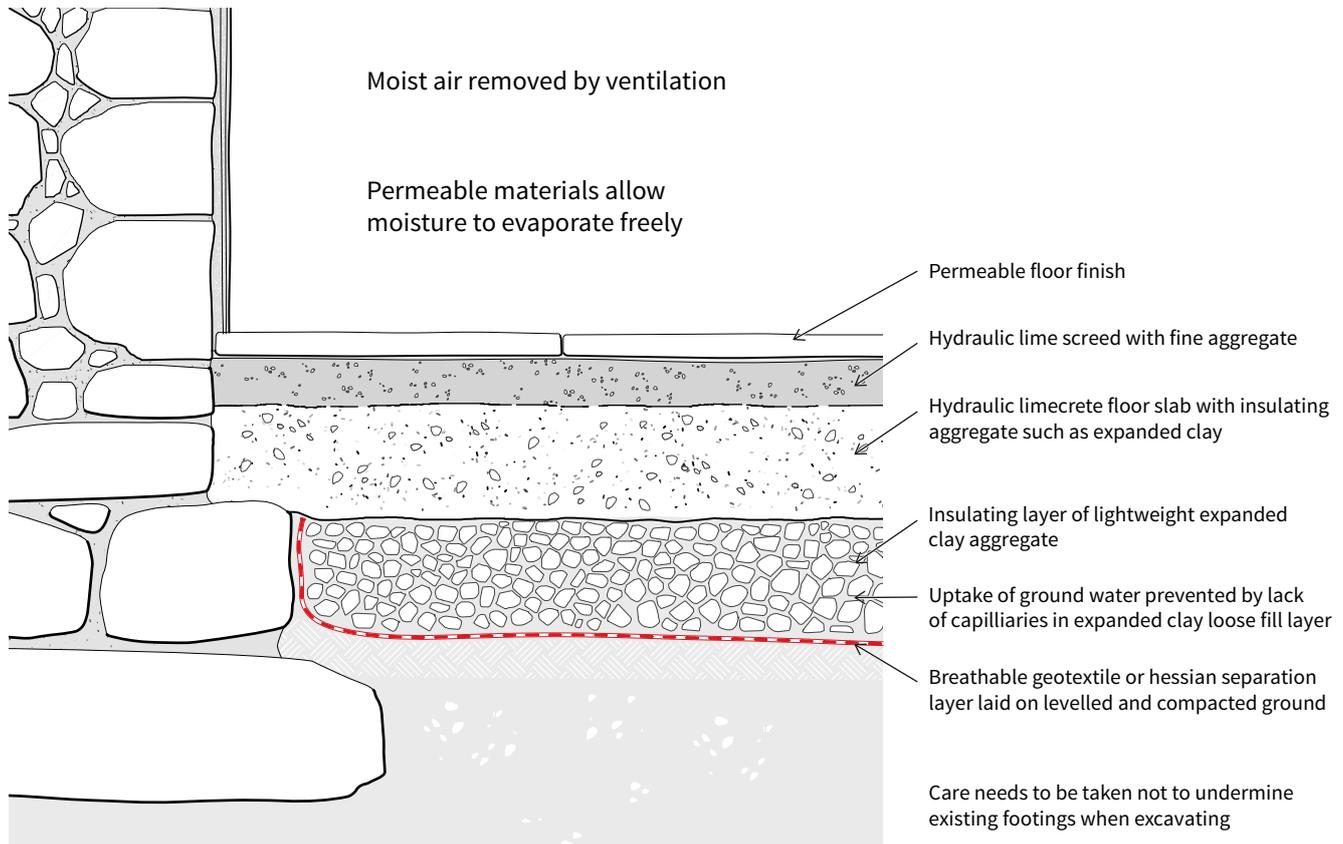
Figure 6: Insulating limecrete slab

Where a decision is taken to insulate a historic floor then one option is to provide a permeable insulated floor slab as shown here. Expanded clay is used as the insulant.

A typical installation consists of a build-up of three layers:

- Principal insulating layer – a layer of expanded clay aggregate laid loose, normally over a breathable membrane to prevent the ingress of subsoil particles
- Insulating lime concrete slab – a layer of insulating aggregate, normally also expanded clay, with hydraulic lime binder
- Screed – a screed made with a suitable blend of hydraulic lime with a fine aggregate. This layer can be replaced or finished with re-used tiles or stones in order to reinstate a historic floor finish

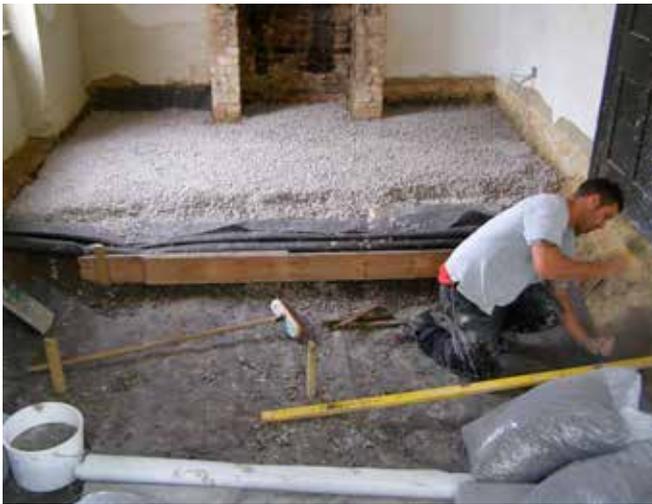
Figure 7
An insulated hydraulic lime floor being laid.
© Matthew Clements/Mike Wye and Associates.

A typical installation of an insulating lime concrete floor involves the excavation of the ground to the required depth, then levelling and compaction of the ground before installation of the breathable membrane. This need for substantial excavation is the principal disadvantage of this system. Any floor finishes laid on a lime concrete floor should be permeable to retain the movement of moisture vapour through the floor.
